PROPERTY INSPECTION REPORT

Concerning: 11002 Hammerly #40, Houston, TX 77043
(Address or Other Identification of Inspected Property)

By: Scott Carey, Lic# 23052 07/05/2018
(Name and License Number of Inspector) (Date)

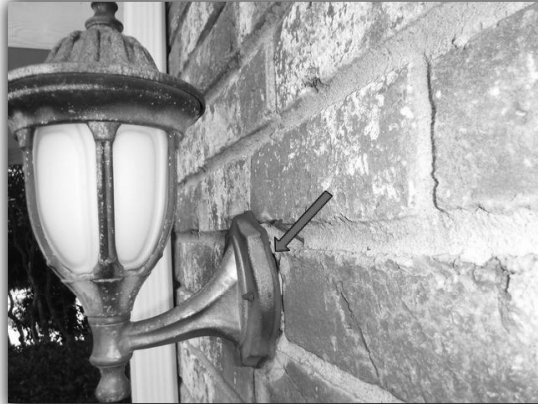
Seal

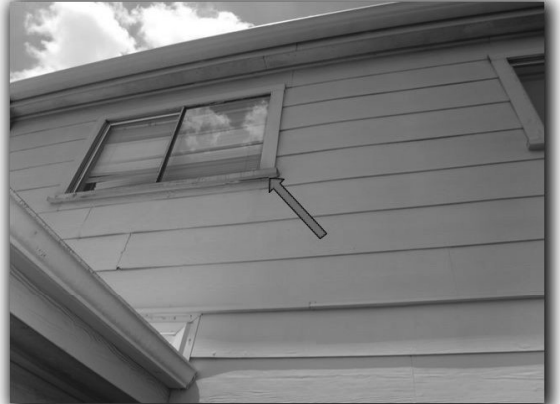
Seal

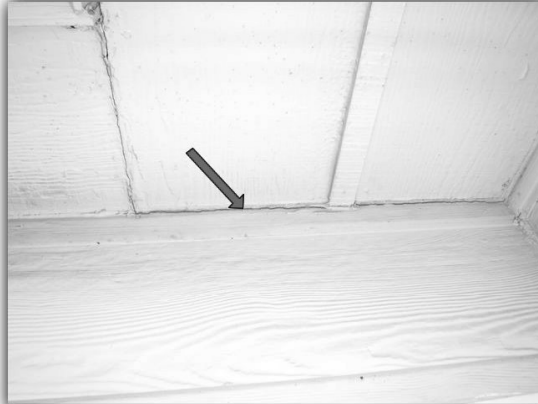
Seal

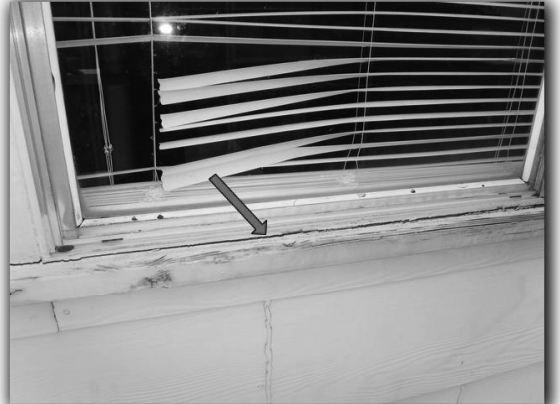
Seal

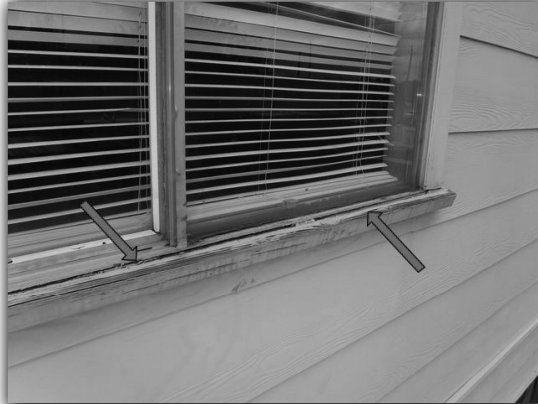
Moisture Damage / Seal

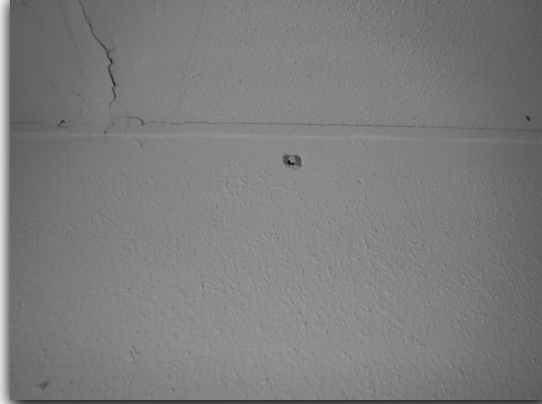
Tape joint & Nail Pop(s)

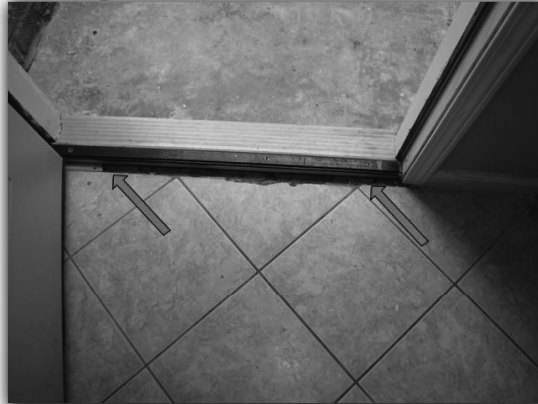
Tile Damage @ Front Entry

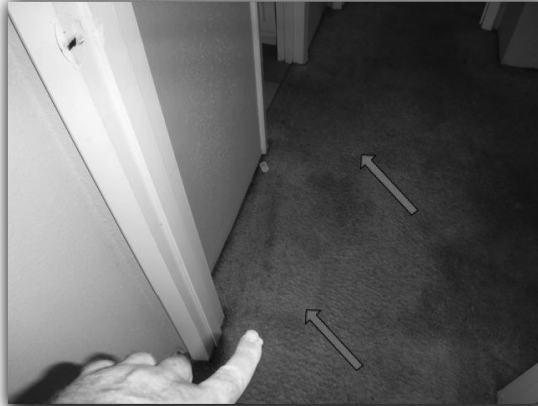
Deflection in Floor(s)

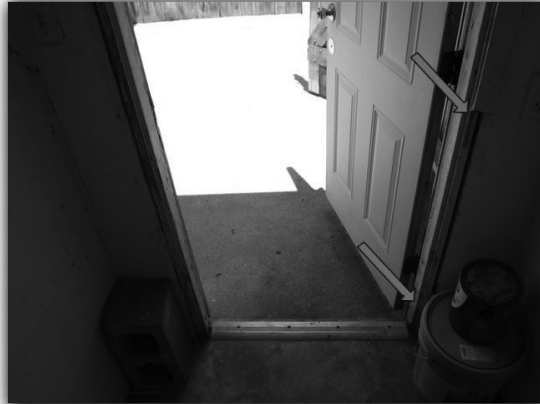
Moisture & Trim Damage

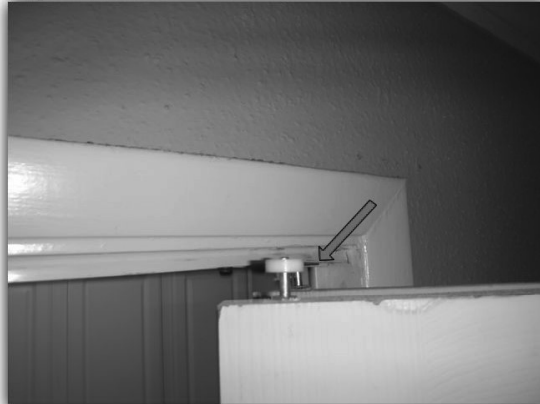
Damaged Hardware

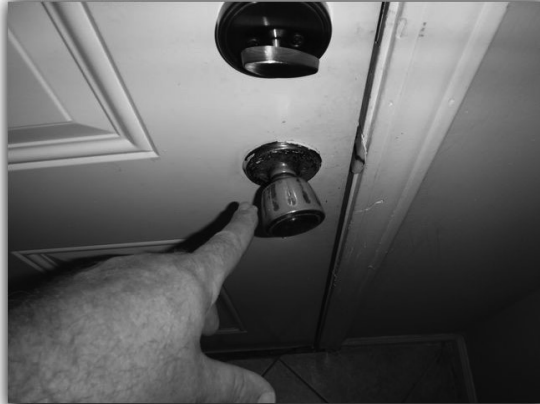
Front Door Handle

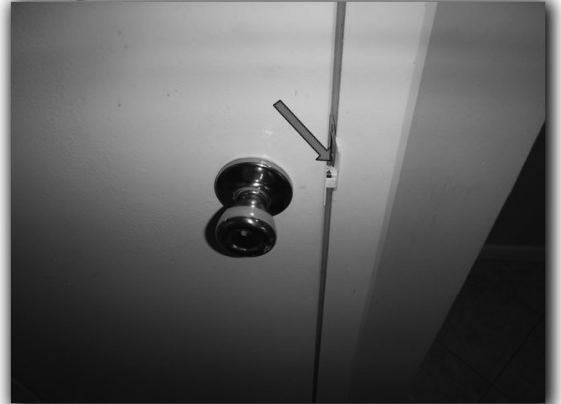
No Catch @ Hardware

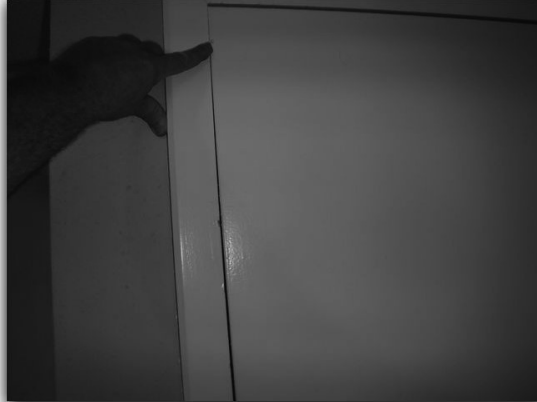
HVAC Door Rubs

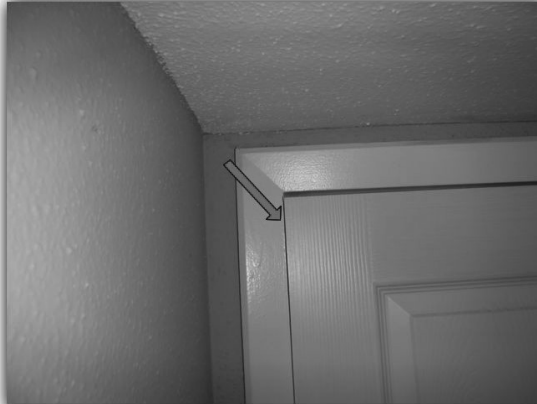
Master Door Rubs

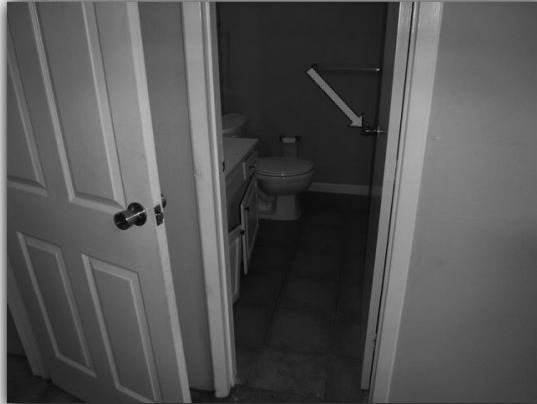
Missing Privacy Lock

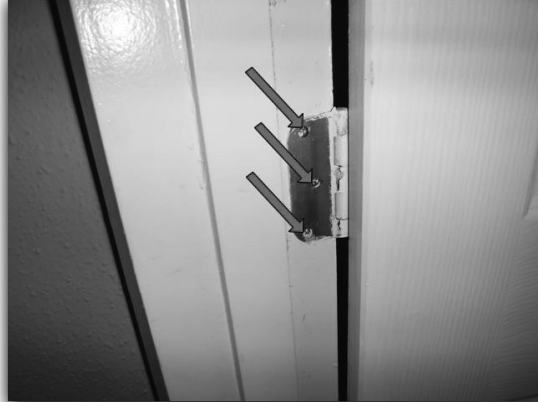
Missing Screws

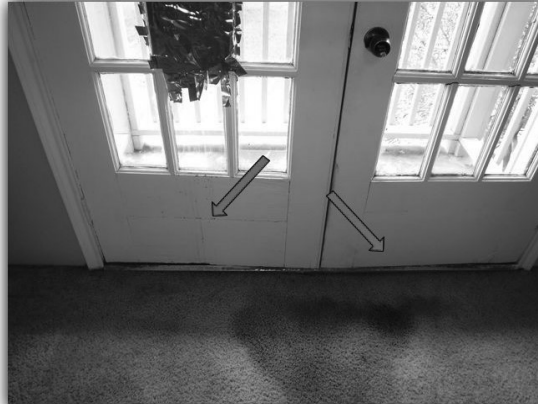
Moisture Damage

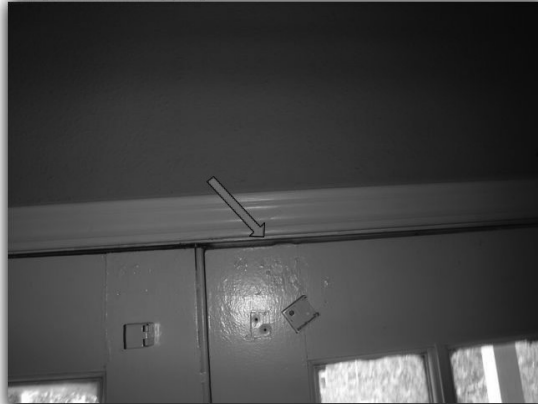
Missing Weather Stripping

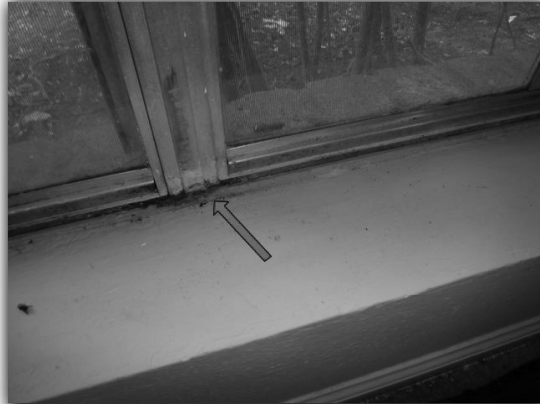
Moisture Damage

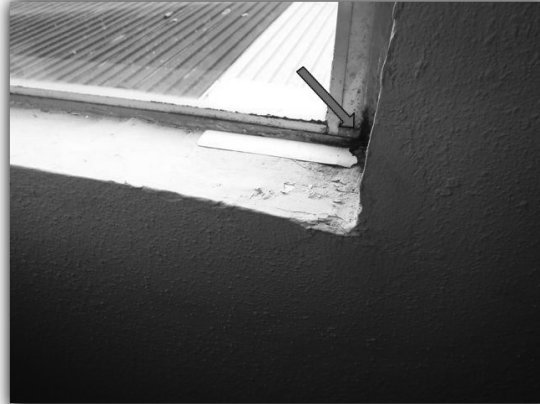
Moisture Damage

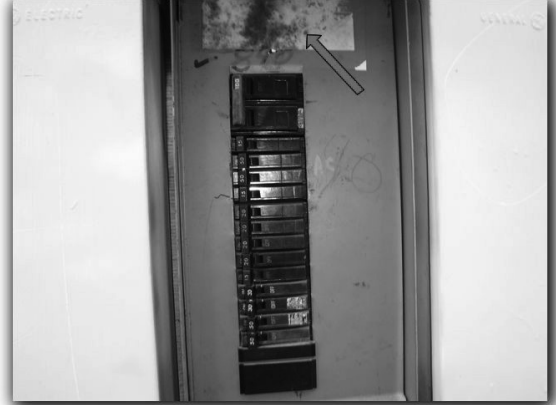
Incomplete Labeling

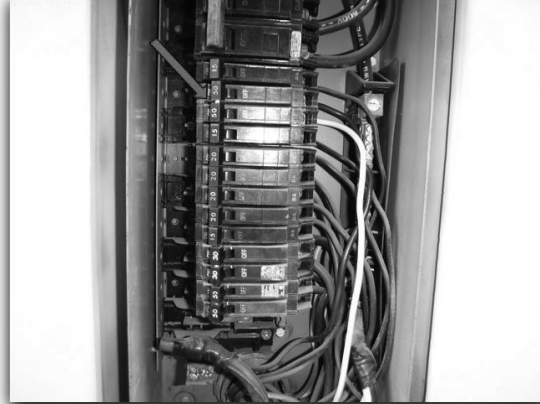
A/C on 50 amp.

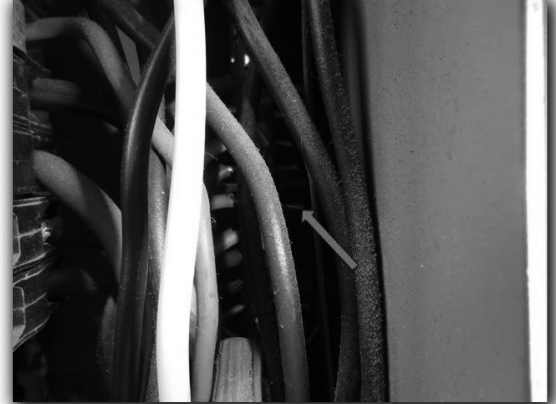
Aluminum Wires

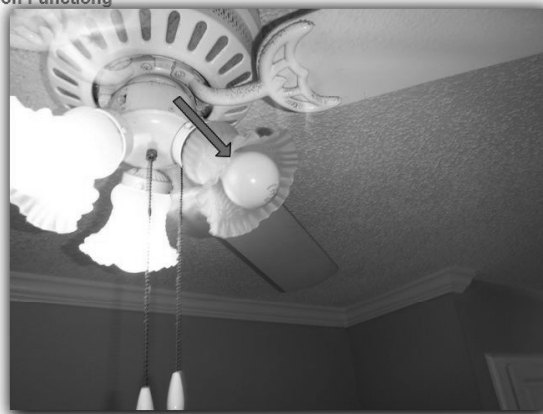
Non Functiong

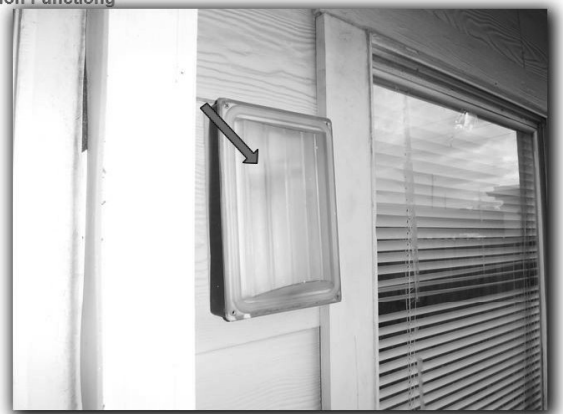
Non Functiong

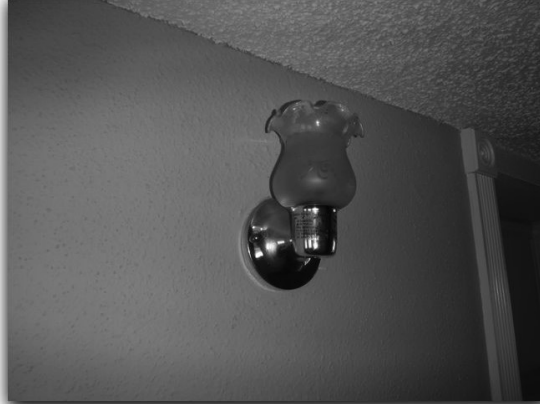
Non Functiong

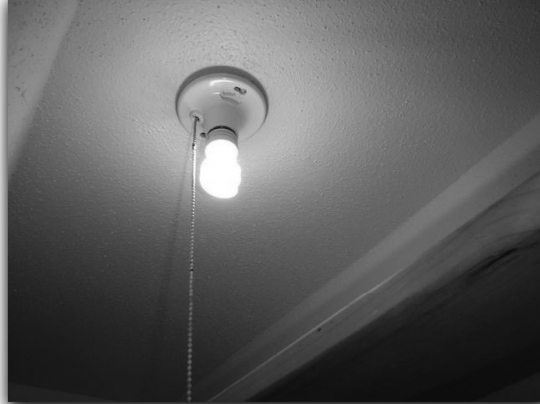
Missing Cover(s)

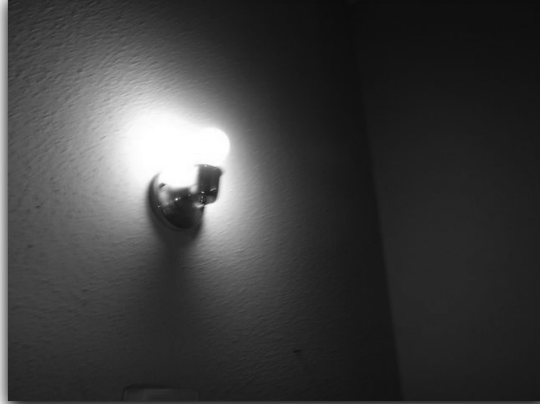
Missing Cover(s)

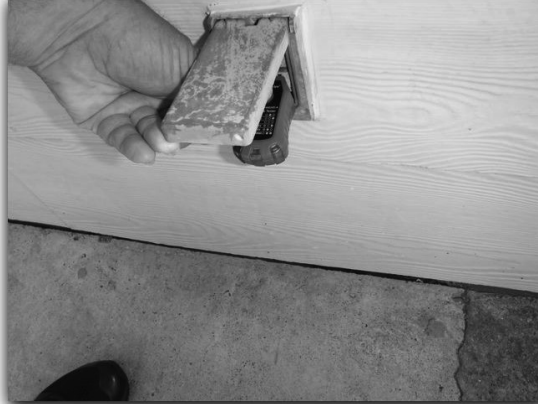
Non GFCI Exterior

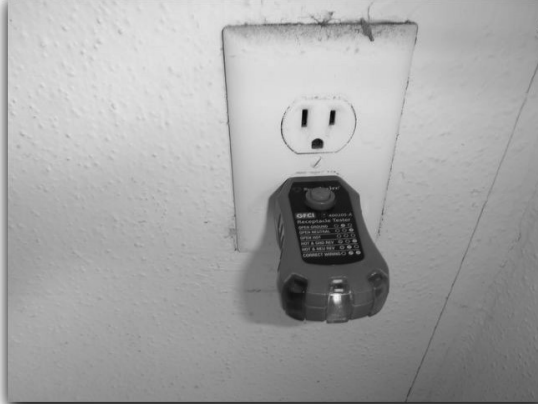
Open Ground

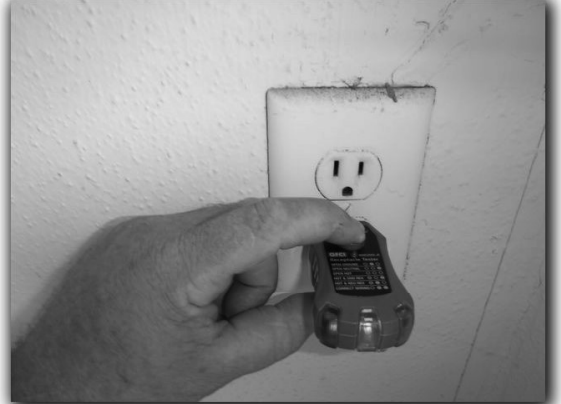
Non GFCI

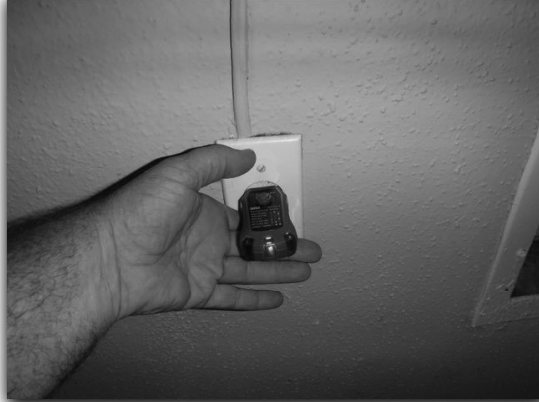
Open Ground @ Laundry

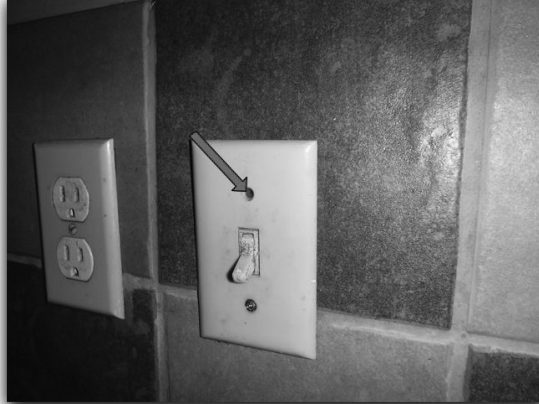
Missing Screws

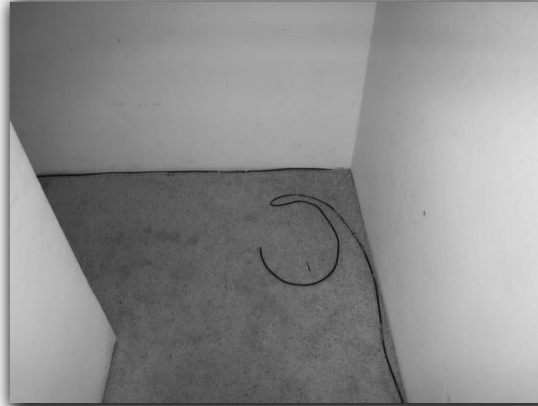
Undetermined Wires

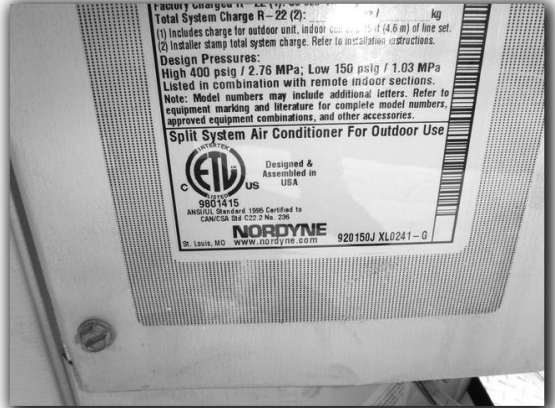
-Low-pressure line insulation shows advance weathering and age. Recommend adding new insulation materials to help reduce condensation issues and promote efficient operation of unit.

Deteriorated / Missing Insulation

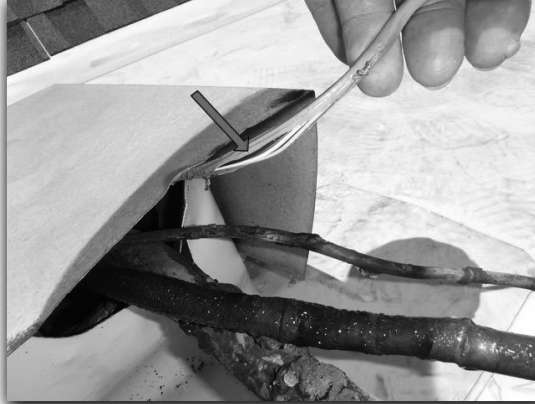
Exposed Wiring

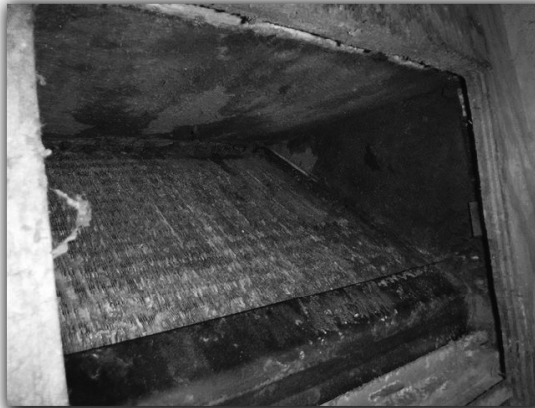
-The thermostat wire at the compressor and condenser unit(s) were observed to be spliced and was exposed to the weather. Recommend properly terminating wire nuts and wrapping with proper electrical tape to prevent premature deterioration.

Thermostat Wiring

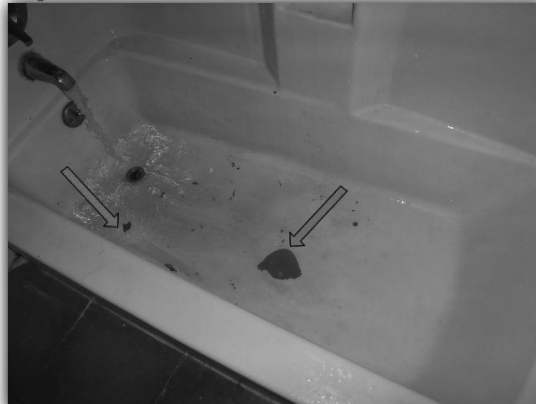
- The surfaces for the upstairs master bathroom sink and bathtub were observed damaged / deteriorated. Repair as needed for ease of cleaning.

Damaged Surface

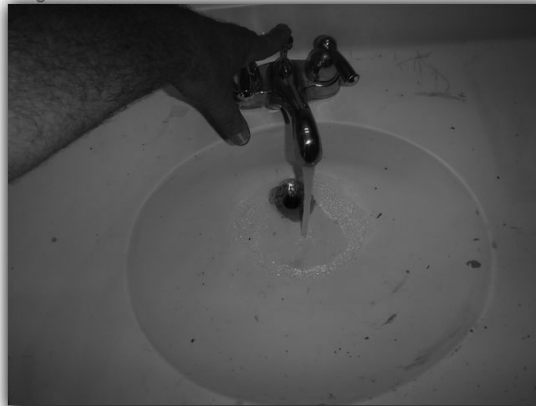
Damaged Surface

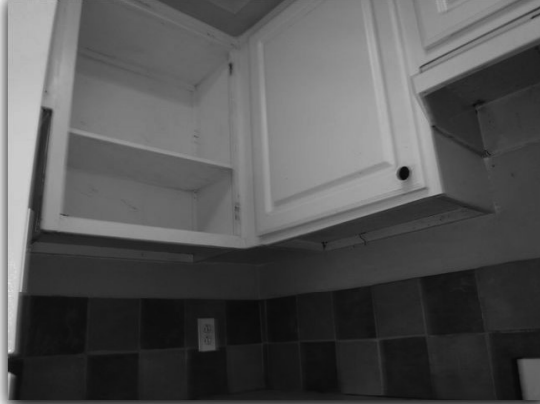
Missing Door Front

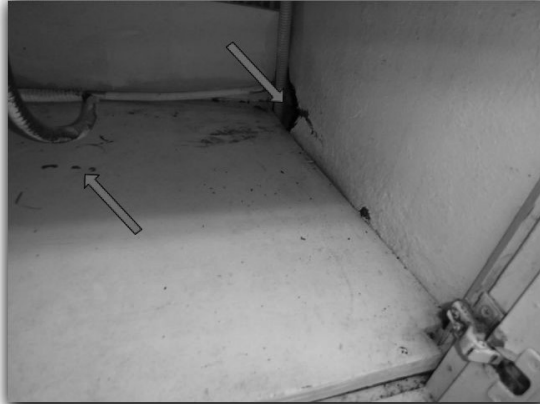
Damaged Cabinet Base

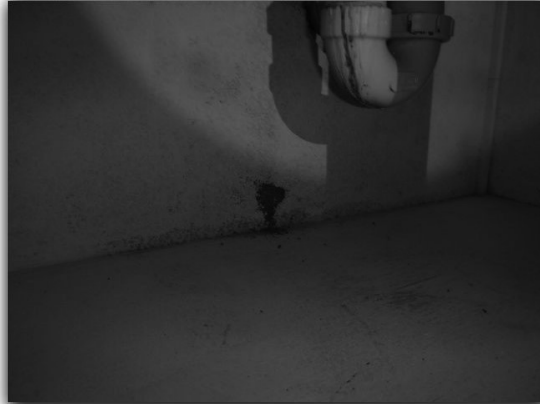
Previous Moisture Damage

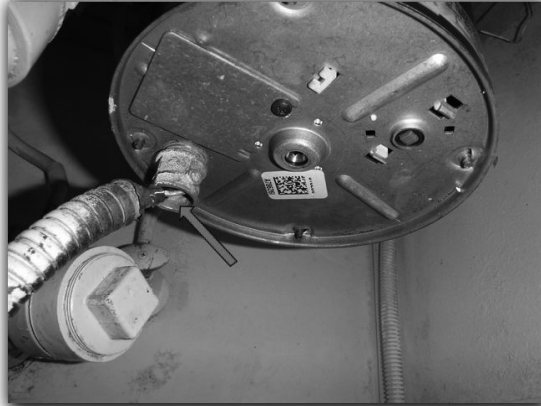
Exposed Wiring

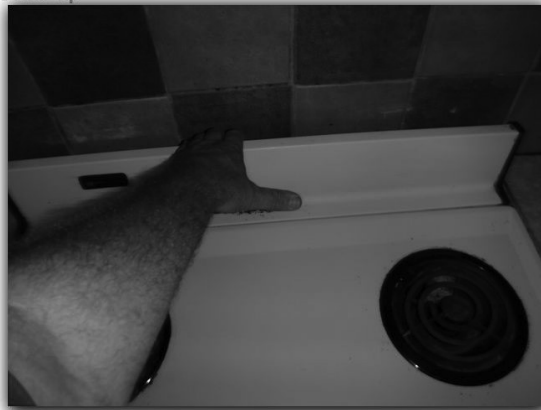
No Anti-Tip

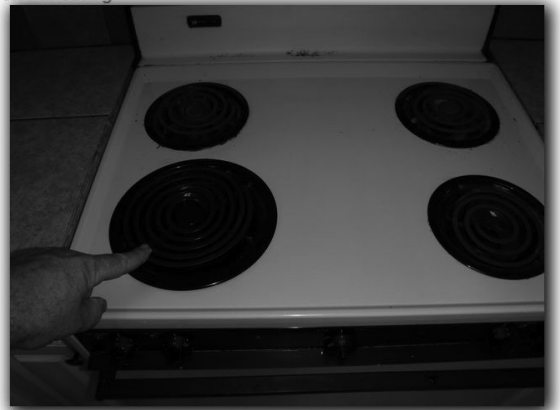
Non Functioning
