PROPERTY INSPECTION REPORT

Concerning: 4930 Laurel Hill Ct, Sugar Land, TX 77478
(Address or Other Identification of Inspected Property)

By: John Tatum, Lic #9459 07/16/2019
(Name and License Number of Inspector) (Date)

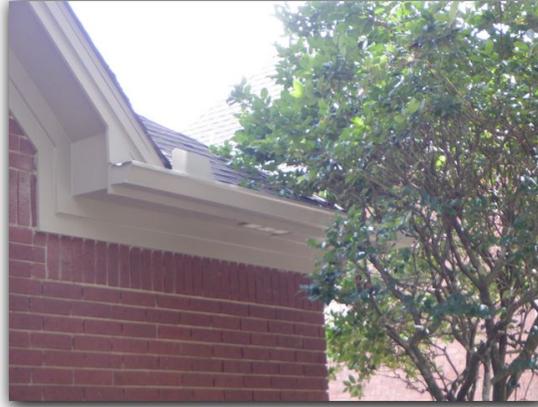
Tree limbs in contact with roof should be cut back.

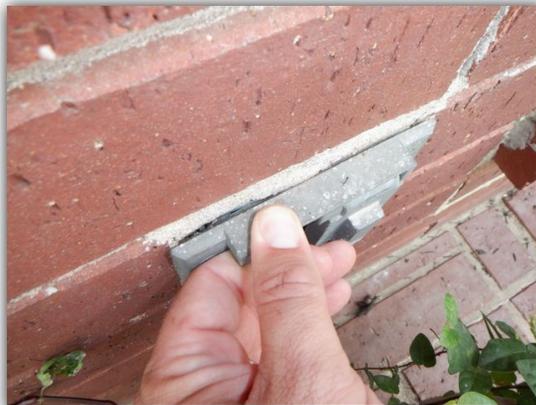
Exterior outlet(s) not sealed well against rain water entry.

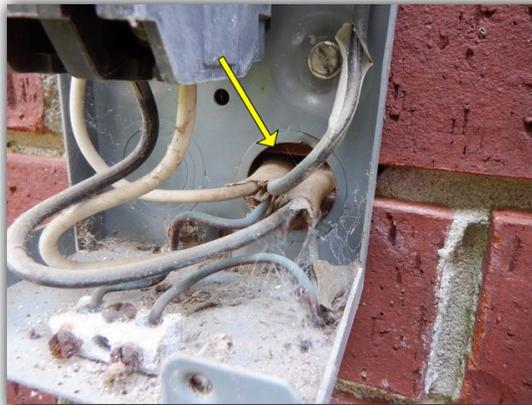
cables should be clamped
where they enter the panel
they should also be secured
within 12 inches of the panel

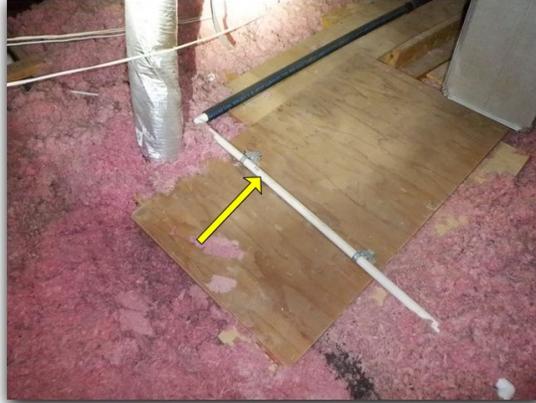
Primary drain line should be insulated along entire length in attic to prevent warm attic air condensing on cool drain line and dripping condensation.
