PROPERTY INSPECTION REPORT

Prepared For: Frank Galloway
(Name of Client)

Concerning: 5700 Bullard Dr, Austin 78757
(Address or Other Identification of Inspected Property)

By: George Corwill, Lic #TREC #21093 07/06/2017
(Name and License Number of Inspector) (Date)

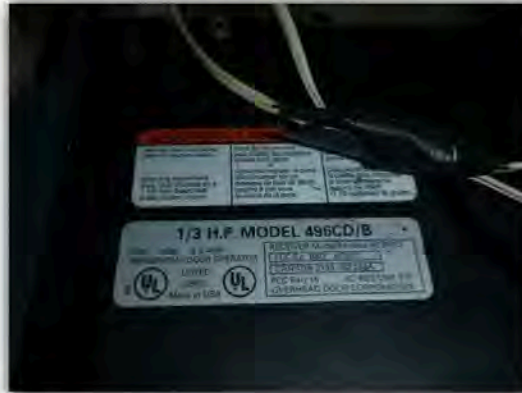
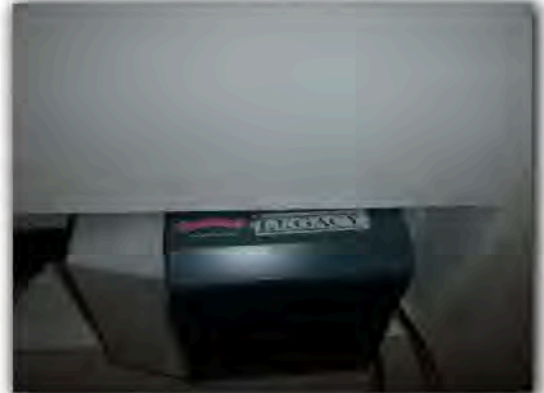
Overhead garage door lock(s) not disabled on door. Manufacturers recommend disabling locks when openers are installed to prevent damage to door/opener unit.

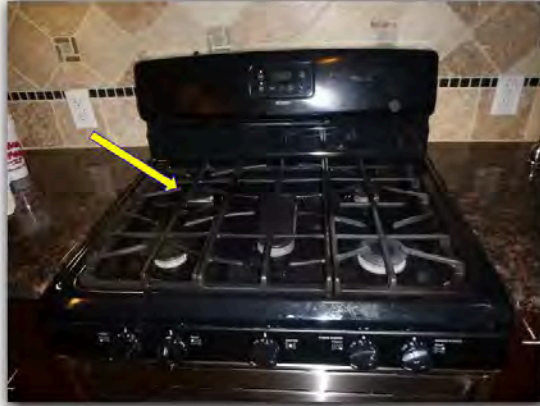
Rear left burner(s) failed to operate.

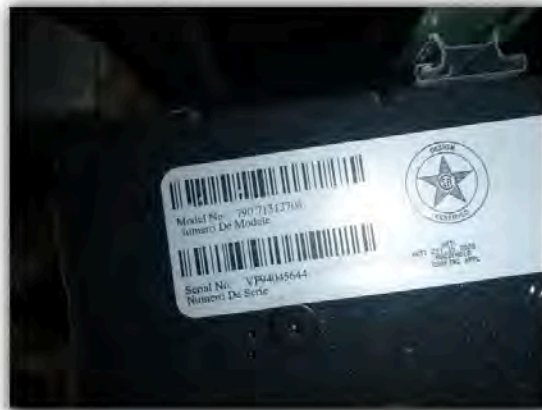
The gas valve was not installed/ inaccessible.

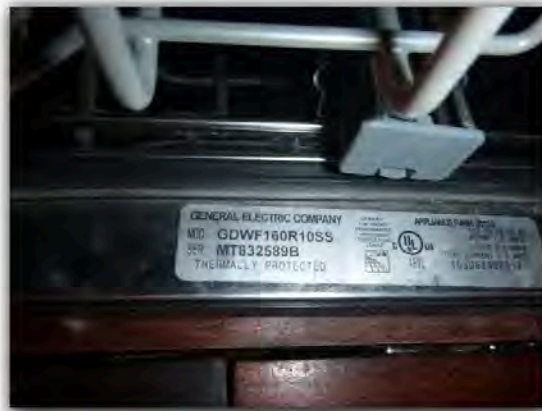
Drainline installed without an air gap. The drainline should be raised to the underside of the countertop.

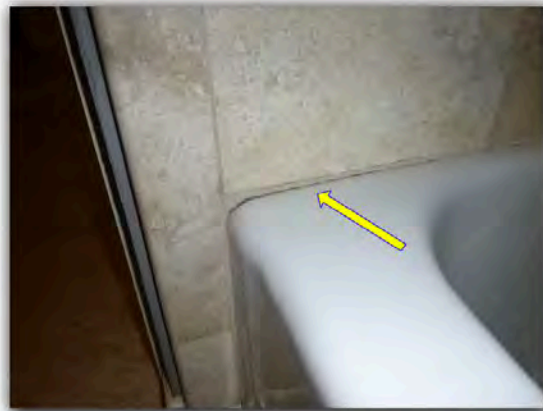
Reseal perimeter of tub to tile and wall joints

Seal fixtures, spout to wall at enclosure.

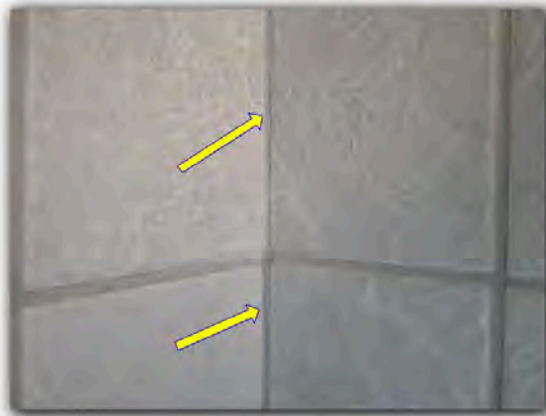
TUB/SHOWER ENCLOSURE:
Grout cracked at front right joint of enclosure walls, in need of repairs.

Seal fixtures, spout to wall at enclosure.

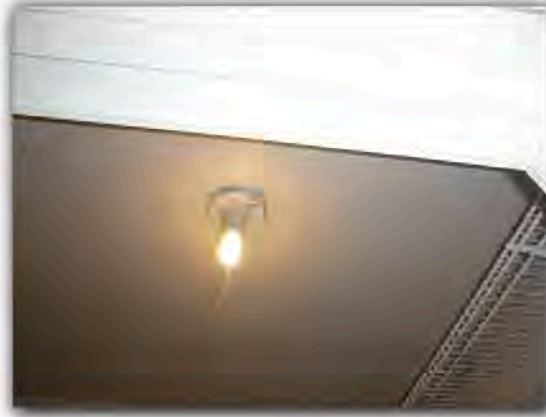
Smoke detectors are not present in all required locations. Smoke detectors should be installed in all sleeping areas & levels of the structure. None installed in sleeping areas. Alarms installed in Hallway appeared old and did not function with test button. Manufacturers recommend replacing alarms every 10 years or less.

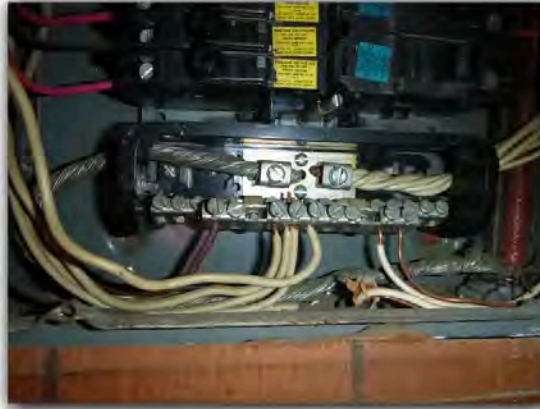
Two or more neutral wires are connected to a single lug on the bus bar. Move the wires to create one to one connection between wires and lugs.

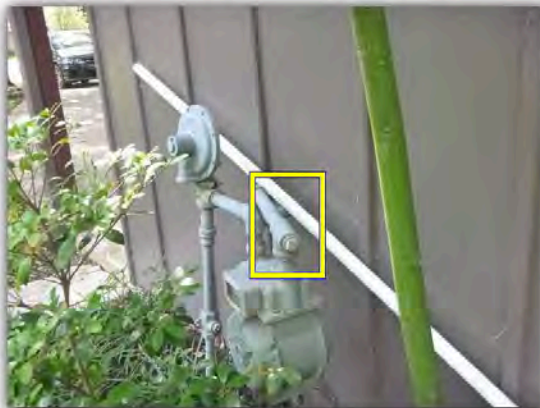
No visible bonding wire installed at gas line exterior of house. Add properly after meter.

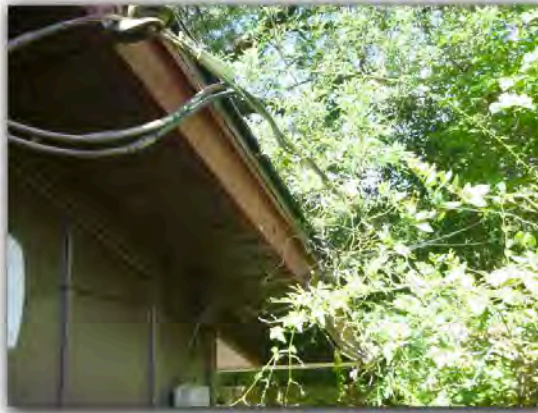
Service drop is too close to ground near structure.

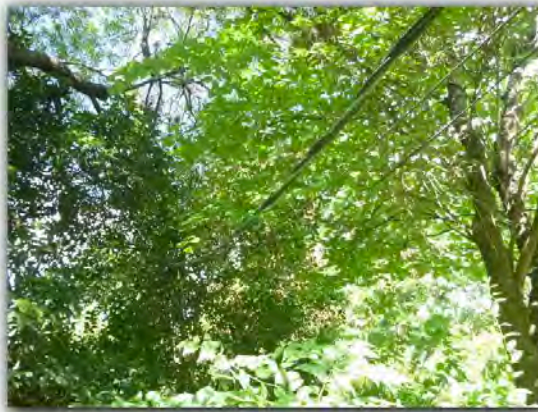
Service drop or overhead conductors are contacting tree limbs. Call the power company for trimming.

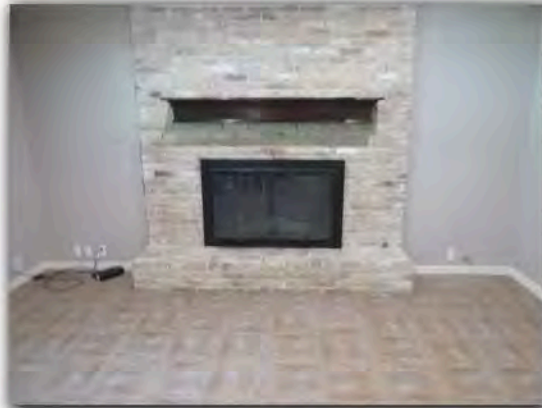
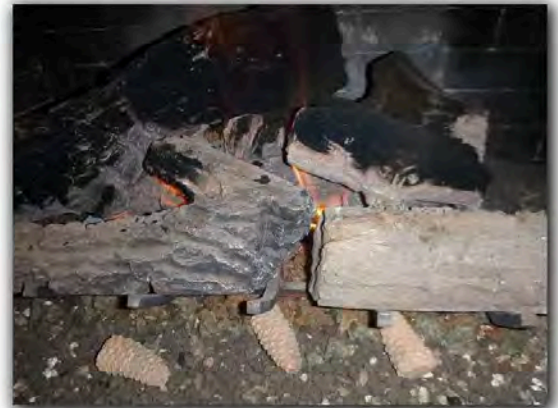
Damper needs to be partially blocked open for use with a gas log.

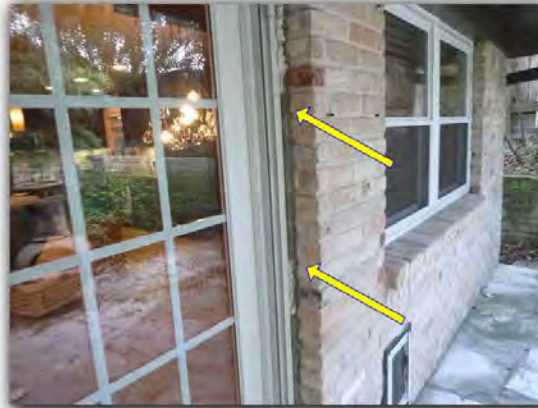
Rear patio door needs resealed at exterior.

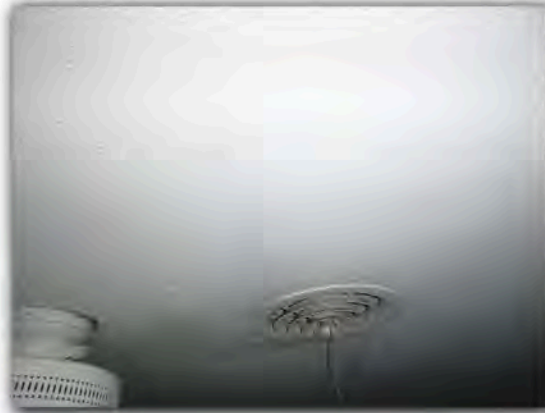
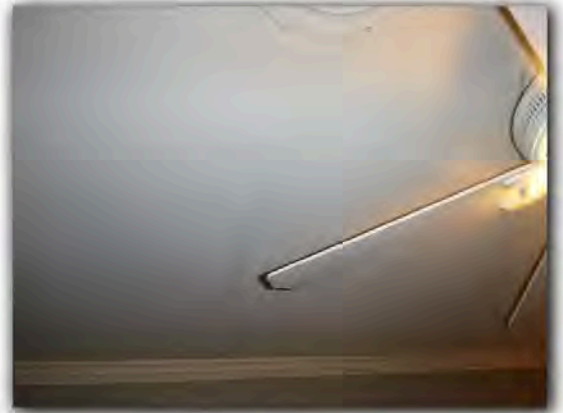
Previous patching and current fractures noted on ceiling in Master bedroom and left rear Bedroom.

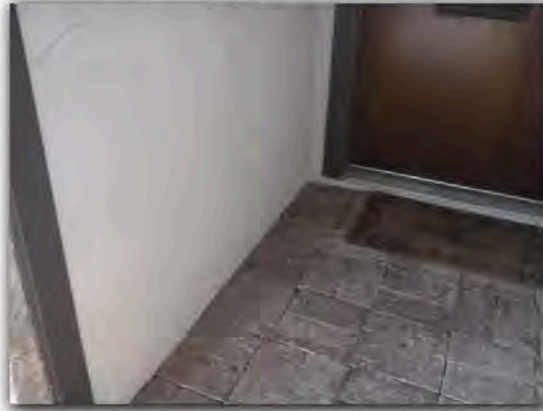
stucco siding and may allow for deterioration over time of stucco and/or metal trim.

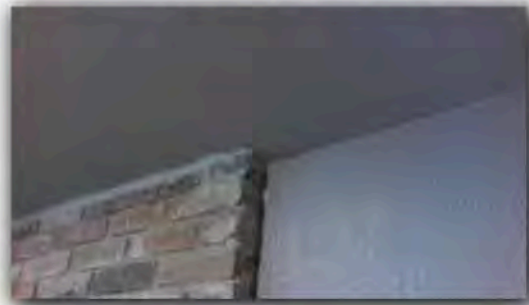
Tape cracks are present in ceiling surfaces -Living room.

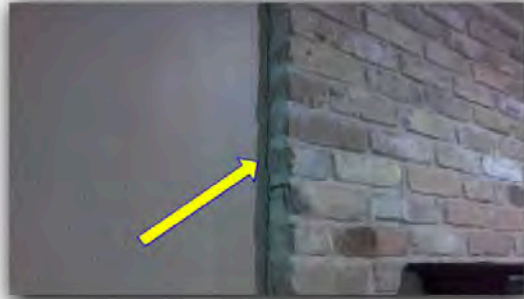
Fracture/separation at wall to fireplace joint. Repair.

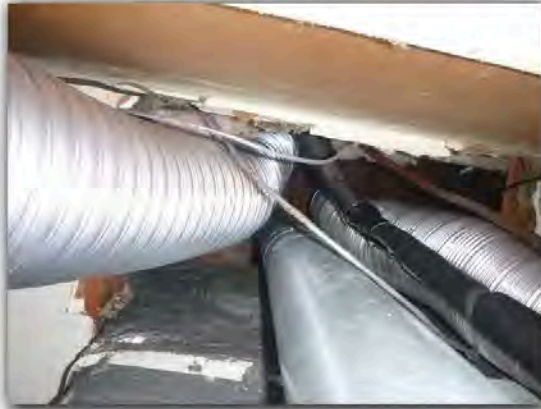
Fire blocking is missing at area from a/c unit.

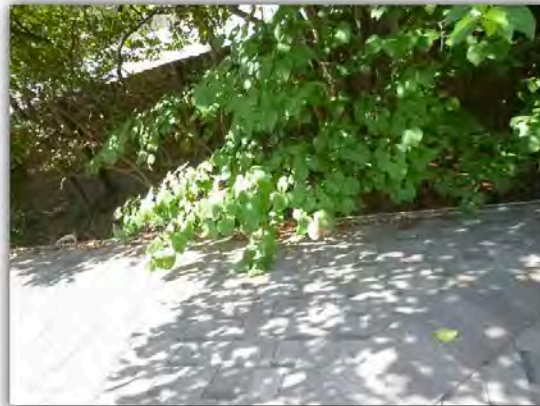
Tree limbs are observed in contact and rubbing the surface of the roof. Trim to avoid excessive wear.

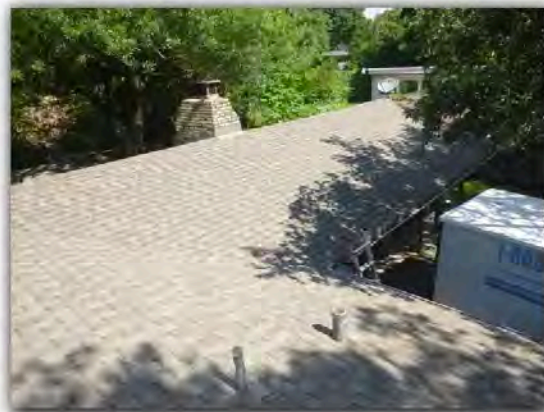
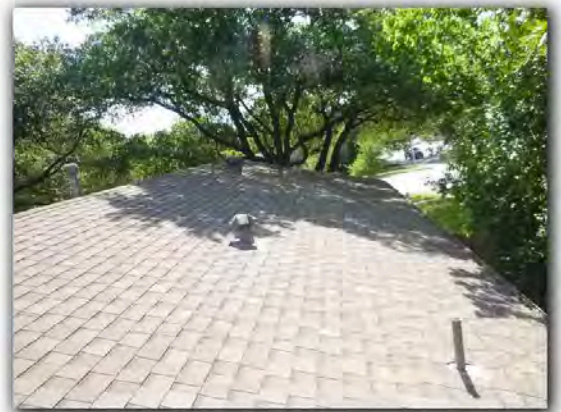
Some debris is laying on roof.

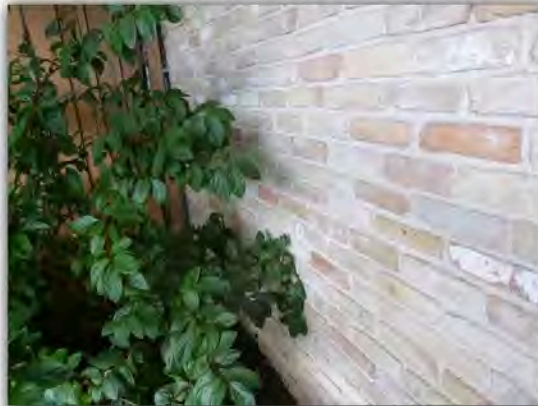
Soil high on siding, planters and shrubs touching structure are conducive conditions for entry of wood destroying insects.
