This Home Inspection is exclusively prepared
for:
Chris Colluro
By:
David Moore
TREC#5509

TEXAS REAL ESTATE CONSUMER NOTICE CONCERNING HAZARDS OR DEFICIENCIES

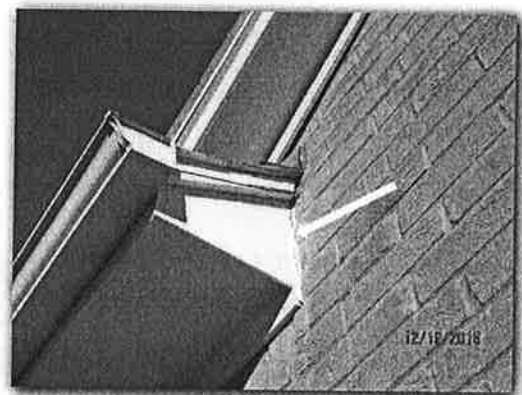
X: Fiber-cement siding needs butt-joint sealant repair on Both sides of the house. Hardie Corporation requires all butt joints be caulked for warranty purposes.

recaulked
