## PROPERTY INSPECTION REPORT

Concerning: 3119 Pine Chase Drive , Montgomery, TX 77356  
(Address or Other Identification of Inspected Property)

By: Eric Phillips Lic.#: TREC #21717 09/05/2019  
(Name and License Number of Inspector) (Date)

Inspection No. 521157-1-212

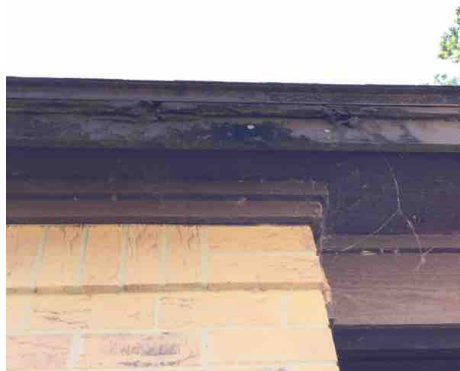
- Squirrels have damaged some areas of eaves while trying to chew their way into the attic. Damage in these areas needs repair and paint. Monitor all suspect areas for future damage. Recommend consulting a pest control company for recommendations on how to minimize future occurrences of damage.

- Replace any moisture damaged eave components.

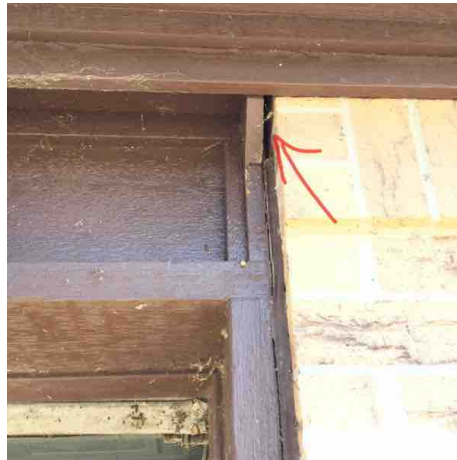
- Generally, caulking and sealing between siding/brick and structure should be refreshed throughout in order to close all gaps from moisture and insect infiltration.

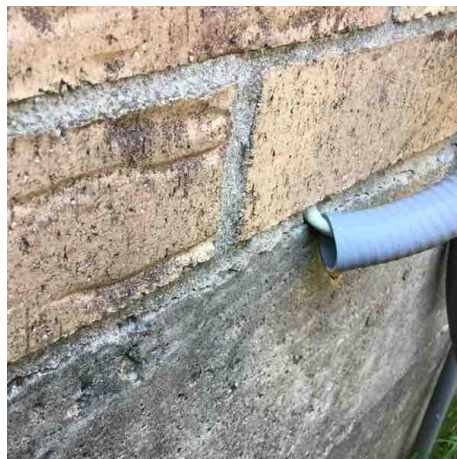
- Seal all exterior wall penetrations to prevent moisture and insect infiltration.

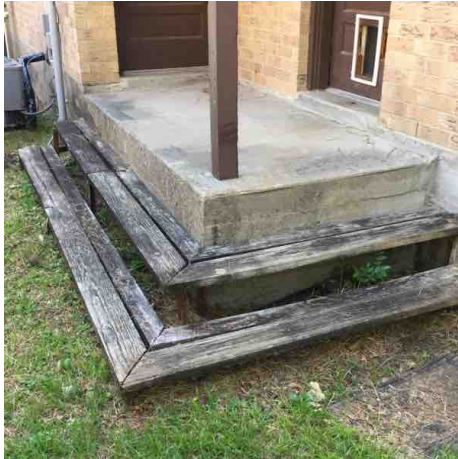
- Wooden steps off of side porch will need replacement.

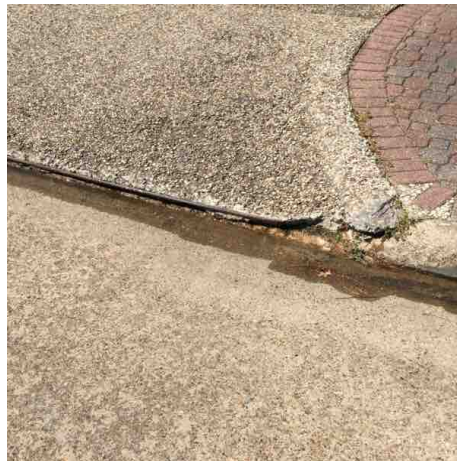
- Driveway needs repairs

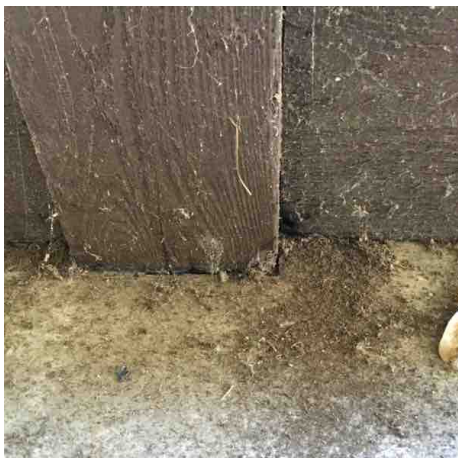
- Moisture damage to columns supporting rear porch overhang will need repair

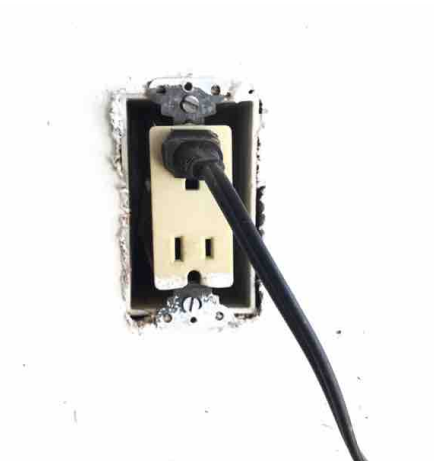
- Exterior weatherproof covers should be installed with the hinge up. Foam inserts also need replacement

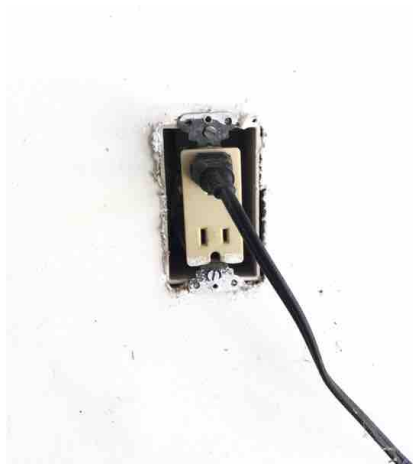
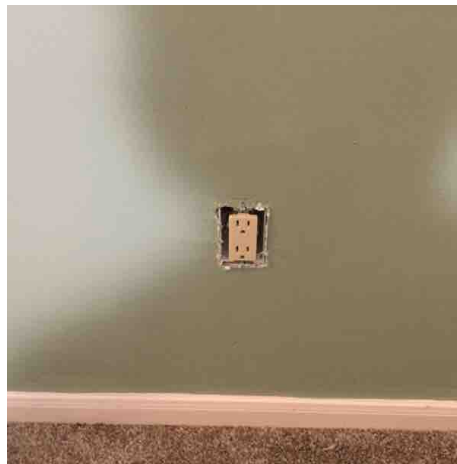
- **GFCI protection is not in place on ANY required electrical receptacles. Current best practices require installation of GFCI receptacles in outdoor areas, garages, kitchens, baths, laundry rooms and within 6 feet of the edge of sinks to reduce risk of electrical shock.**
- All receptacles should have listed covers installed.
