HouseCheck
Property Inspection Report

210 Birchwood Dr, Spring, TX 77386
Inspection prepared for: Chris Shannon
Real Estate Agent: Travis Foote - INETO Real Estate Services

Date of Inspection: 6/3/2019 Time: 1:00 PM
Age of Home: 1975 Size: 2609
Order ID: 619

PROPERTY INSPECTION REPORT

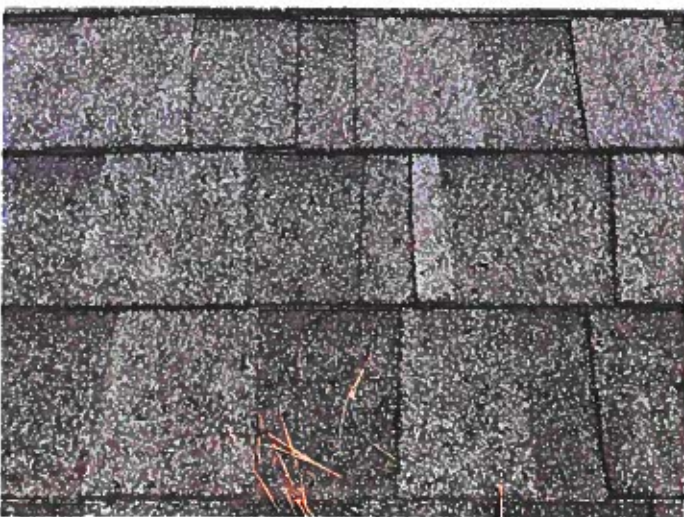
Garage

- All deficiencies noted in red should be further evaluated by a roof professional.
- **Lifted flashings at base of mast for service entrance conductor, . This can allow water penetration under flashing. Flashing should be flush with roof covering.**
- **Current standards mandate all plumbing vent stacks extend a minimum of 6 inches above the roof slope. One or more were observed to not meet this standard.**
- **Furnace vent pipe heavily rusted. This can allow moisture penetration.**

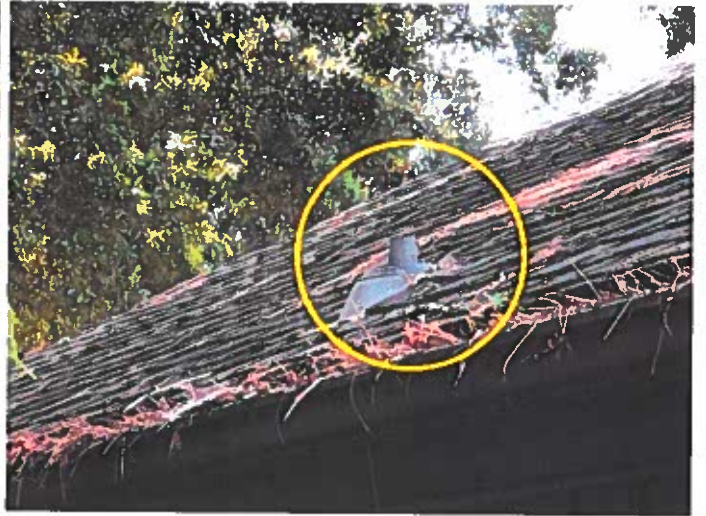
Plumbing vent

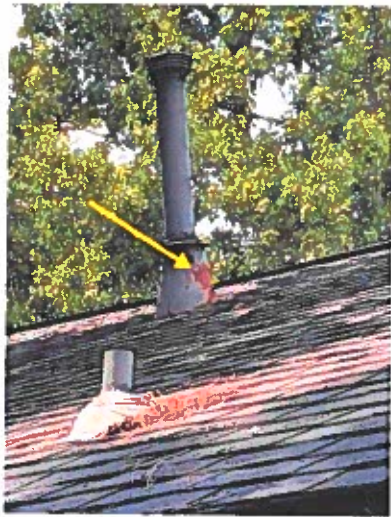
Furnace vent

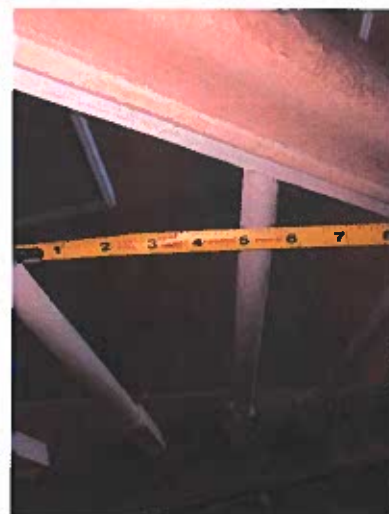
Baluster spacing

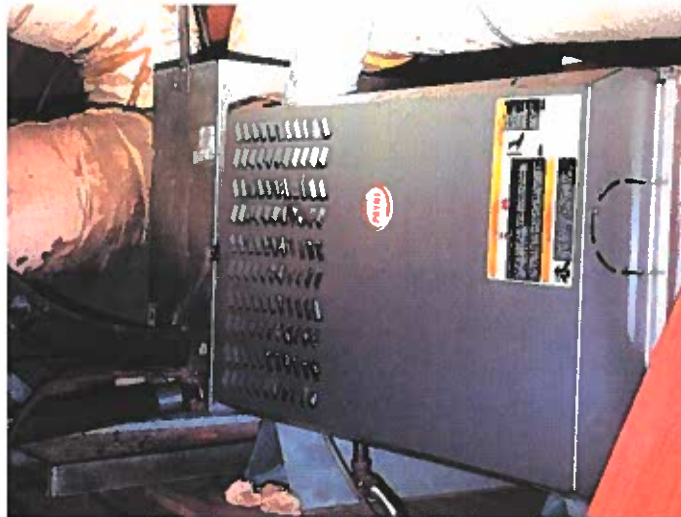
Payne furnace

- Missing drip leg (sediment trap) to the gas supply line for the HVAC system.

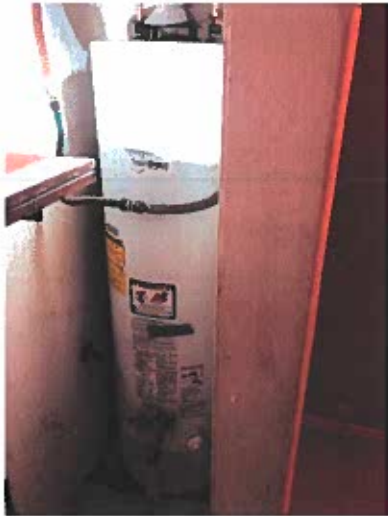
- The water heater(s) is/are 2007 model manufactured by GE
- Limitation: Gas service was not active at the residence during the time of the inspection. Unable to test water heating equipment functionality.
- Missing drip pan and drain line to the exterior underneath the water heater.
- Missing drip leg (sediment trap) for the gas line to the water heater.
- Temperature/pressure relief line slopes uphill this is a potential safety hazard. The drain for a TPR valve is to slope continuously downhill to prevent water being trapped in the line. This condition should be further evaluated by a licensed plumber.
- Water heater vent pipe incorrectly installed. This type of vent should be installed vertically.
- TPR valve discharge line constructed from multiple flexible connectors. This is an improper material. Line should be constructed from CPVC.

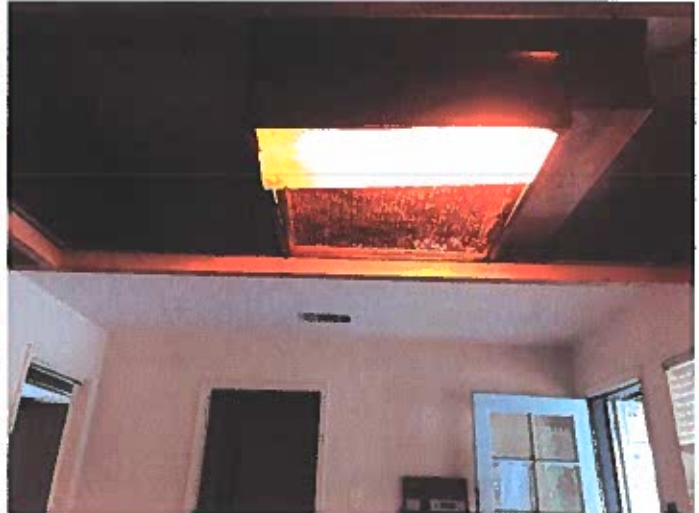
Vent hood

- Type: Hood with fan (unit vents to the exterior)
- The charcoal filter present is excessively dirty for the unit. Recommend replacement to avoid a potential grease fire hazard.

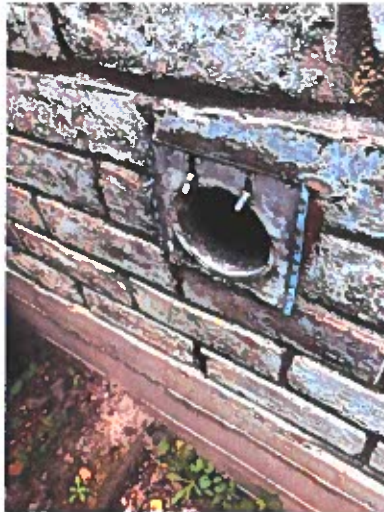
- Dryer vent missing cover, assembly should be replaced.
