Moisture Assessment Report

Edwards McReynolds

1616 Castle Ct

7/18/2019

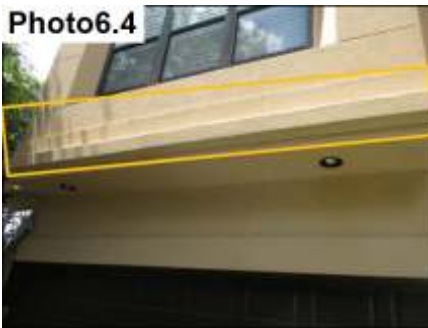
Photo6.3
Semi-Firm Substrate/ Install Relief

- The substrate in this bottom of the bumpout wall is semi-firm. The inspector suggests to have a qualified stucco waterproofing contractor to install a relief in an effort to allow proper moisture evacuation. Please refer to photos #6.2, #6.3, #6.4 and #6.5 for more detail.

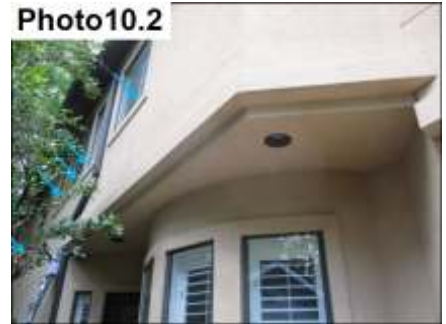
Photo10.2

Window Sealants/ Maintain

Grid Location	Item Description	Moisture Readings	Substrate Condition	Observations
Blue Arrow	Window Sealants			The window sealants are present in this location. The inspector states that this is a positive detail and suggests to maintain all sealants in an effort to prevent moisture intrusion. Please refer to photos #10.2, #10.3, #10.4, #10.5 and #10.6 for more detail.
D2	Bottom Wall	17%	Firm	A moisture probe was made at the bottom wall. The substrate was firm with no damage noted at this time.
E1	Bottom Wall	16%	Firm	A moisture probe was made at the bottom wall. The substrate was firm with no damage noted at this time.

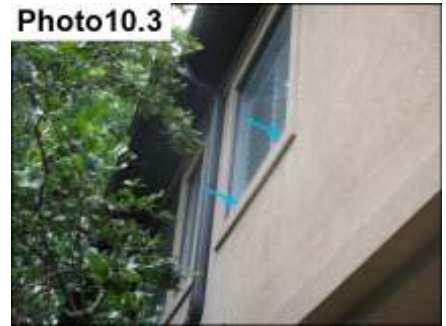
Photo10.3

Window Sealants/ Maintain

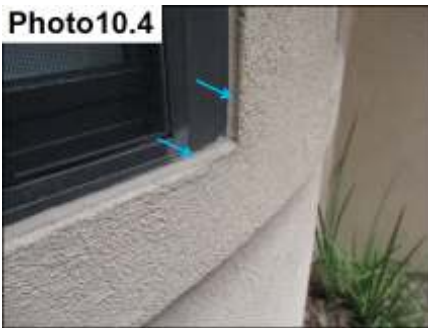
Photo10.4

Window Sealants/ Maintain

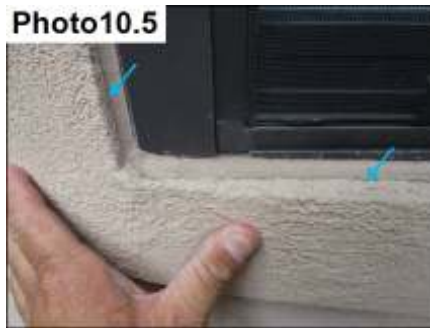
Photo10.5

Window Sealants/ Maintain

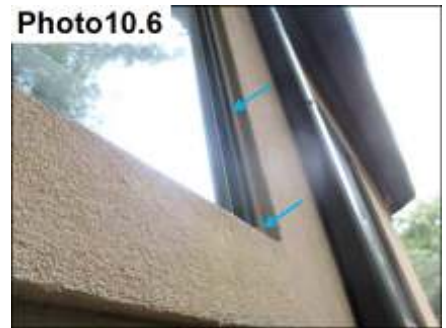
Photo10.6

Window Sealants/ Maintain

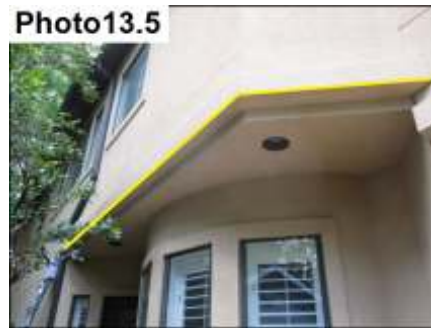
Bottom Wall Without Relief/ No Modification

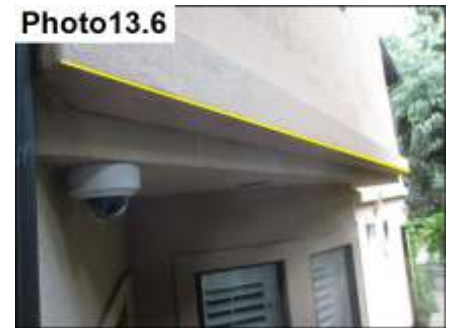
Bottom Wall Without Relief/ No Modification

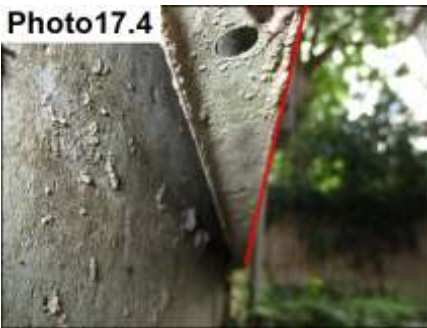
Photo17.4

Black Plastic/ Cut

Grid Location	Item Description	Moisture Readings	Substrate Condition	Observations
Red Lines	Black Plastic			Black plastic has been noted in this area. This is when the substrate has been sealed with black plastic, which creates a reservoir to hold moisture. The inspector suggests to consult with a qualified stucco waterproofing contractor to cut the black plastic in an effort to prevent the substrate from rotting. Please refer to photos #17.2, #17.3 and #17.4 for more detail.
Yellow Line	Bottom Wall Without Relief			The bottom wall in this location does not have a relief but the substrate is firm and dry. The inspector suggests no modification at this time. Please refer to photo #17.5 for more detail.

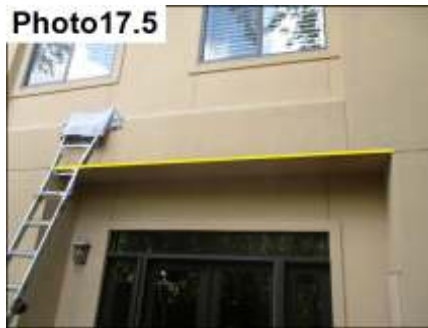
Photo17.5

Black Plastic/ Cut

Bottom Wall Without Relief/ No Modification

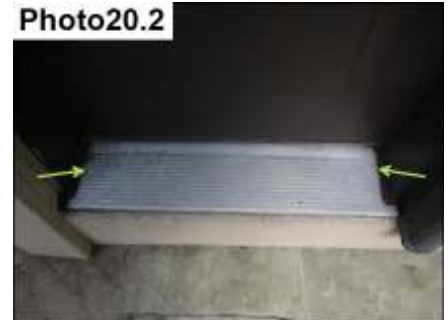
Photo20.2

Door Trim And Miter Sealants/ Seal

Grid Location	Item Description	Moisture Readings	Substrate Condition	Observations
Green Arrows	Door Trim And Miter Sealants			The door trim and miter sealants are present in this location. The inspector states that this is a positive detail and suggests to maintain all sealants in an effort to prevent moisture intrusion. Please refer to photos #20.2 and #20.3 for more detail.
Purple Box	Rust Stains			Rust stains are noted in this area. The inspector suggests to clean this location with a wire brush and paint as needed. Please refer to photo #20.4 for more detail.

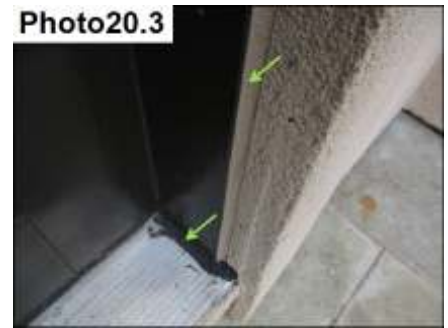
Photo20.3

Door Trim And Miter Sealants/ Seal

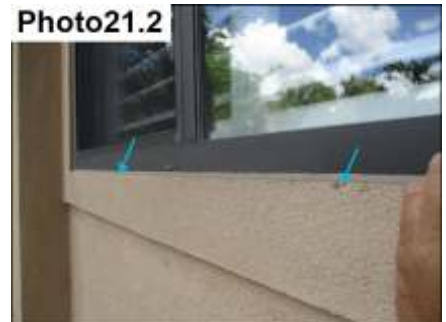
Window Sealants/ Maintain

Grid Location	Item Description	Moisture Readings	Substrate Condition	Observations
Blue Arrows	Window Sealants			The window sealants are present in this location. The inspector states that this is a positive detail and suggests to maintain all sealants in an effort to prevent moisture intrusion. Please refer to photos #21.2, #21.3 and #21.4 for more detail.
D6	Left Wall	28%	Firm	A moisture probe was made at the left wall. An elevated moisture reading was noted with a firm substrate.
I6	Right Wall	18%	Firm	A moisture probe was made at the right wall. The substrate was firm with no damage noted at this time.
E4	Bottom Wall	18%	Firm	A moisture probe was made at the bottom wall. The substrate was firm with no damage noted at this time. Please refer to photo #21.5 and #21.6 for more detail.
H3	Bottom Wall	16%	Firm	A moisture probe was made at the bottom wall. The substrate was firm with no damage noted at this time. Please refer to photo #21.6 and #21.6 for more detail.

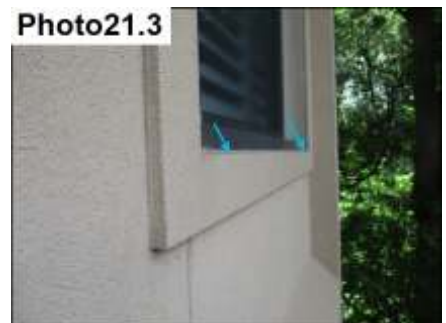
Window Sealants/ Maintain

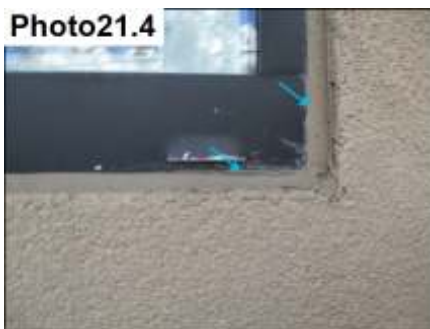
Window Sealants/ Maintain
