Home Inspection  
1302 Linwood Dr  
Wharton, TX. 77488

## PROPERTY INSPECTION REPORT

**Concerning:** 1302 Linwood Dr, Wharton, TX 77488  
(Address or Other Identification of Inspected Property)

**By:** James Ezell, Lic #21864 04/25/2020  
(Name and License Number of Inspector) (Date)

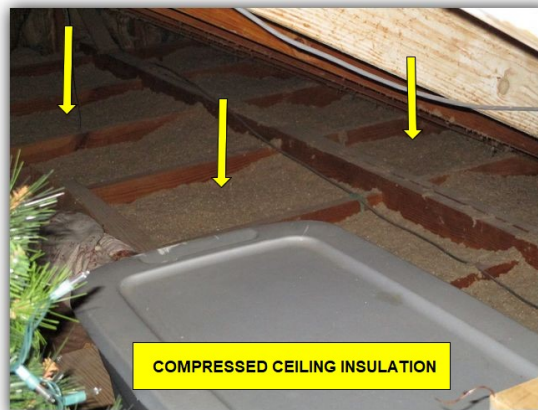
- The older ceiling insulation has compressed overtime. This decreases the overall efficiency of the home.

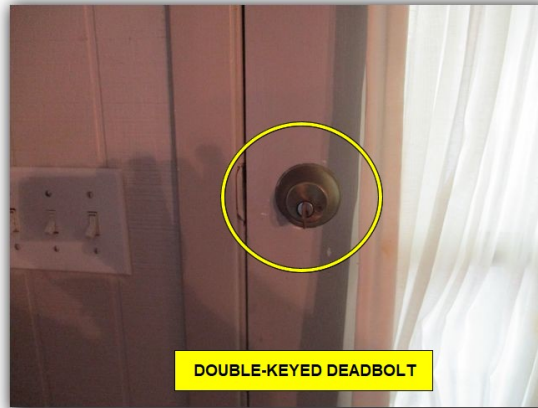
Type:  Metal    Wood    Fiberglass    Doors / panels are damaged

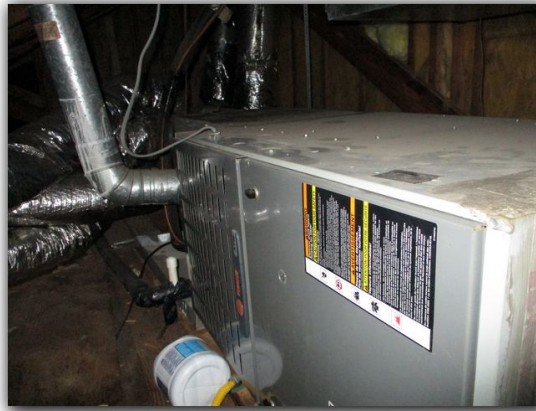
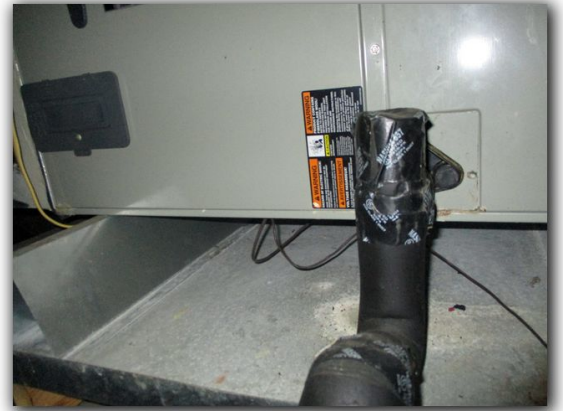
- The downstairs heating unit is gas and appears to be in overall good working condition at this time.
- The upstairs heating unit is electric and appears to be in overall good working condition at this time.

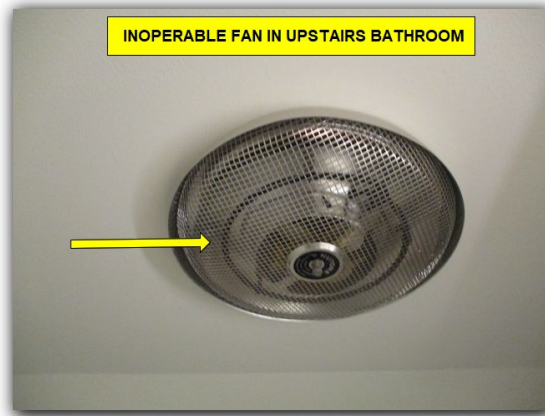
- The heating fan in the upstairs bathroom is inoperable. It sounds like the fan is binding.
