**Friday, February 17, 2017**

**PROPERTY INSPECTION REPORT**

**Concerning:** 25403 Elm Green St, Spring, TX, 77373  
(Address or Other Identification of Inspected Property)

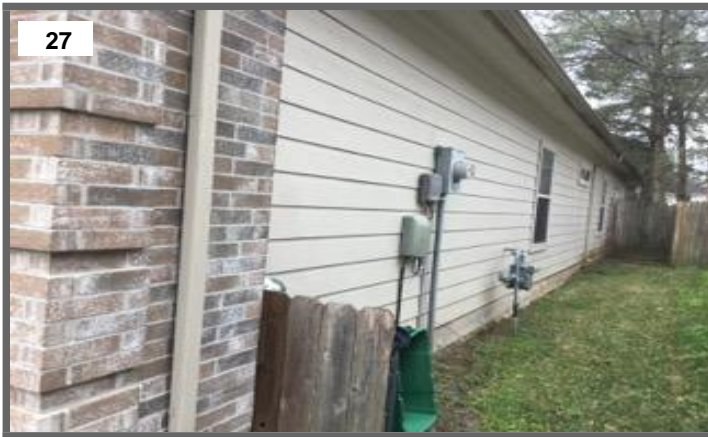
minor mildew

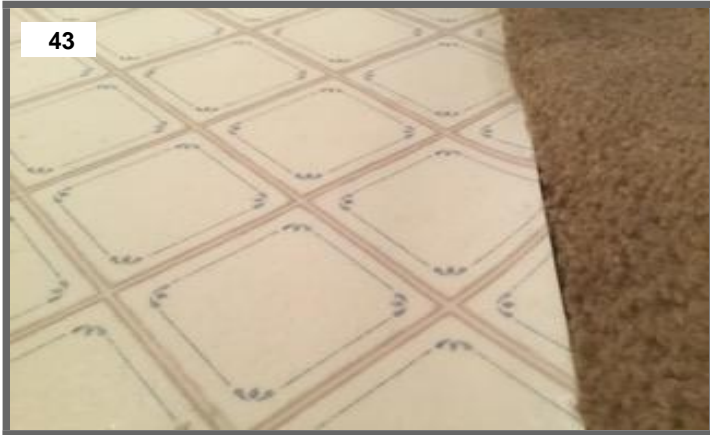
In the Master bathroom, vinyl flooring starting to come up where it meets the carpet.  
Good overall condition .

Master bathroom, vinyl flooring starting to come up where it meets the carpet.

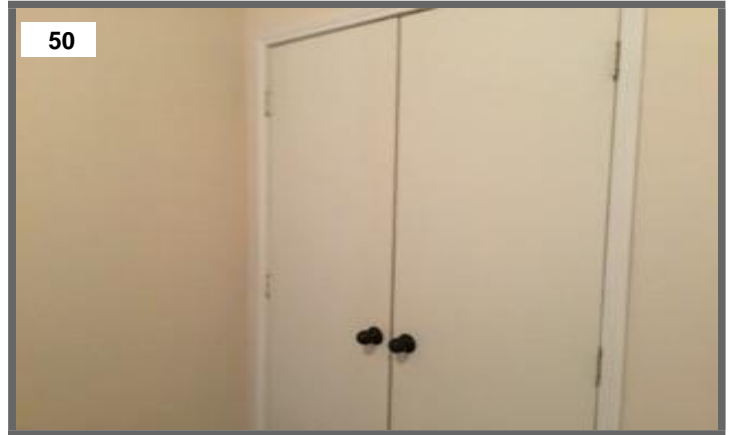
Front right quest bedroom, loose screw on door latch.

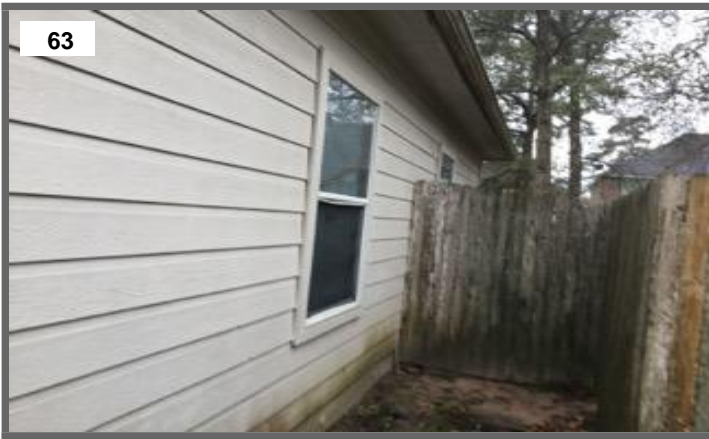
Torn screen

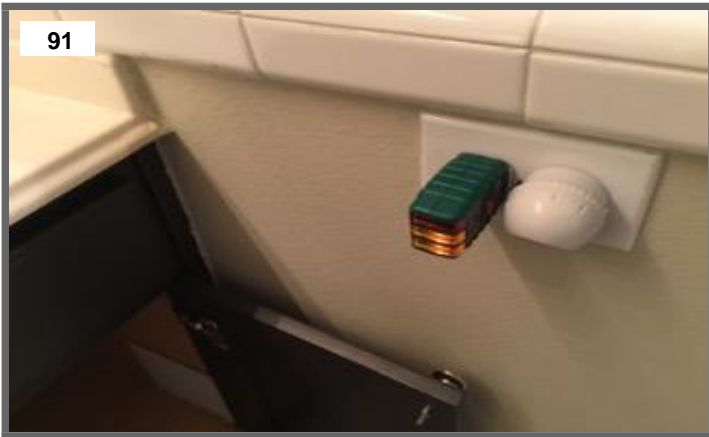
Yes GFCI

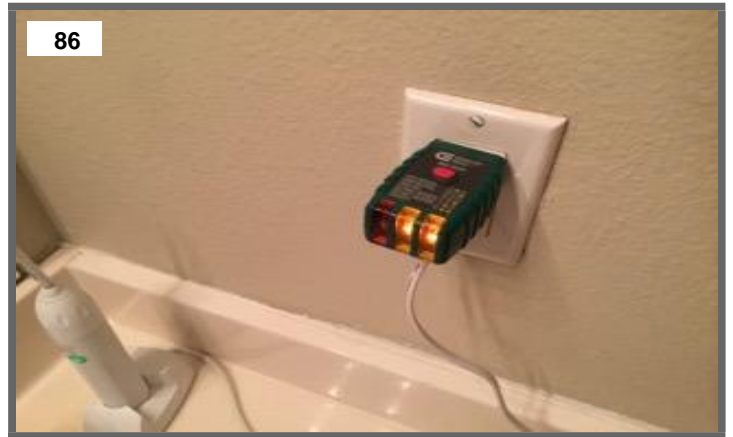
Yes GFCI

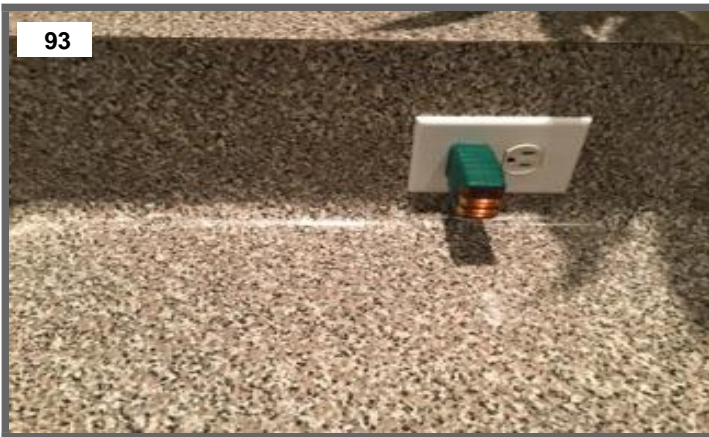
Yes GFCI

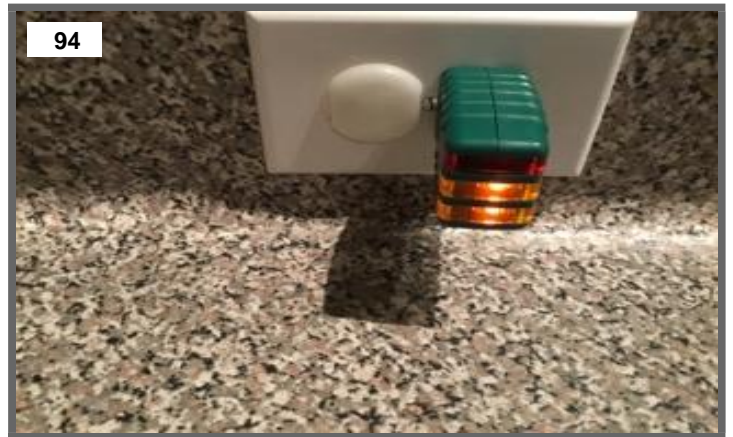
Yes GFCI

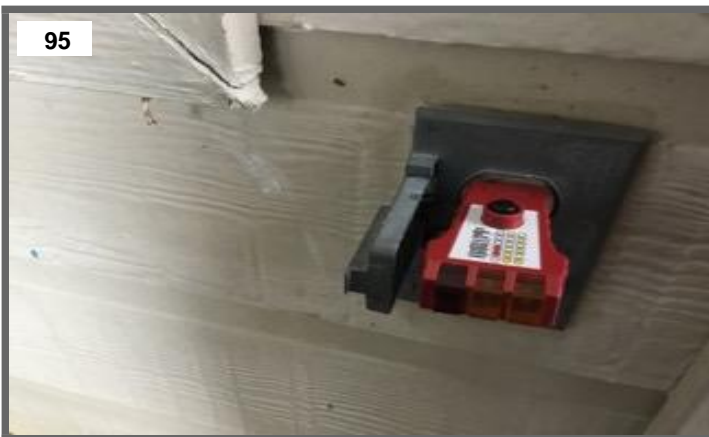
Yes GFCI

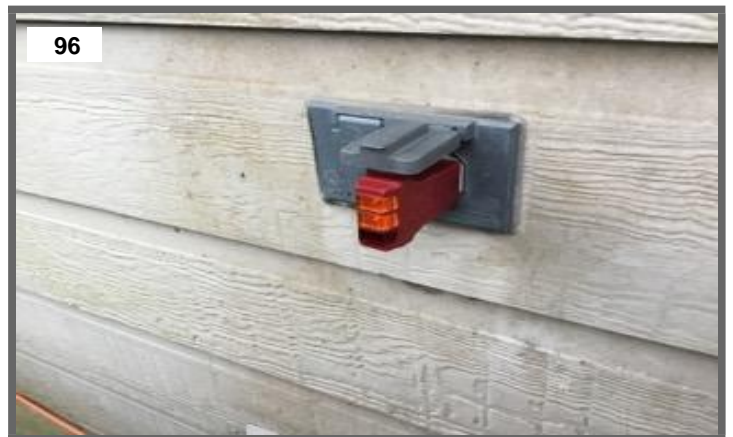
Yes GFCI

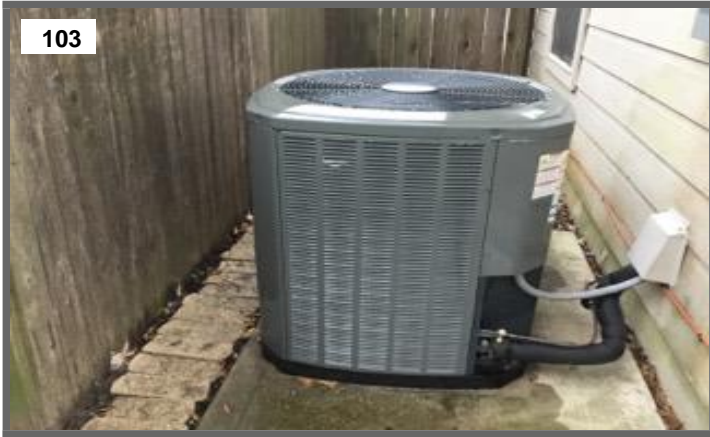
103

5 ton

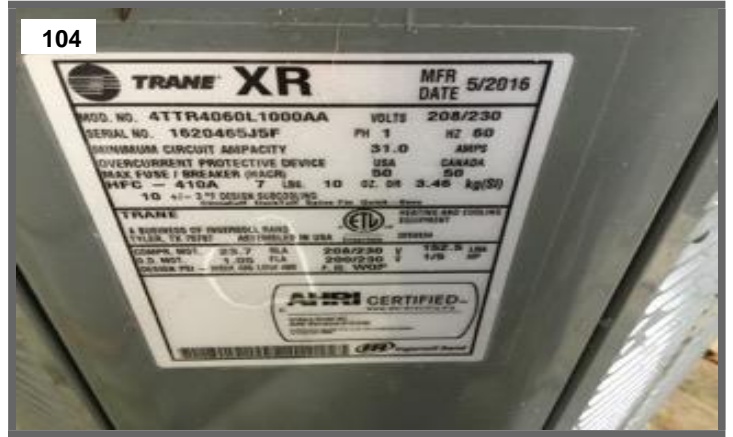
104

4TTR4060L1000AA  
5-2016
