1st Rate Inspections

Property Inspection Report

5907 Bridgegate Dr, Spring, TX 77373
Inspection prepared for: Anthony Echevarria
Real Estate Agent: -

Date of Inspection: 12/10/2019 Time: 1:30 PM
Age of Home: 1976 Size: 1380
Order ID: 13986

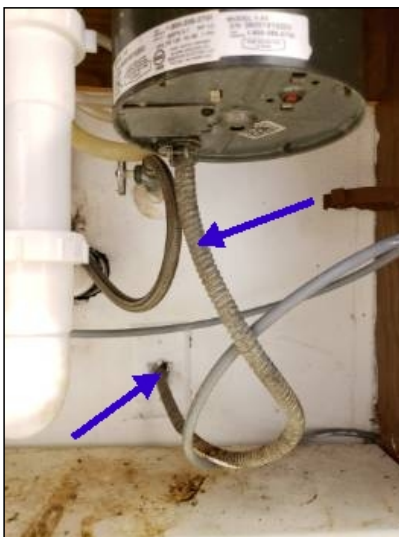
B.1. -Disposal was hard wired, has no disconnect. Disposal should have a cord and plug connection.

-Disposal was hard wired, has no disconnect. Disposal should have a cord and plug connection.

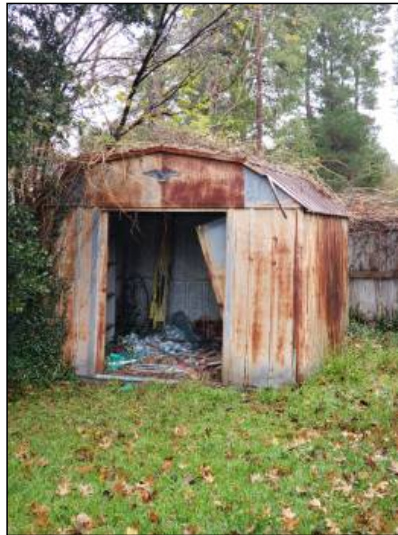
Overview of shed
