HOME INSPECTION REPORT

Prepared For:	Miguel Valdez	
	(Name of Client)	
Concerning:	17114 Ross Lake Ct, Humble, TX, 77346	
	(Address or Other Identification of Inspected Property)	
By:	Charles Rowden 22155 David Jones 22116	5-6-2020
	(Name and License Number of Inspector)	(Date)
	(Name, License Number of Sponsoring Inspector)

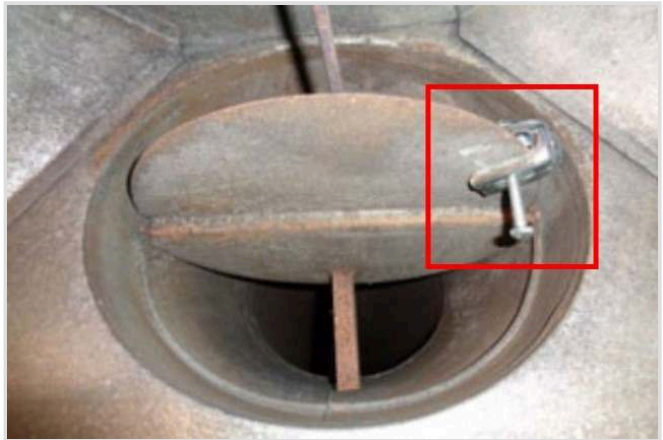
Units were performing as intended at the time of inspection.
An artificial gas log insert was installed in the firebox and no damper clamp present. Having a properly installed damper clamp will prevent carbon monoxide from a pilot light or other sources, from exiting into the room where the fireplace is located.

Example of a damper clamp

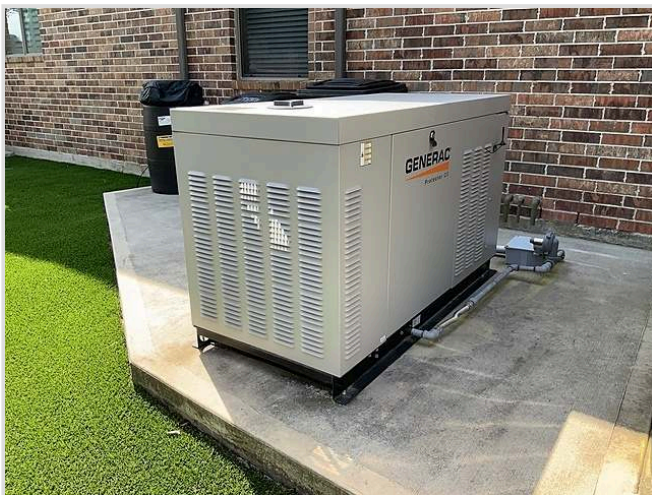
Note: The generator and switch box were not inspected. These are considered specialty equipment and are not within the scope of the inspection.

Not inspected

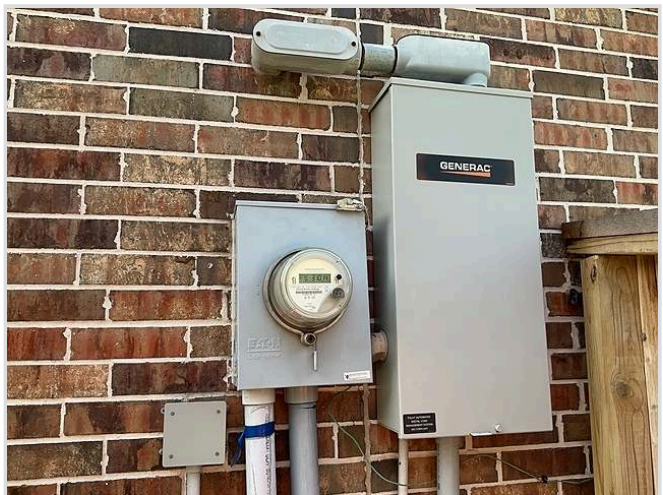
Not inspected

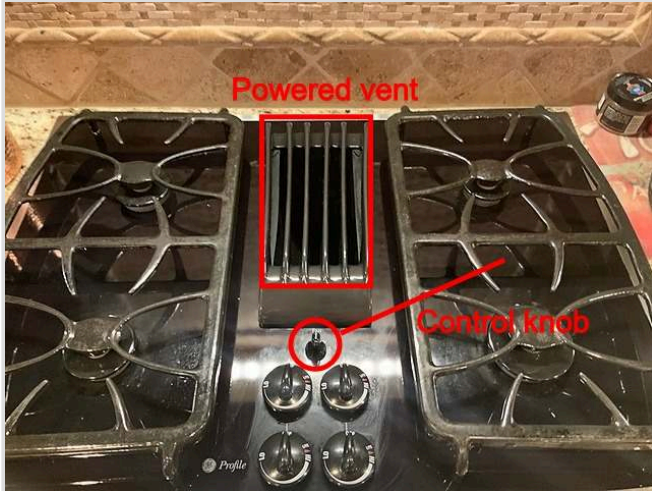
Performing as intended

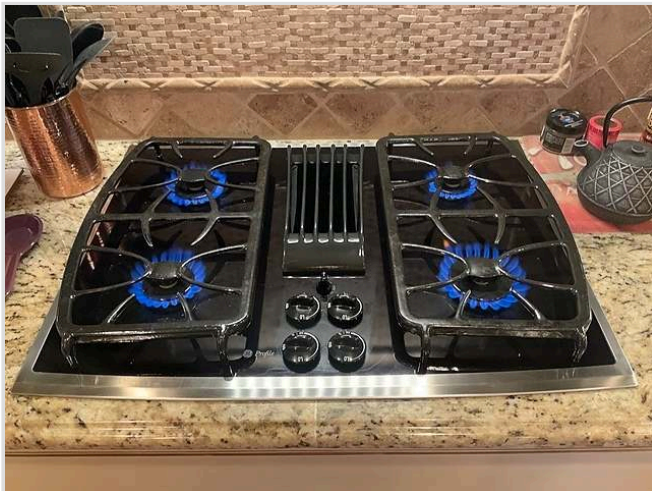
Performing as intended

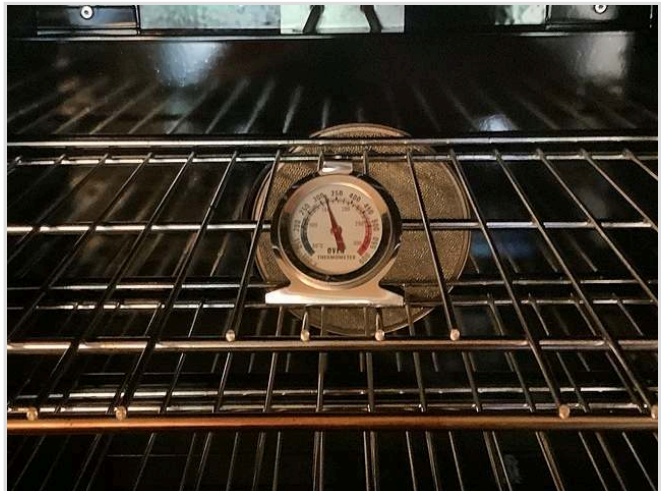
Upper oven unit heated approximately 30 degrees cooler than digital setting.

Upper oven unit temperature reading (approximately 320 degrees)

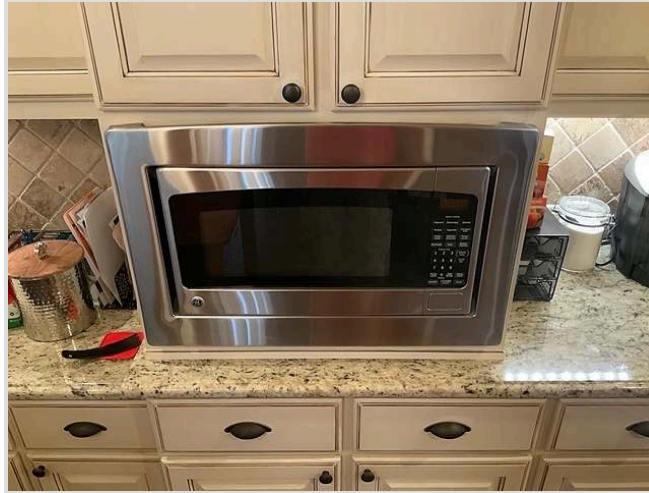
The G/E unit was functioning as intended at the time of the inspection.

Microwave oven

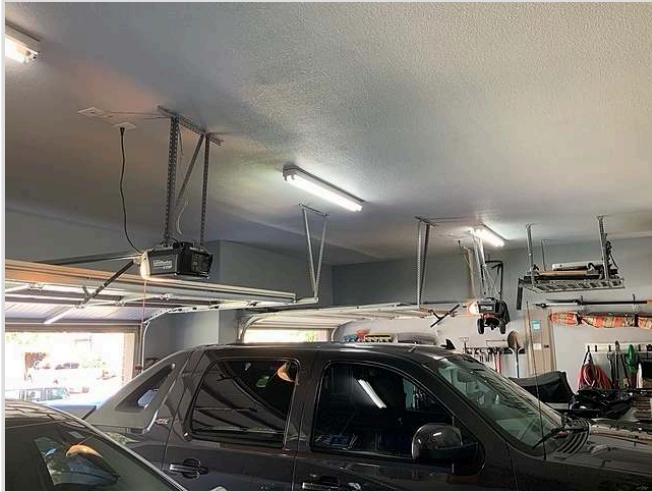
The LiftMaster units were functioning properly at the time of the inspection.

Functioning properly

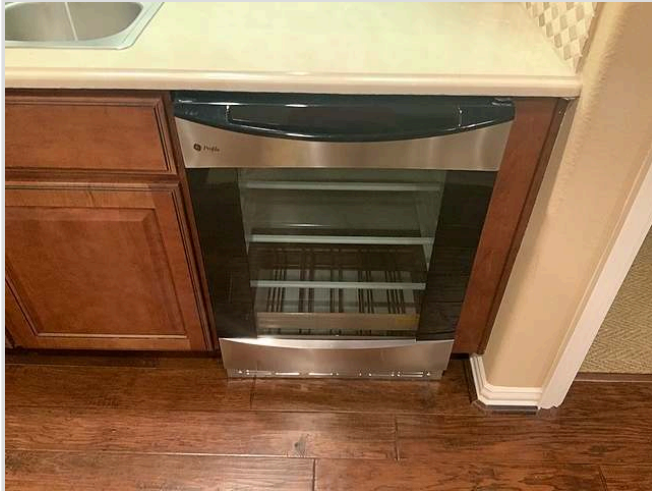
The wine cooler was not inspected.

Not inspected

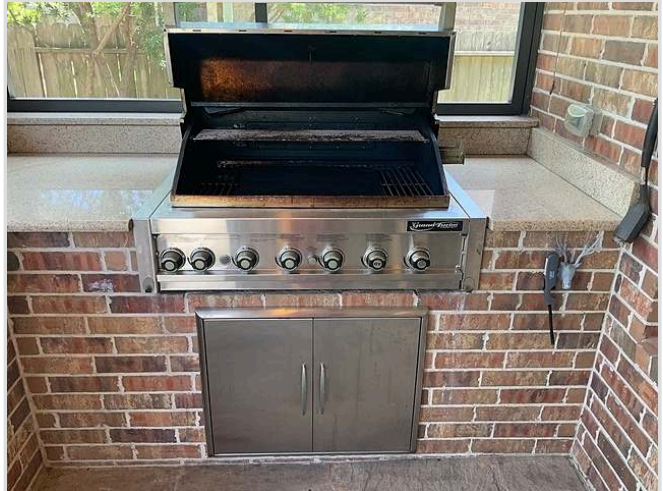
Gas grill on the rear exterior porch was not inspected.

Not inspected

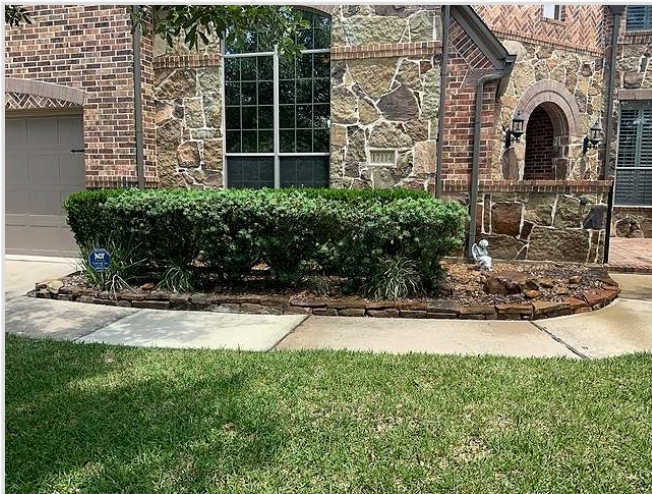
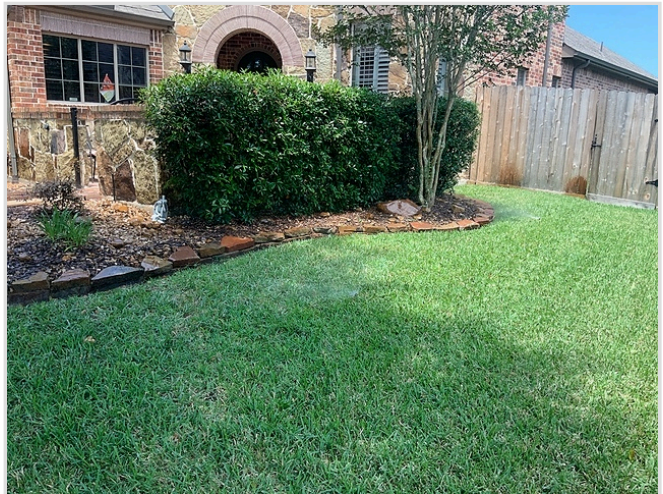
Zone 1

Several spray heads had improper spray patterns and were in need of adjustment.
