PROPERTY INSPECTION REPORT

Concerning: 2122 Avenue K, Galveston, TX 77550
(Address or Other Identification of Inspected Property)

By: Danny Marlow Lic.#: 23187 01/05/2021
(Name and License Number of Inspector) (Date)

Home Inspection Report

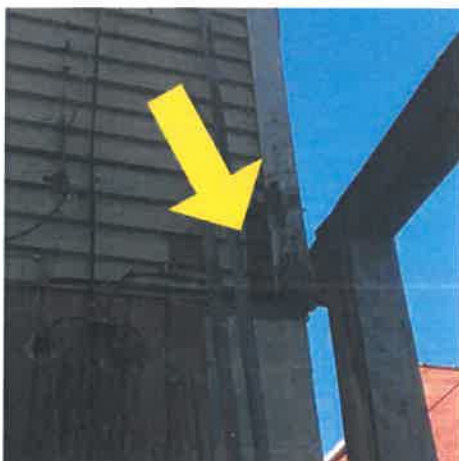
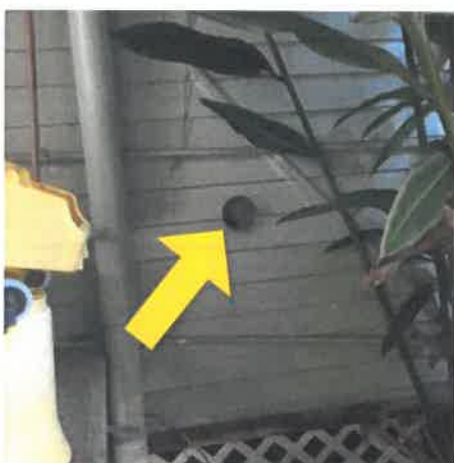
This hole has been patched.

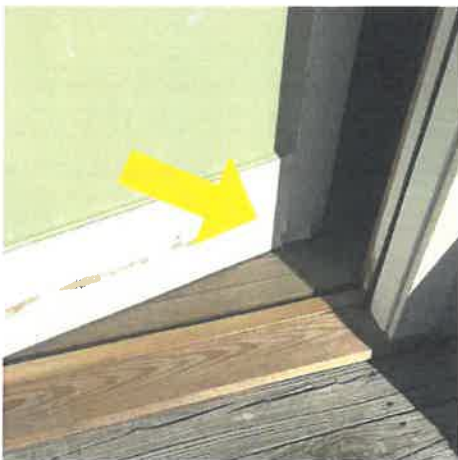
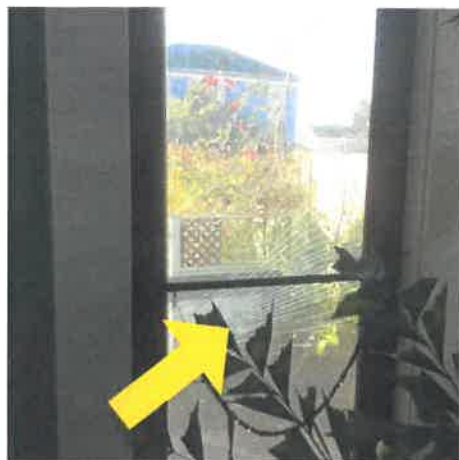
this has been replaced

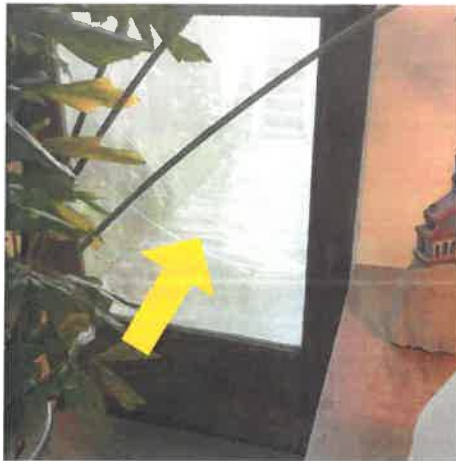
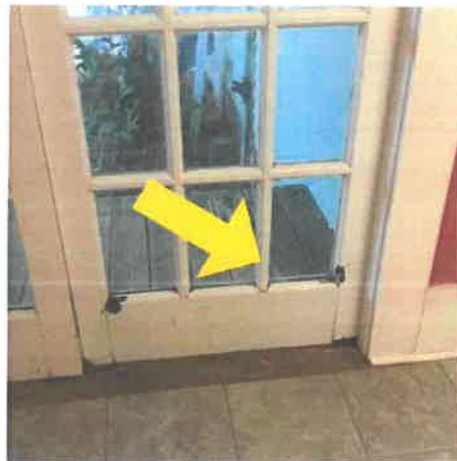
- Windows are old and in various states of repair (missing weatherstripping, not opening, missing hardware). Budget for replacement in the near future.
- There were windows at garage that were noted as being broken out and boarded up.
- There was a broken window noted in upstairs back bedroom.

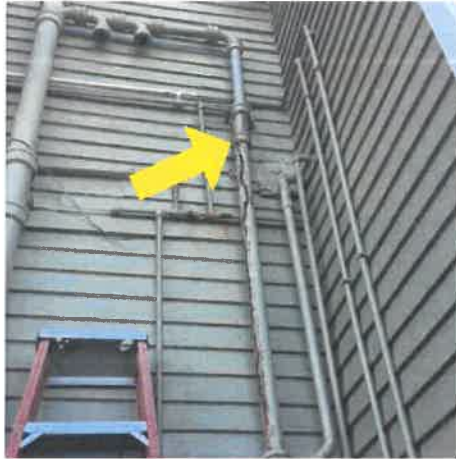
this pipe is not being used

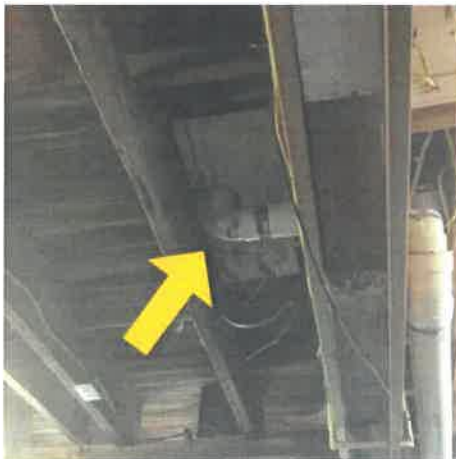
This has been fixed.

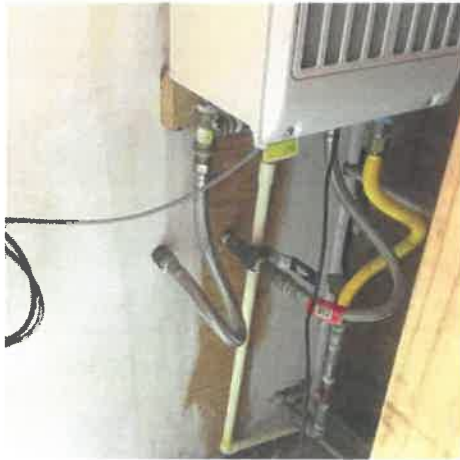
40 gallon water heater (garage apartment).

- Natural gas energy source.
- System was operating as designed at time of inspection.
