Your Inspection Report

1112 13th St
Galveston, TX 77550

PROPERTY INSPECTION REPORT

Concerning: 1112 13th St, Galveston, TX
(Address or Other Identification of Inspected Property)

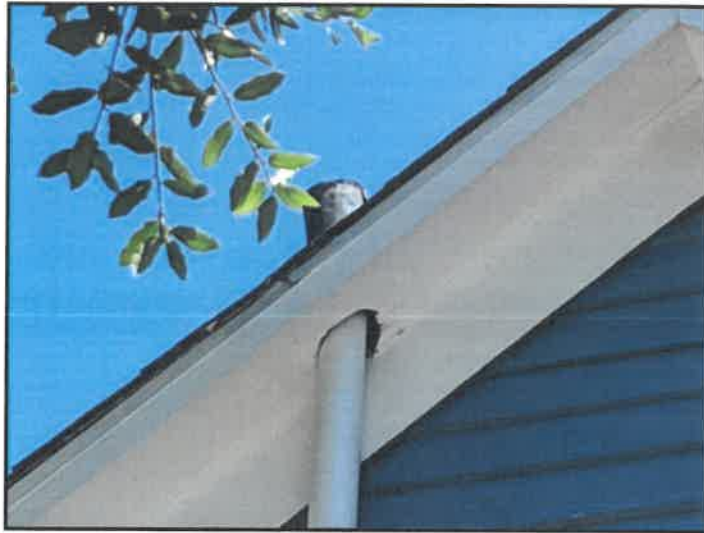
7. Vertically misaligned

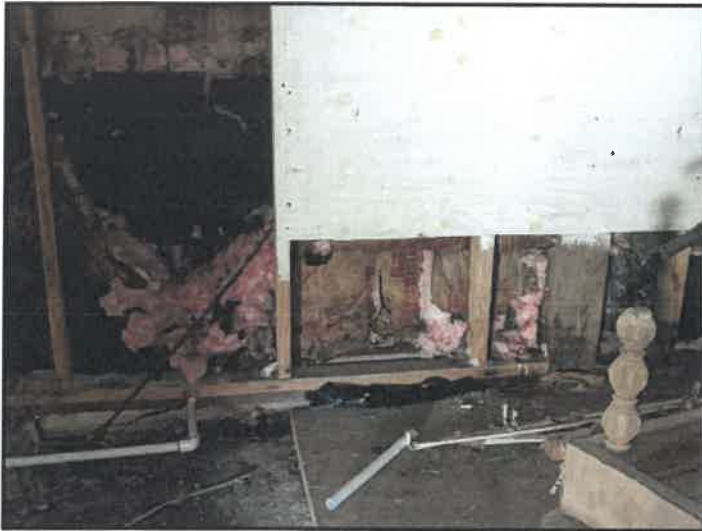
18. Mechanical damage

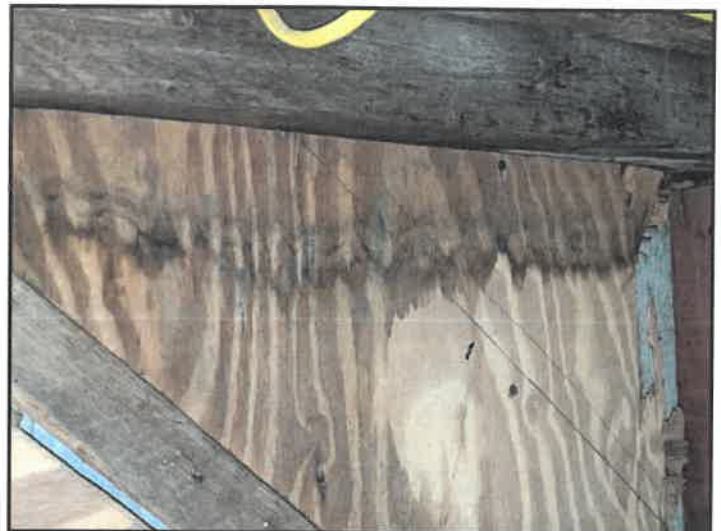
19. Mechanical damage

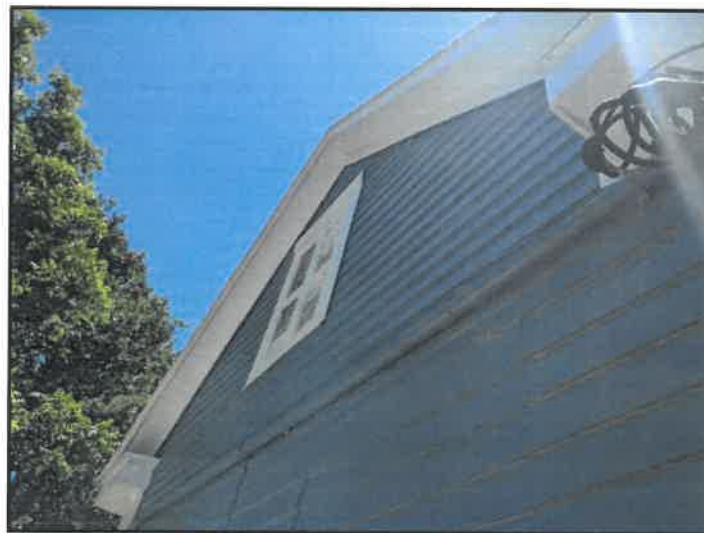
21. Missing

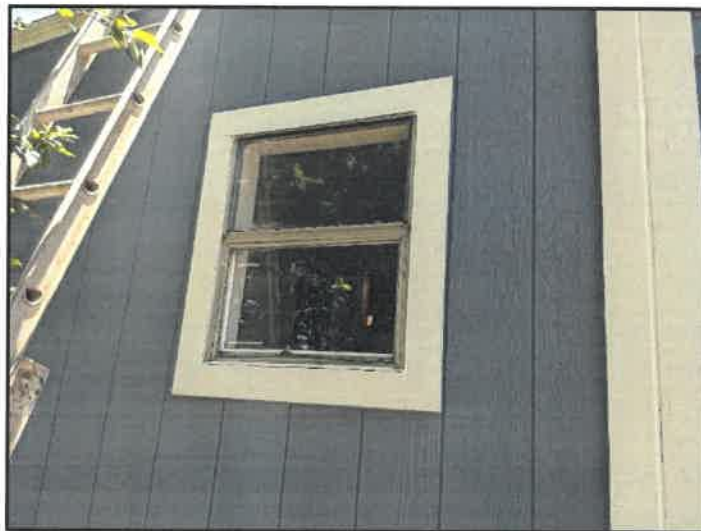
23. Missing

Task: Provide

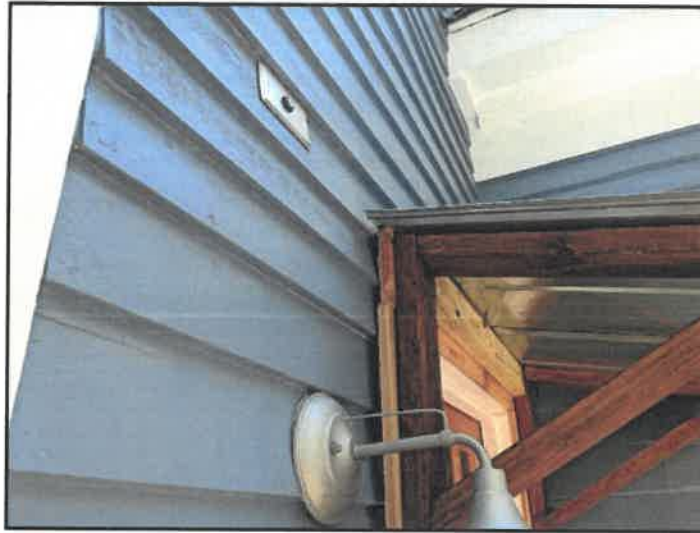
26. Missing

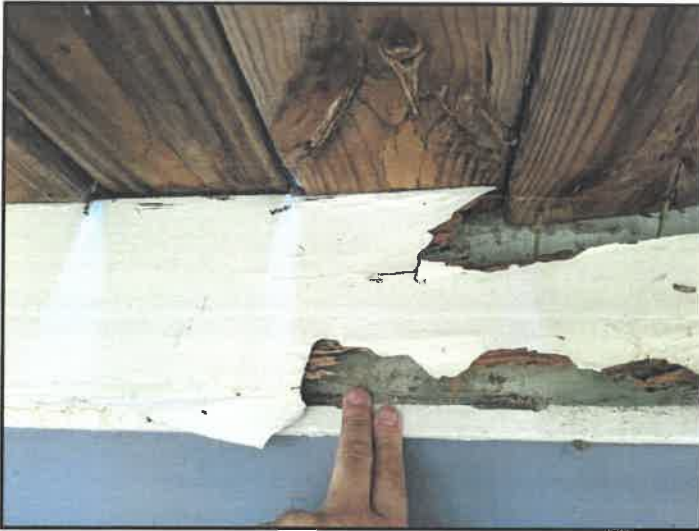
28. Rot or insect damage

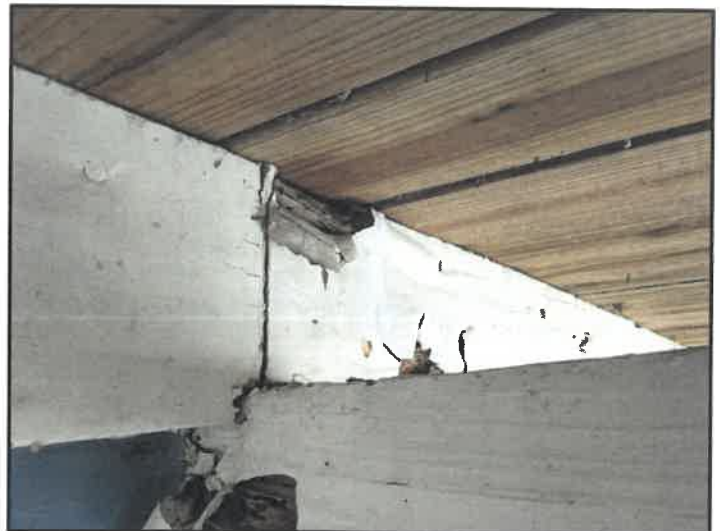
29. Rot or insect damage

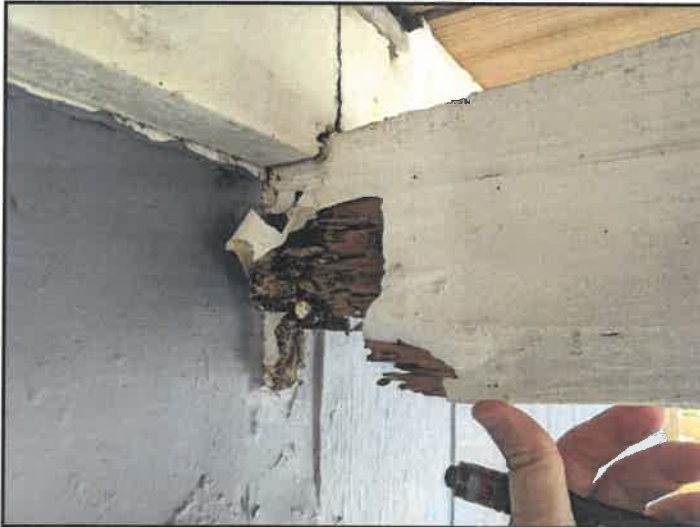
30. Rot or insect damage

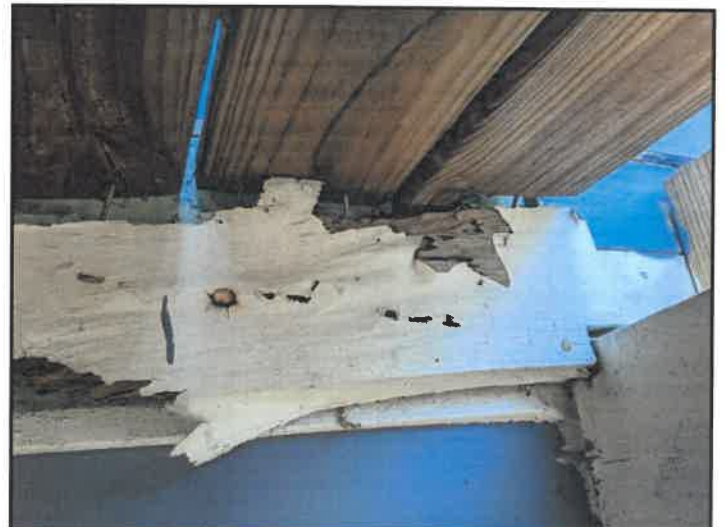
31. Rot or insect damage

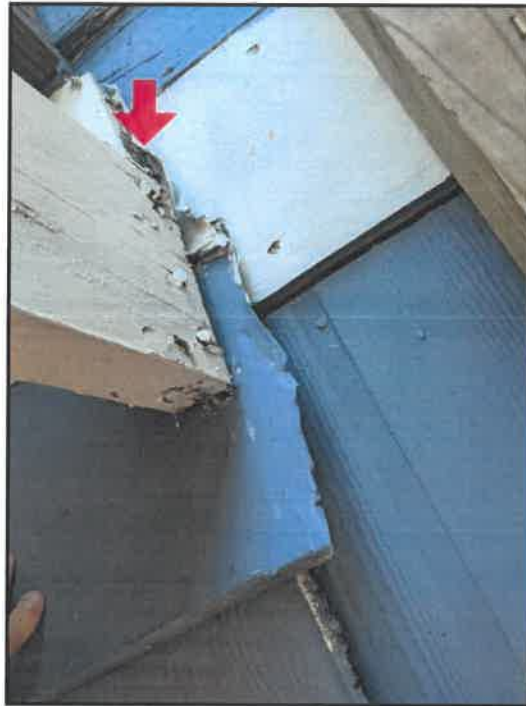
32. Damage

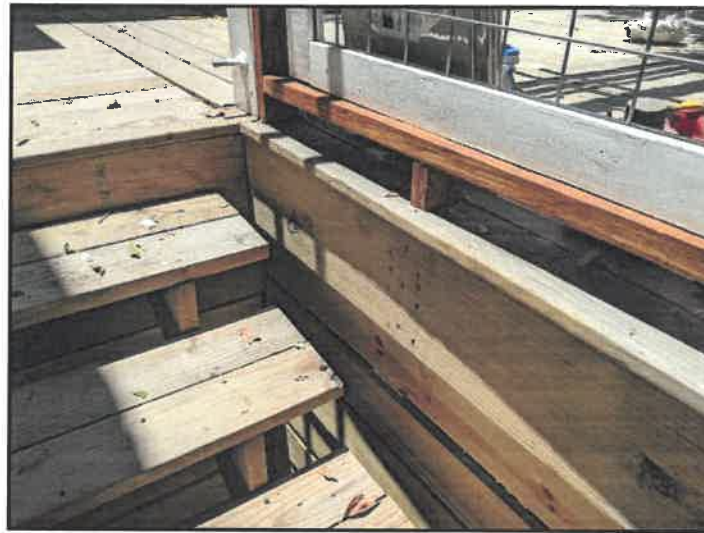
36. Missing

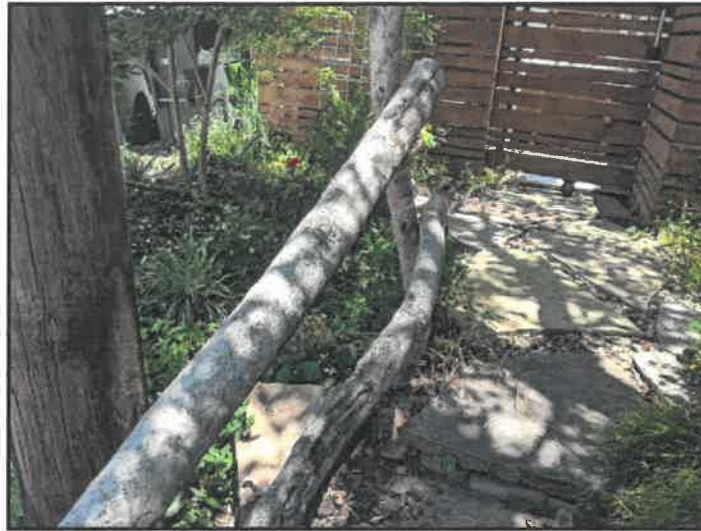
37. Ineffective

31. Condition: • [Ineffective](#)

Implication(s): Fall hazard

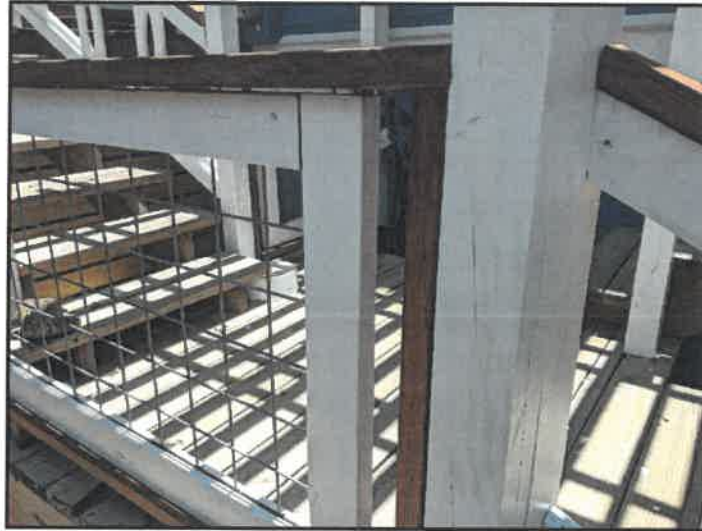
40. Spindles (balusters) climbable

33. Condition: • [Spindles \(balusters\) climbable](#)

Implication(s): Fall hazard

Task: Improve

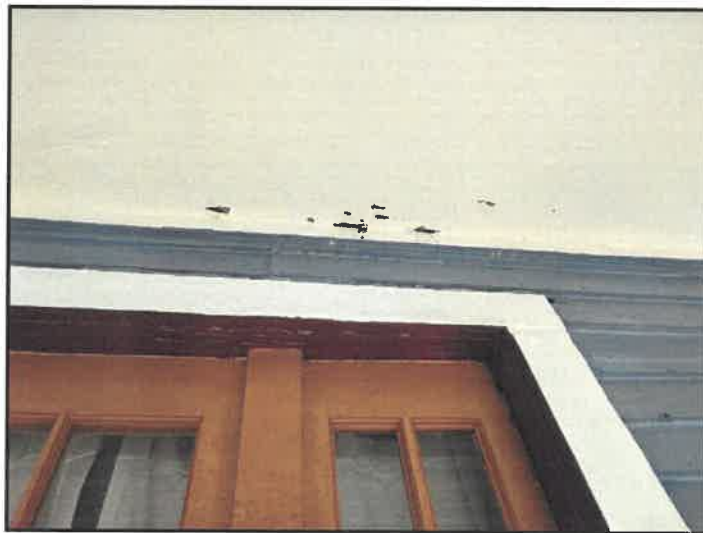
41. Rot or insect damage

34. Condition: • [Rot or insect damage](#)

Location: Front Porch

Task: Further evaluation

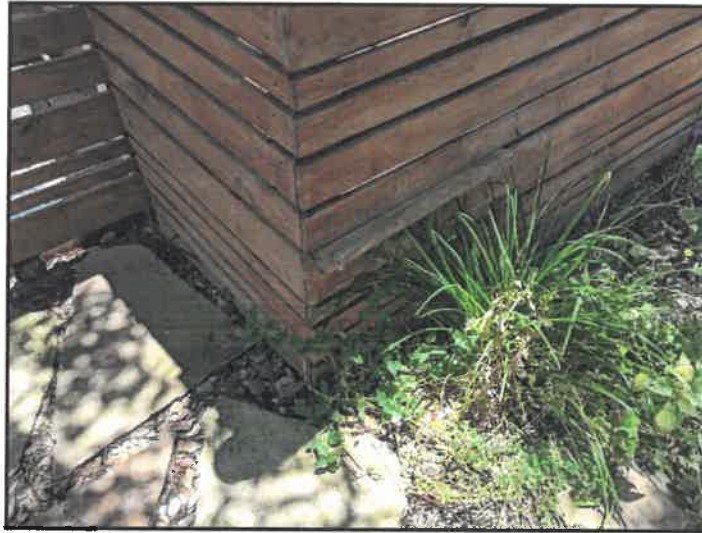
42. Rot or insect damage

35. Condition: • Rot or insect damage

Implication(s): Material deterioration

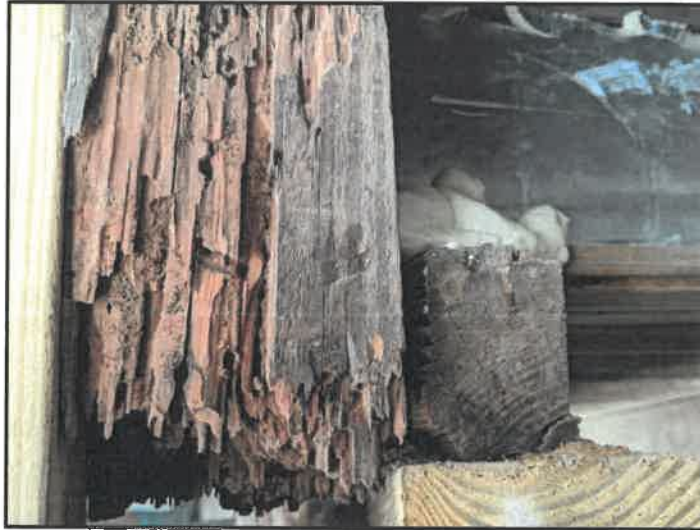
46. Insect damage

40. Condition: • [Insect damage](#)
Implication(s): Weakened structure
Location: Front Left Side Garage
Task: Monitor

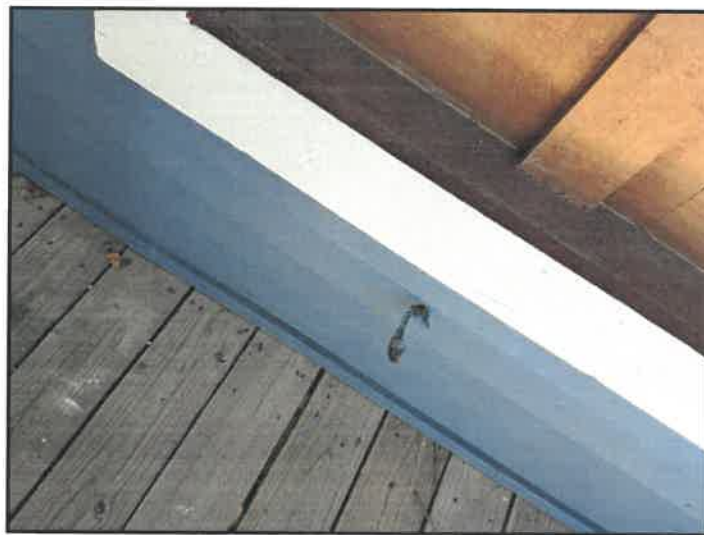
58. Exposed on walls or ceilings

49. Condition: • [Exposed on walls or ceilings](#)

Task: Correct

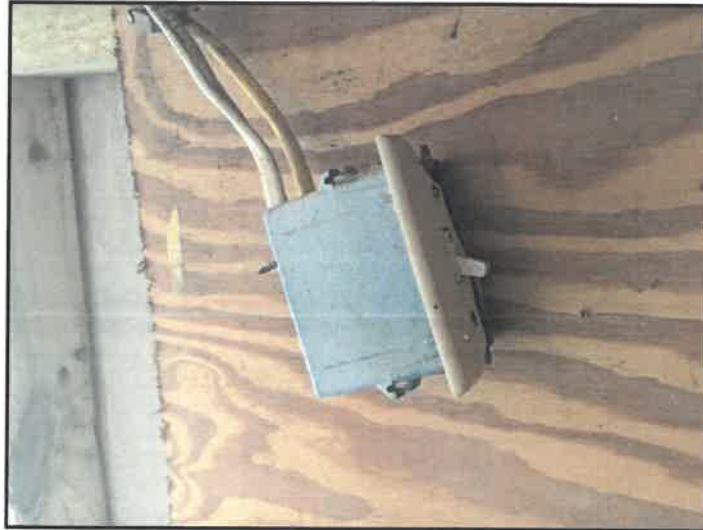
65. Inoperative

55. Condition: • [Inoperative](#)

Implication(s): Inadequate lighting

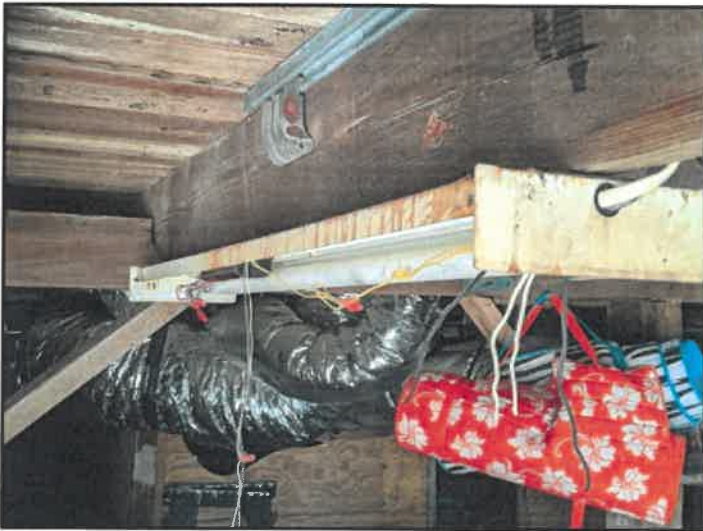
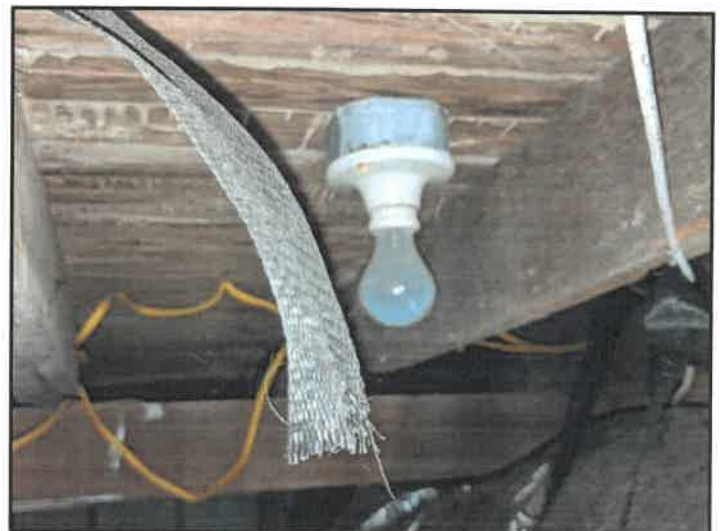
56. Condition: • [Inoperative](#)

Implication(s): Inadequate lighting

Location: Various Garage

66. Inoperative

67. Inoperative

Task: Remove

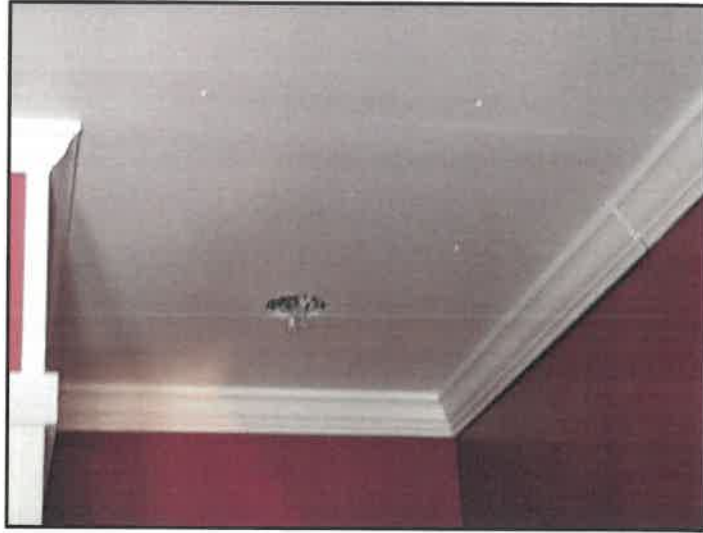
68. *Missing*

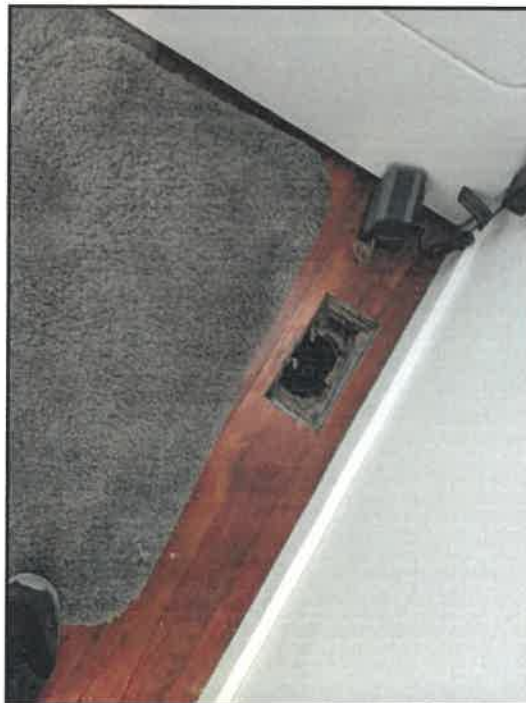
67. **Condition:** • [Missing](#)

Location: Laundry Area

77. *Missing*

Task: Replace

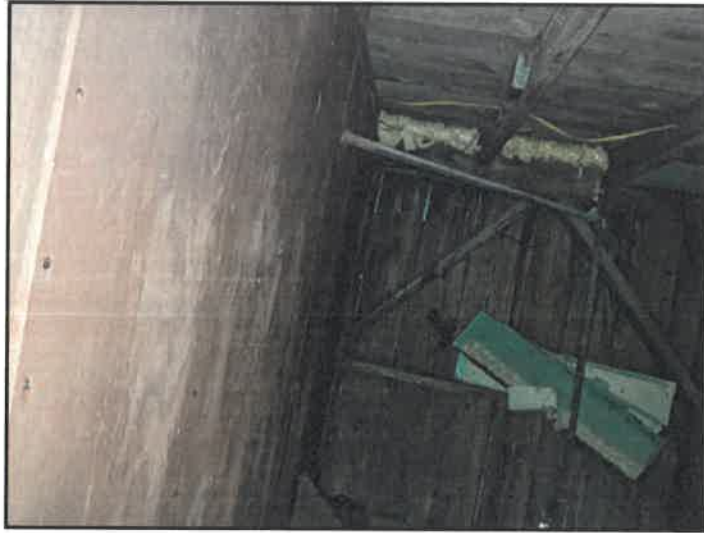
69. Condition: • Inadequate

Implication(s): Chance of condensation damage to finishes and/or structure

79. Inadequate

68. Condition: • Recommendation: Remove wood paneling in garage and old insulation to increase ventilation throughout crawlspace.

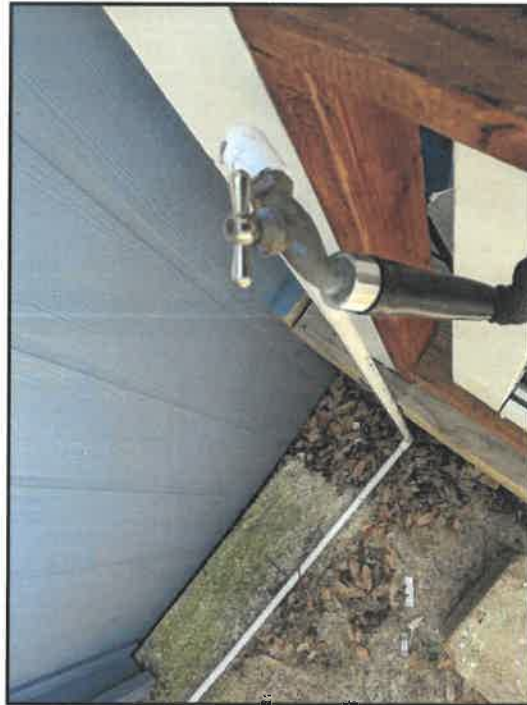
71. Condition: • [Poor support](#)

Implication(s): Chance of water damage to contents, finishes and/or structure | Leakage

84. Poor support

70. Condition: • Recommendation: Add backflow preventers to outdoor faucets.
Recommendation: Secure any loose service piping throughout the home.

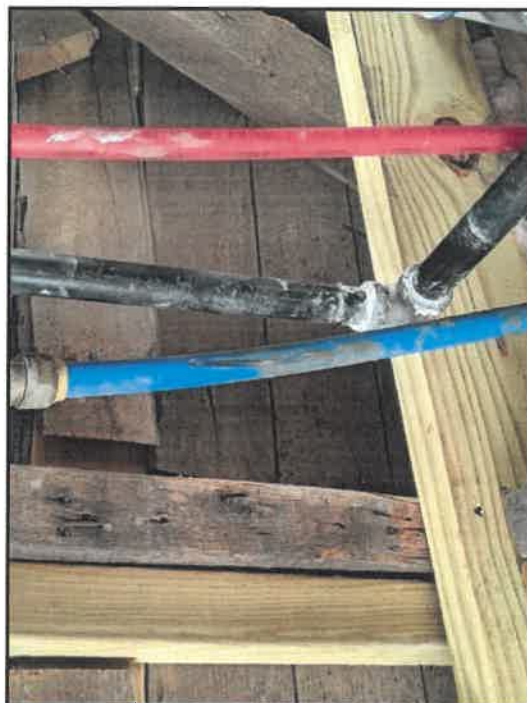
72. Condition: • [Inadequate support](#)

Location: Middle Garage

85. Inadequate support

Task: Improve

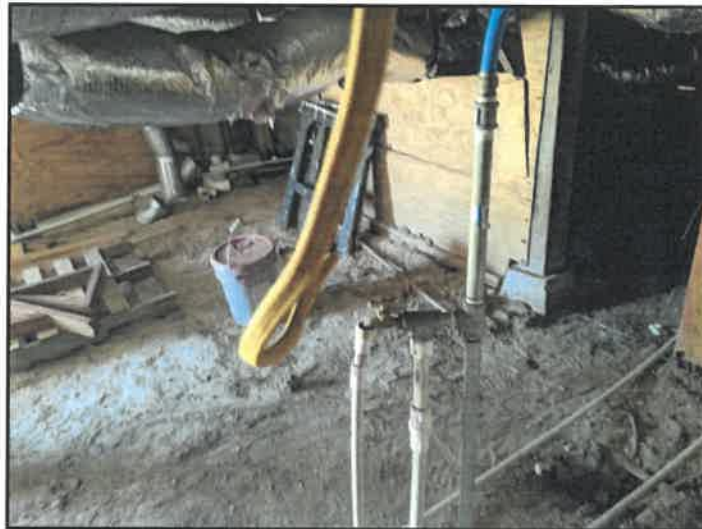
75. Condition: • [Loose](#)

88. Loose

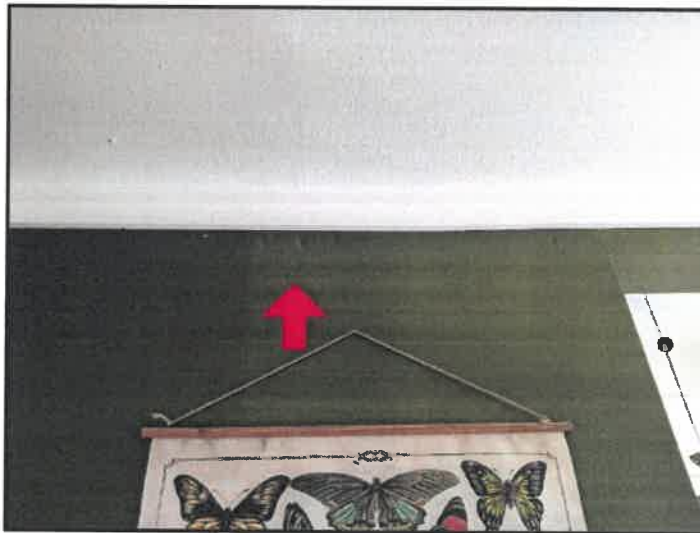
78. Condition: • [Typical flaws](#)

Location: Various

93. Typical flaws

Task: Monitor
