PROPERTY INSPECTION REPORT

Concerning: 5300 Silverbelle Ln, Richmond, TX 77406
(Address or Other Identification of Inspected Property)

By: Chris Blanks, Lic #23710 04/22/2021
(Name and License Number of Inspector) (Date)

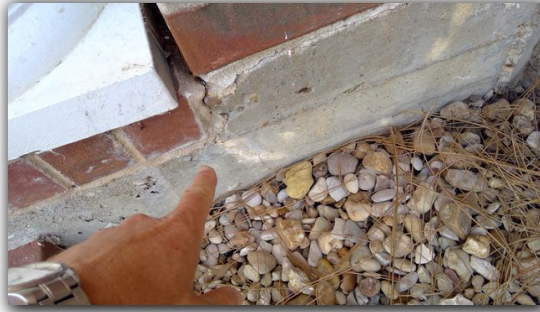
- The foundation's rebar is visible at the edge of the garage foundation and should be properly sealed to prevent deterioration.

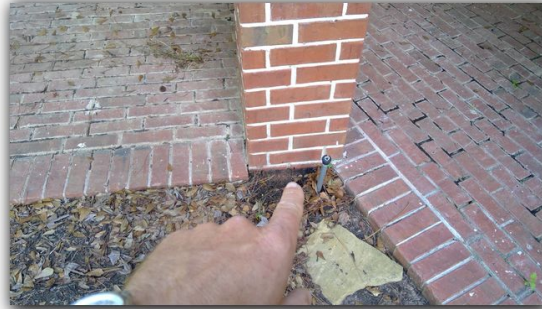
- A high soil line is present against the side(s) of the structure. Under current

building standards, there should be at least 4 inches of the foundation visible below masonry, stone veneer or stucco and at least 6 inches of foundation visible below wood type veneer or Exterior Insulation Finishing Systems (EIFS). This is also considered to be a conducive condition for wood destroying insects and should be monitored/remedied accordingly.

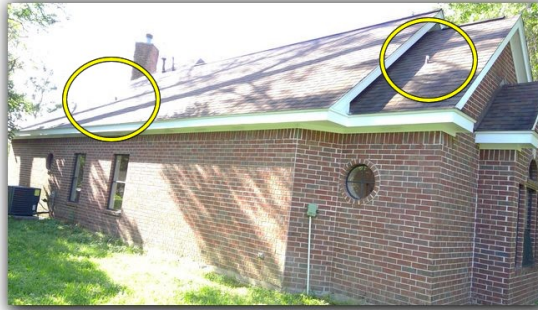
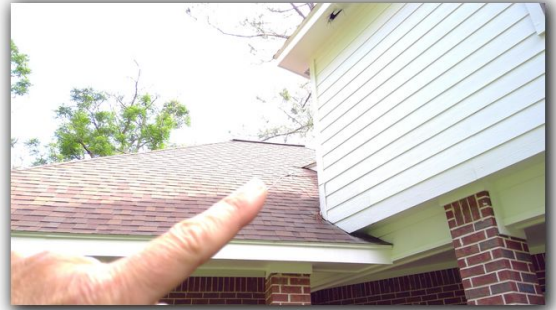
- Lead roof jacks are in need of replacement. In their present condition, moisture penetration in to the attic space is possible.

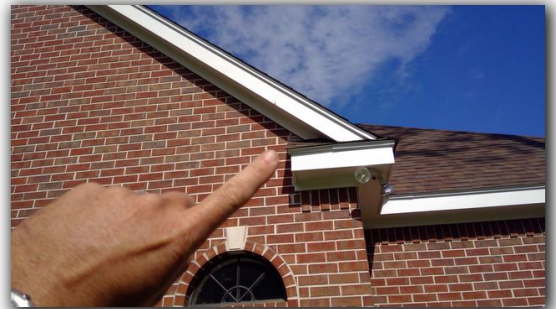
● Missing flashing was observed. This should be corrected to prevent wind driven rain and moisture intrusion into the roof system.

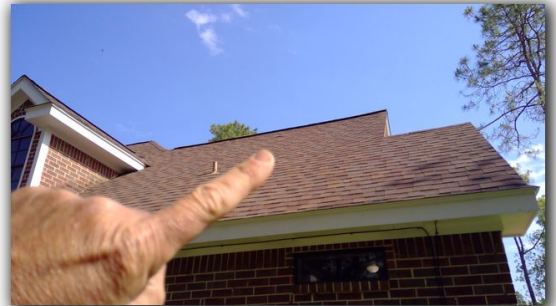
● Lifted shingles were observed on the roof. This should be repaired.

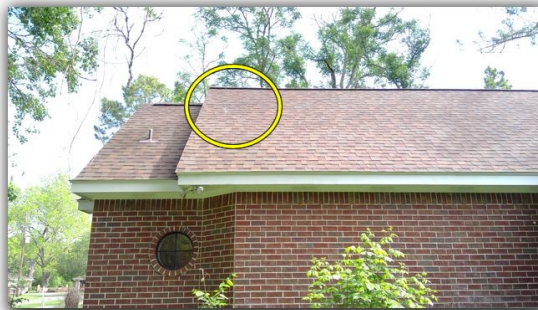
● Shingle damage is present on the surface of the roof. This damage should be repaired by a qualified roofing professional.

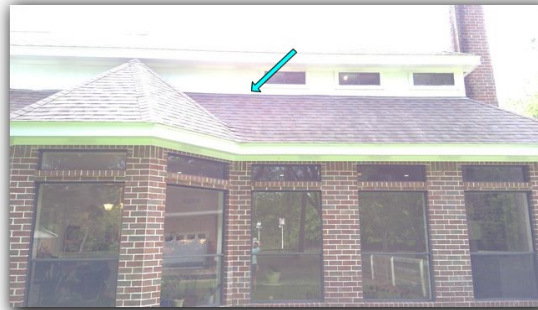
● Lifted flashing was observed. This should be corrected to prevent wind driven rain and moisture intrusion into the roof system.

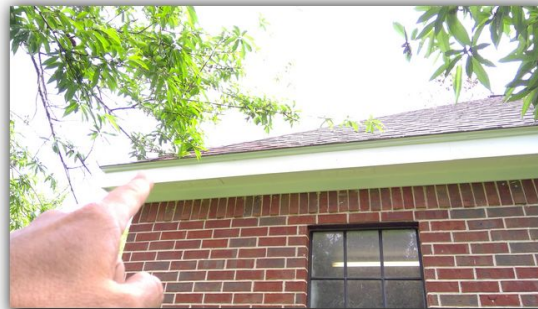
- Tree branches are near or in contact the roof structure. These limbs can cause damage to the roof covering and structure. These limbs should be trimmed away from the structure.

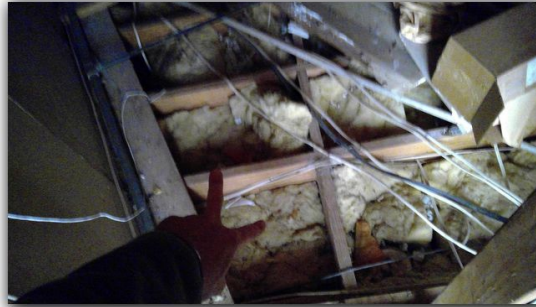
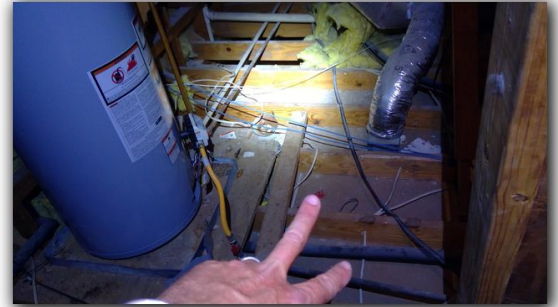
- The amount/thickness of attic insulation is lower than typical/missing in one or more locations. It is recommended to have 10+ inches of insulation to achieve

an R-30 rating.

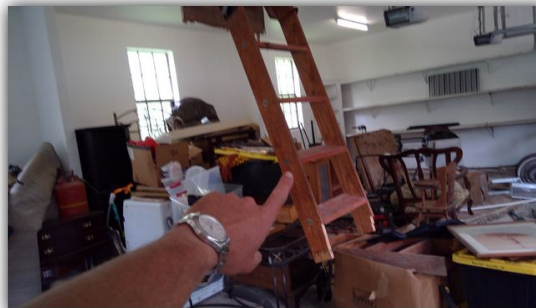
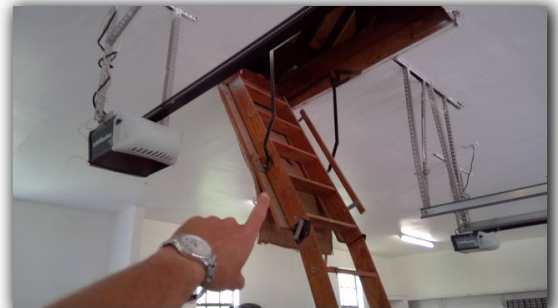
- An access ladder is damaged and in need of repair.

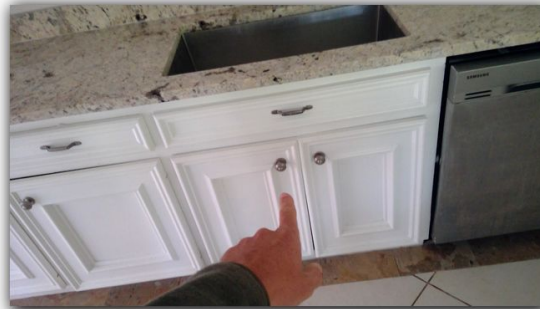
- Cabinet doors rub and need adjustment.

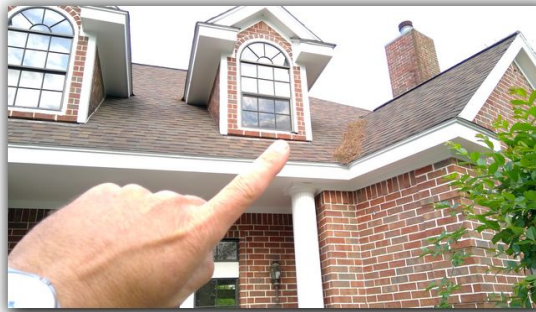
- Trim boards are present that are showing signs of deterioration/rot and are in need of replacement.

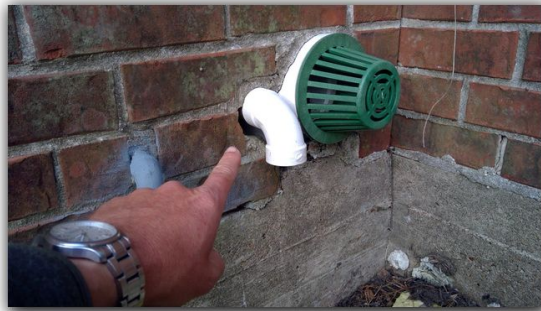
- Expansion joints are present in the brick/stone veneer walls that need to be re-sealed to prevent moisture intrusion into the wall system.

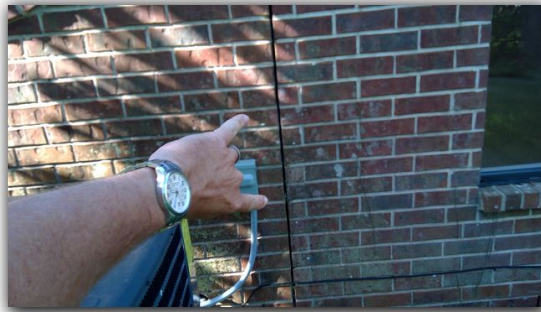
- Cracking was identified within the brick/mortar on exterior walls.

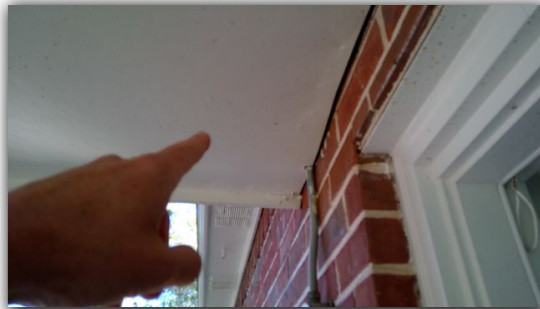
- Damage to the ceilings was observed.

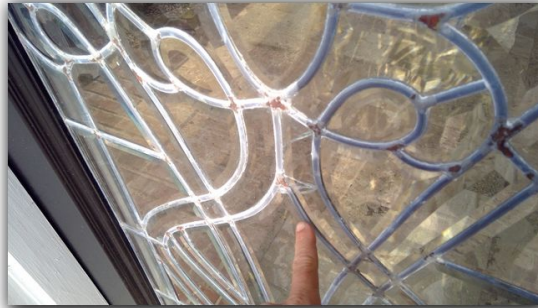
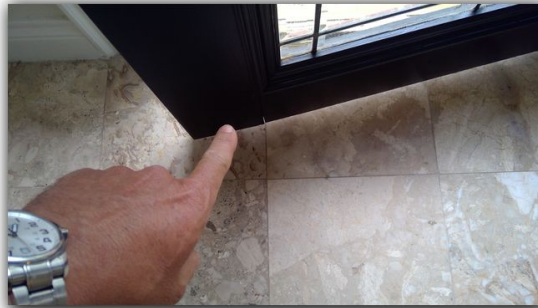
- Glass in the front door is broken. It also drags the threshold and is separating at the bottom.

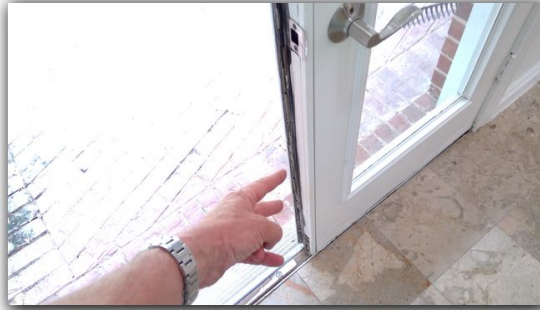
- Weather stripping is missing around exterior door(s). This can result in significant energy loss and potential moisture intrusion into the home.

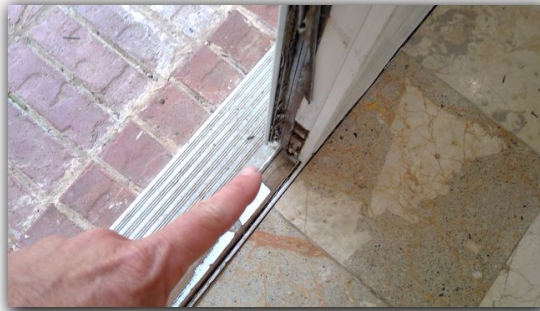
- French doors are present that do not latch/lock properly. Adjustment of the door/hardware is recommended.

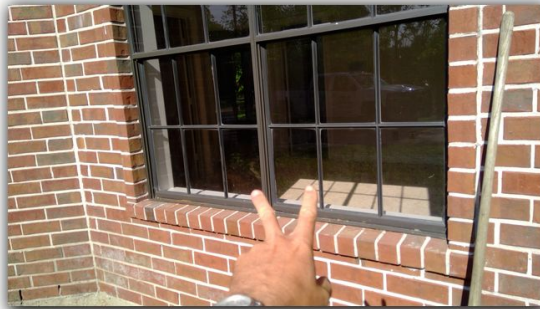
- Window screens are damaged or missing.

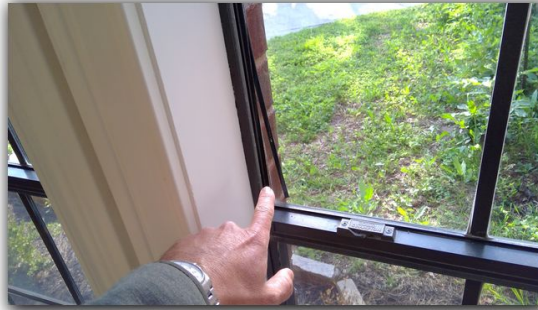
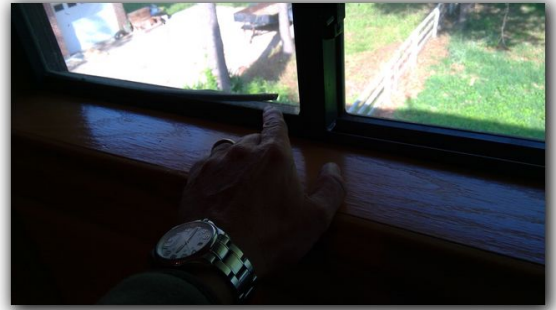
- Plastic muntins are damaged or missing on windows.

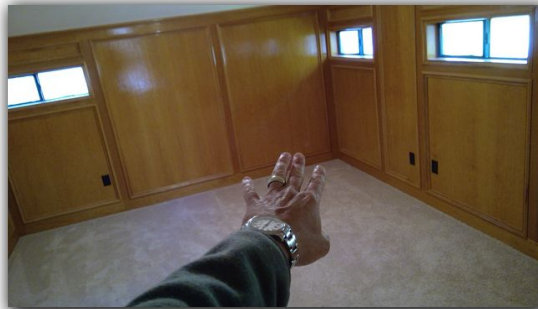
- There are no egress windows present in certain rooms. Due to the lack of emergency egress, these rooms should never be used as a bedroom.

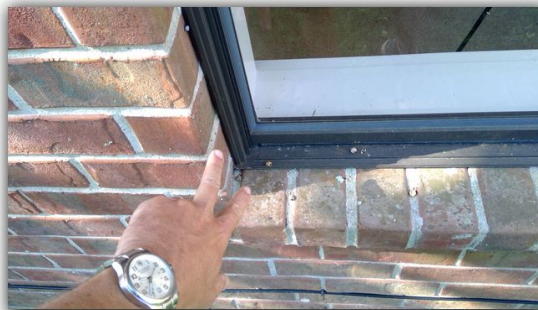
- Caulking around windows is lacking or has deteriorated. This can result in moisture penetration, as well as heating and cooling losses.

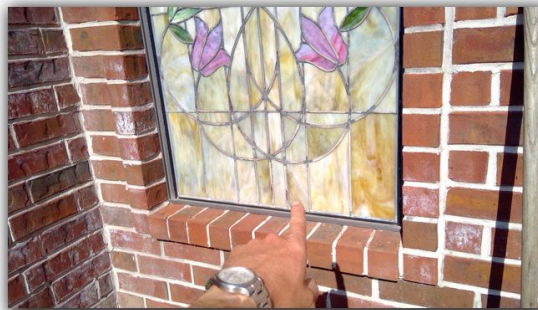
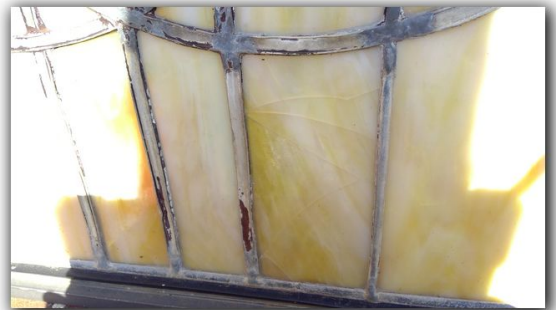
- Broken windows are present.

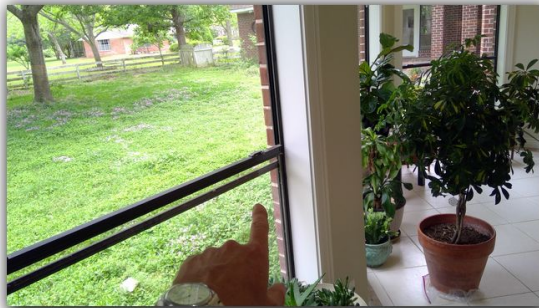
- A glass panel is loose in its frame.

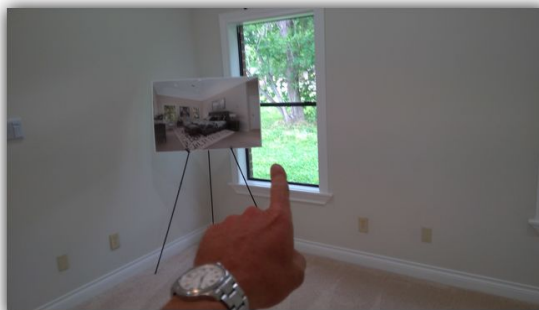
- Windows are present that will not open.

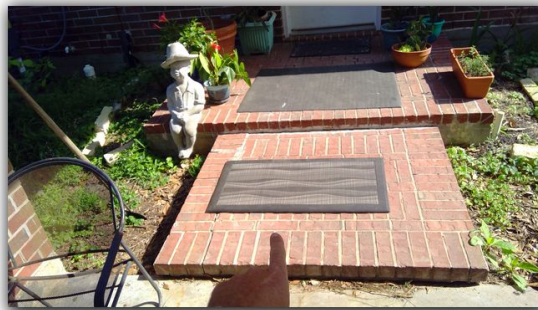
- The side entry steps are leaning and cracked through.

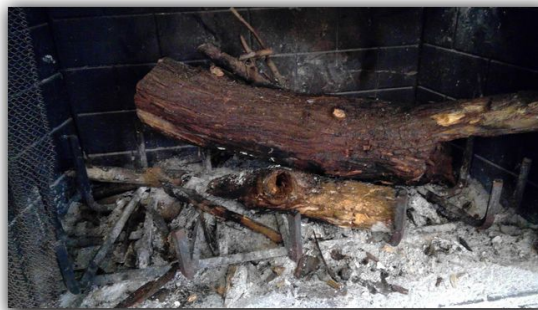
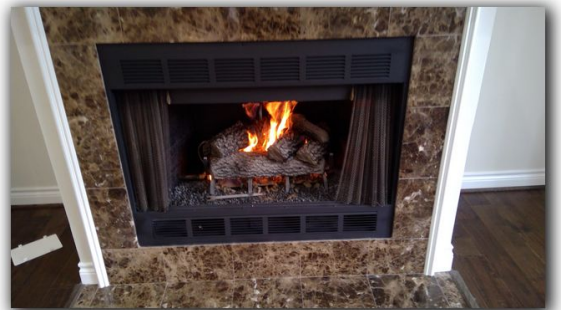
- The fireplace contains a gas log / starter arrangement and a chimney damper that is not blocked in the open position. The damper must be blocked open to ensure combustion byproducts from a gas fire to exit the house via the chimney.

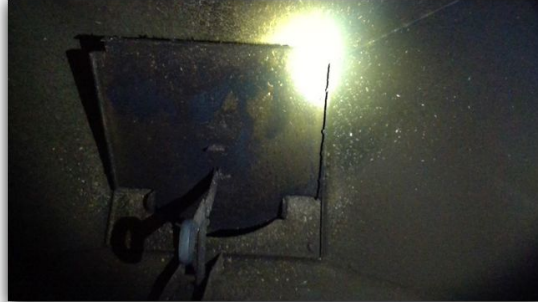
- Creosote buildup is visibly present in the chimney flue. Cleaning is recommended.

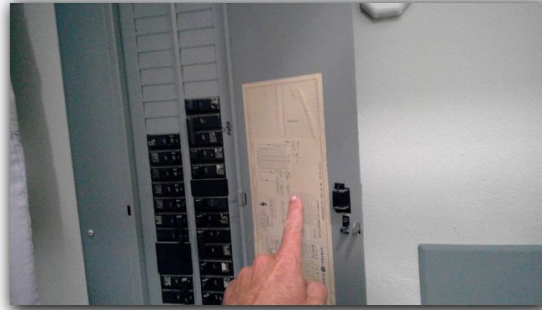
- The electrical panel is not fully labeled.

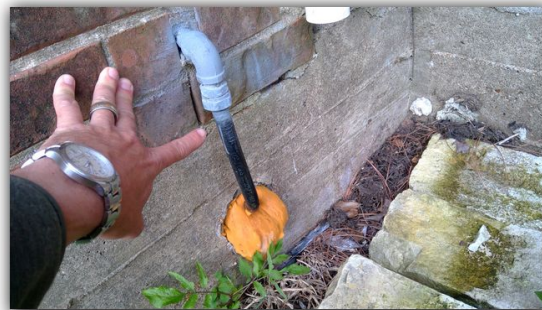
- Corrugated Stainless Steel Tubing (CSST) is used for gas distribution in the home. Bonding of the CSST to the home's electrical system could not be confirmed. It is important that CSST be bonded to the home's electrical system because runs of CSST that are not bonded are prone to significant damage and leakage should the home be exposed to a lightning strike. The resulting damage/leakage could cause a fire. An electrician should evaluate the CSST in this home and bond it to the home's electrical system if not already bonded.

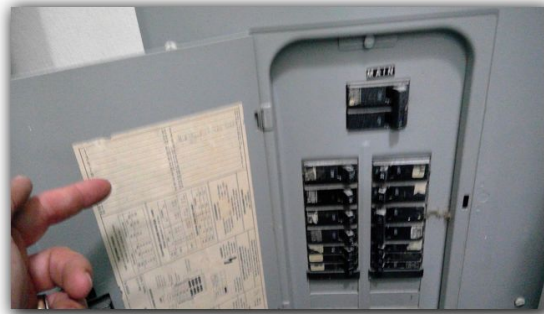
- The electrical panel is not fully labeled.

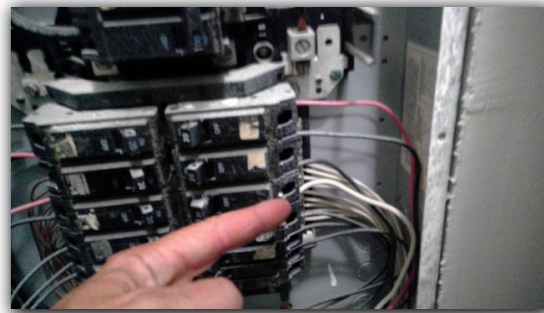
- White wires connected to breakers are not marked with red or black tape as an indicator they are "hot" conductors.

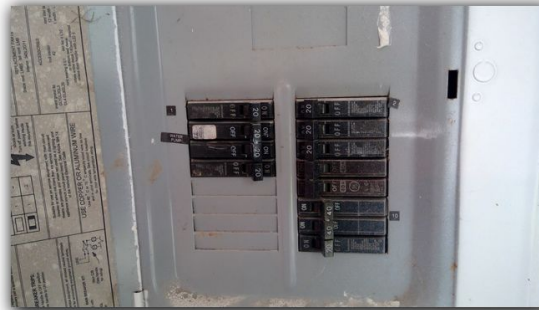
- The electrical panel is not fully labeled.

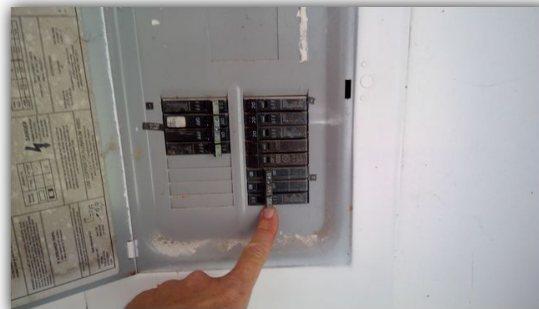
- Breakers were found in the off position upon inspection. With no knowledge as to why the breakers were off, the breakers were not engaged. Engaging a fault tripped breaker can potentially cause damage to the circuit or devices plugged into the circuit. This should be evaluated by a licensed electrician.

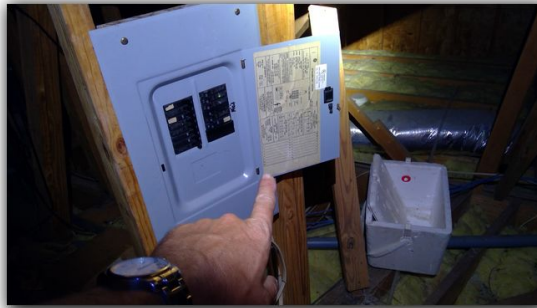
- The electrical panel is not fully labeled.

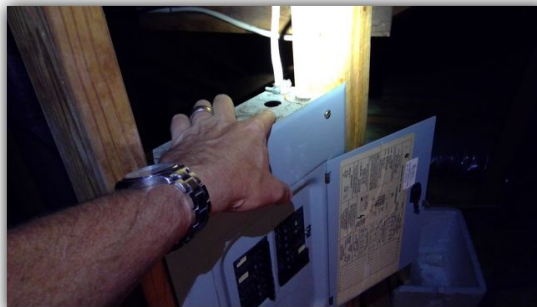
- One or more knockouts are missing, allowing for unsafe access into internal portions of the electrical panel.

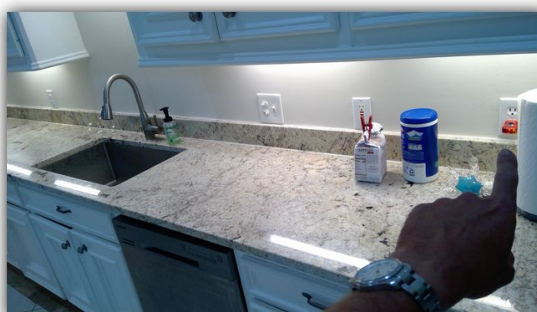
- Ground fault circuit interrupter (GFCI) receptacles are not present as required. GFCI receptacles are necessary for branch circuits with outlets in kitchens, bathrooms, within 6 feet of non-kitchen sinks, garages and accessory buildings, outdoor areas and crawl spaces. This is a recognized safety hazard.

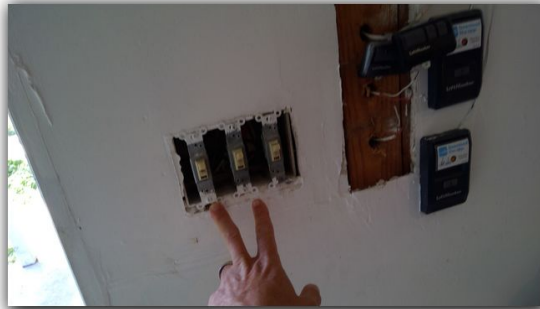
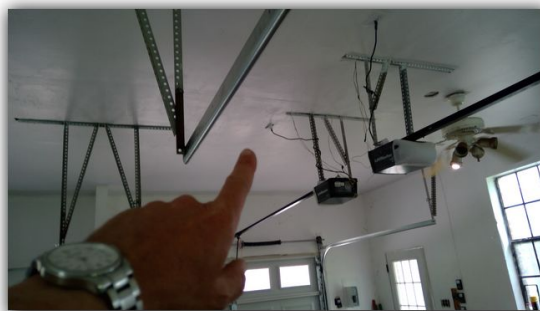
- Missing face plates were observed on receptacles/switches.

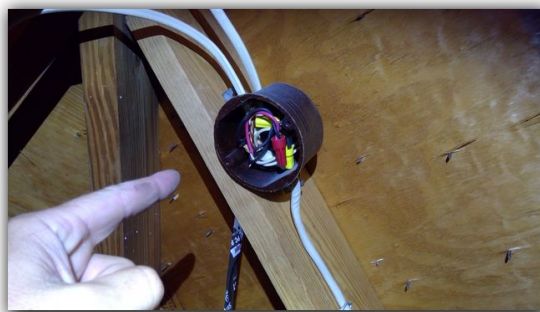
- Open electrical junction box(es) was identified. Junction boxes should be securely closed.

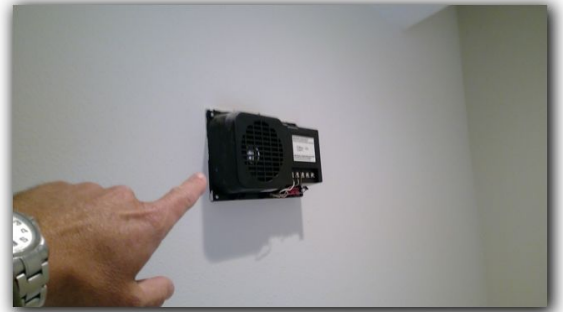
- The rear door bell is inoperable and the chime cover is missing.

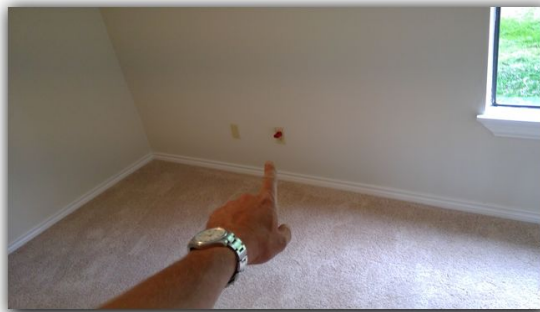
- Receptacles were observed to be inoperable.

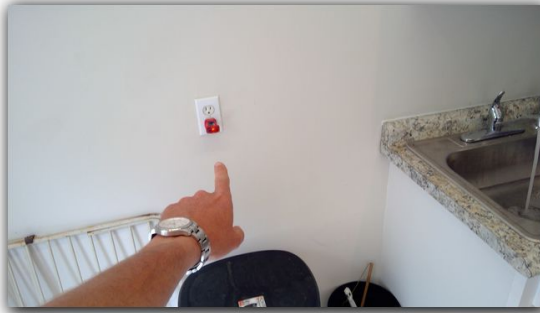
- A test indicates an open ground condition within receptacle(s). This should be corrected.

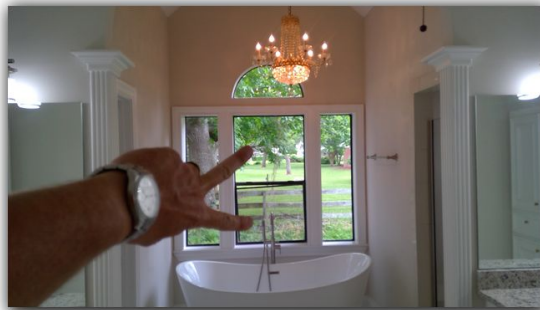
- The light fixture above a tub was observed to be too low and creates a potential shock hazard. The fixture should be 3 feet horizontally from the tub, or a minimum of 8 feet above it.

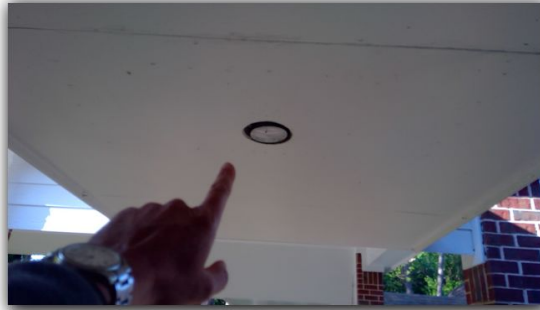
- Trim rings are missing from lights.

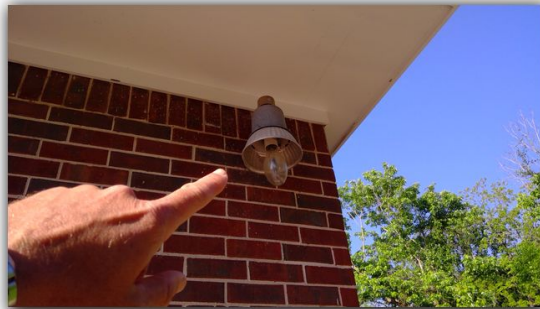
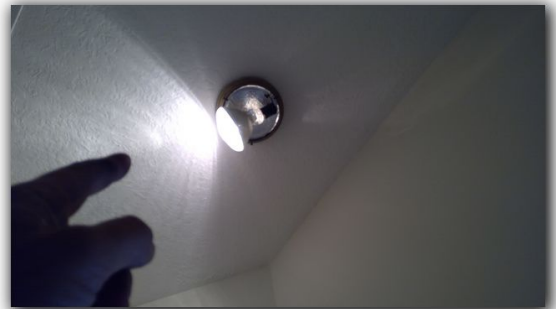
- Several fixtures were present throughout the home with no globes/damaged globes.

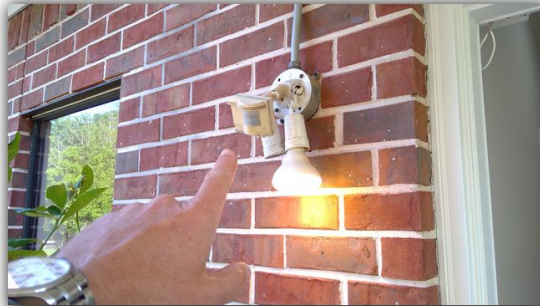
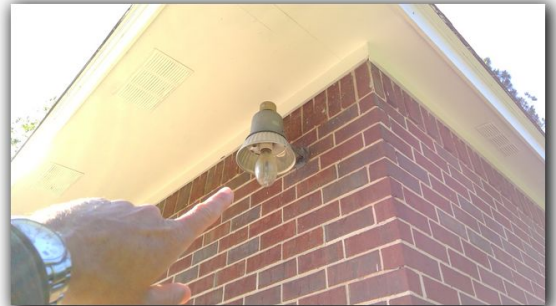
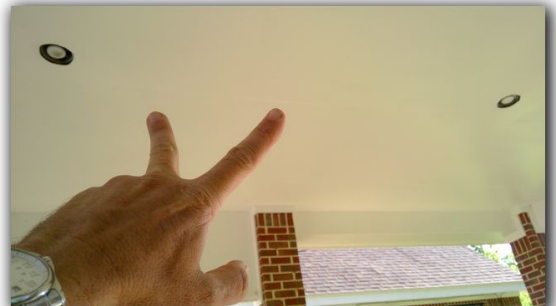
- Light fixtures are broken/inoperable and are in need of repair.

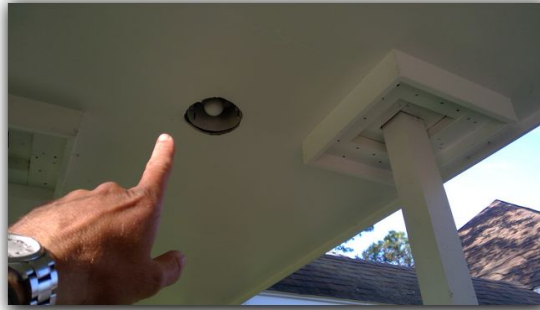
● Light fixtures are inoperable. New light bulbs may or may not remedy the situation.

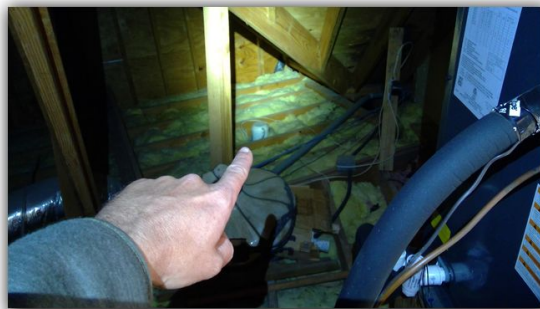
- Conduit is damaged/separated, exposing wiring outside the home. This should be repaired.

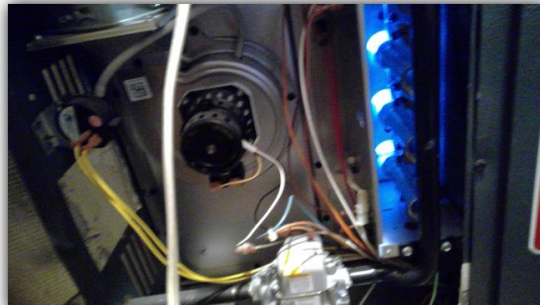
● A sediment trap is not present on the gas piping before it's entry into the furnace. A sediment trap is necessary to capture matter or debris in the gas line that could foul the gas valve or burner system. One should be added.

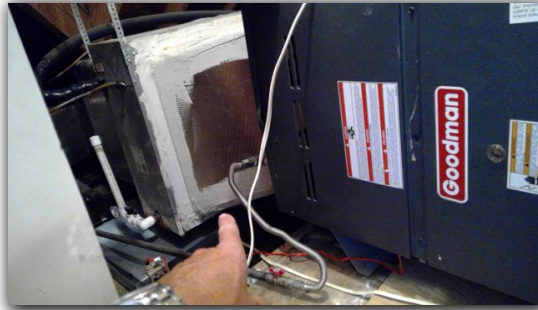
- The furnace exhaust vent flue is too close to combustibles. A "B-vent" requires 1 inch of clearance. Single wall vent flues require 6 inches of clearance.

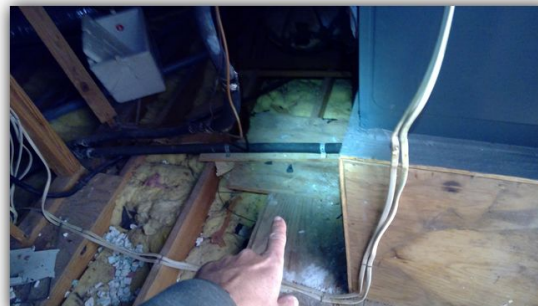
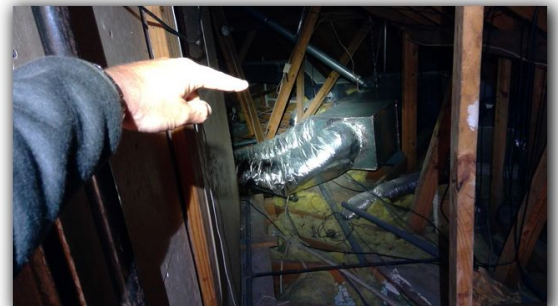
- The primary condensate line is not fully insulated. Without proper insulation, the cold water in the drain line can cause condensation to form on the piping that could drip and damage attic surfaces.

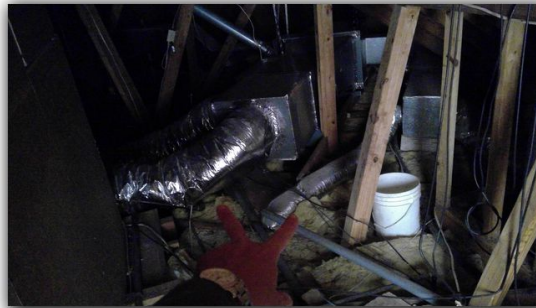
- Duct work was observed to resting on and compressing attic insulation. These ducts should be suspended from the roof structure.

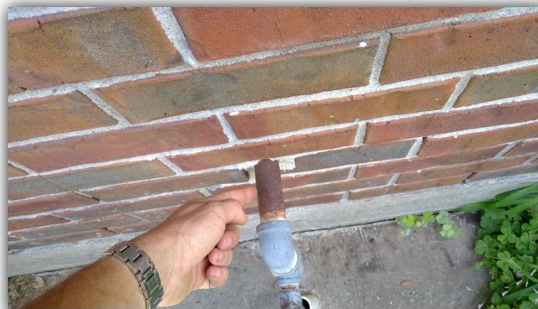
- The propane tank is buried and is of an unknown size. It is only 10% full.

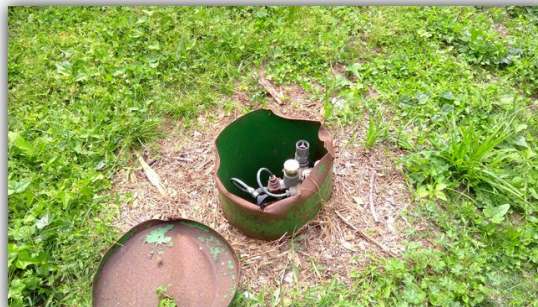
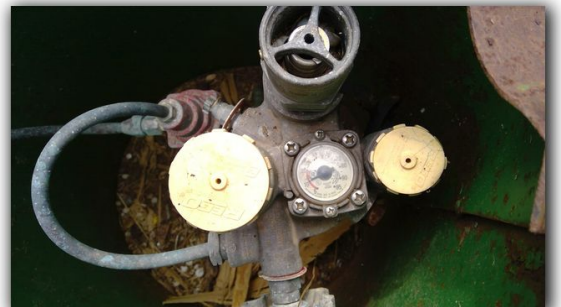
- Corrosion was noted on washing machine hose bibs.

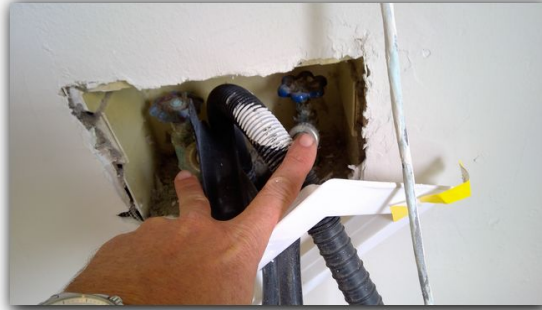
- A gas supply line is not in use and is uncapped. All gas supply lines should be capped when not in use for safety. In the event the gas valve is opened, the cap will prevent the structure from being filled with gas.

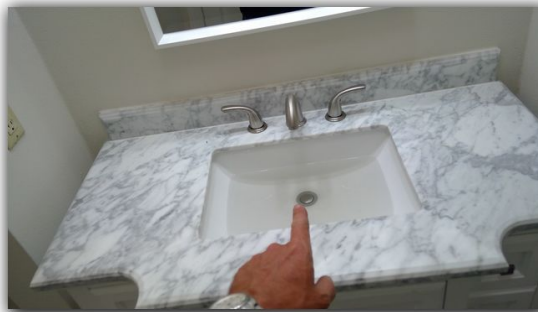
- In the shower(s), caulking/grout is missing or damaged, allowing for potential water leakage. It is possible water damage is present that cannot be observed during a visual inspection.

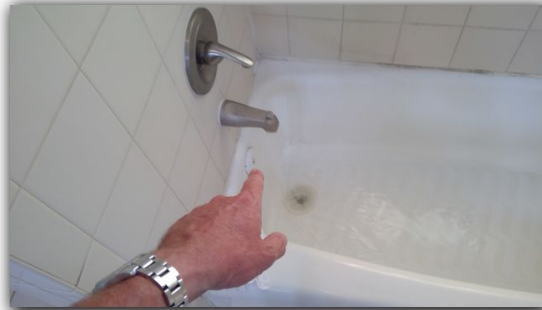
- Drain stops in the tubs are inoperable or missing.

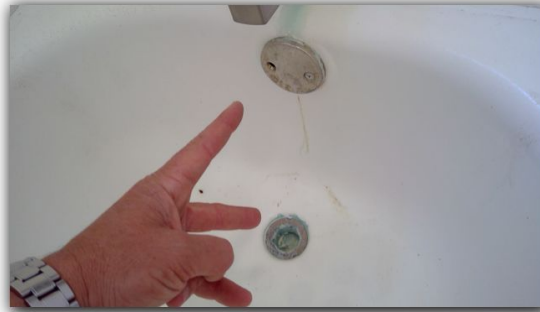
- The enamel surface of the tub/shower is chipped or damaged.

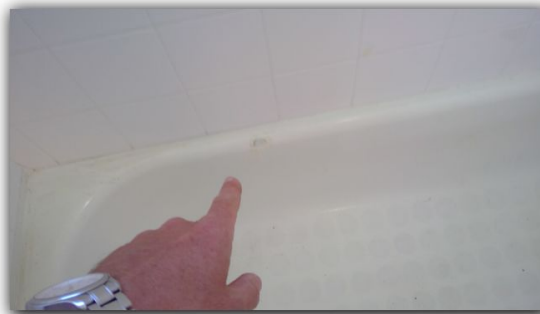
- Damaged shower tile was noted.

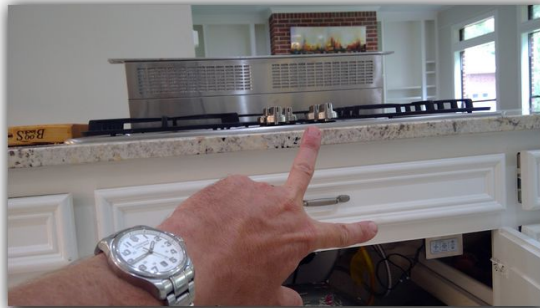
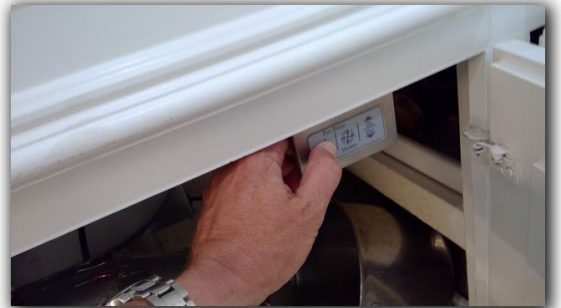
- The range hood raised, but did not come on when controls were used.

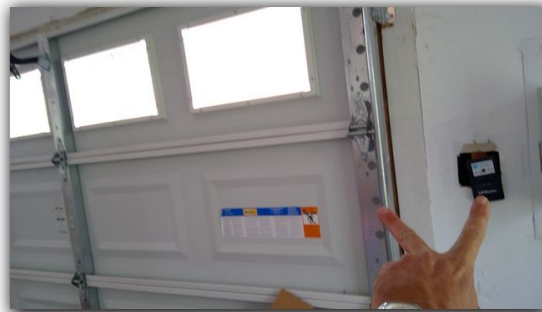
- One of the 5 garage door openers would not respond to controls.

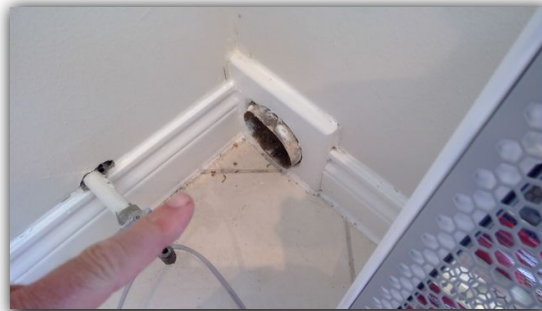
- The dryer vent is dirty with visible lint and debris. It should be cleaned.

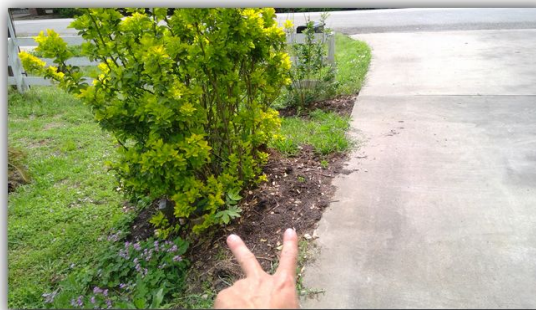
● The conduit carrying the well head wiring is broken and a junction box lid is held on with zip ties. This should be corrected.

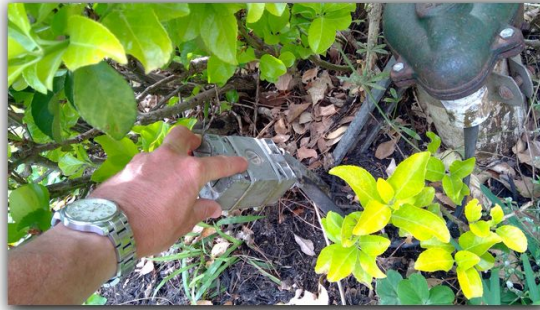
- Wire splices, terminated wiring and contact switches are exposed. They should be covered/contained in junction boxes

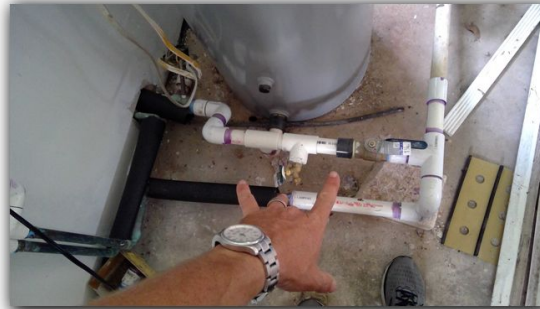
- There is no pressure gauge on the system. When water is turned on, the pressure switch turns on and off very quickly. This causes system pressure to greatly fluctuate. This is also very hard on the submersible pump. This well

system should be evaluated and repaired by a licensed well technician.

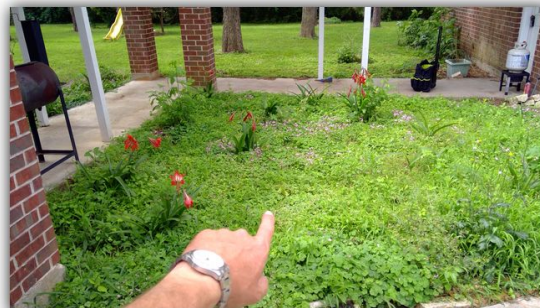
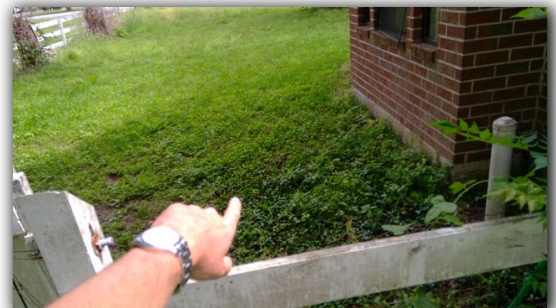
● The owner disclosed two anaerobic septic systems on the property. One is next to the master suite and the other is near the garage and driveway. All components of this anaerobic septic systems are buried and could not be observed without digging up the access ports and pumping down the tanks. Pumping tanks is not within the scope of this inspection. If further evaluation is desired, it is recommended a licensed septic technician pump and evaluate the tank conditions. A functional evaluation of the systems was made by introducing large quantities of water into each system. The systems accepted the volume introduced.

● The lids serving this septic system's tanks are below grade. For maintenance purposes, it is recommended risers be installed on the ports of the tanks that bring the tank lids above grade. Without these risers, the tank lids must be dug up every time the system requires maintenance or pumping.
