PROPERTY INSPECTION REPORT

Concerning: 17506 Memorial Ridge Dr., Spring, TX 77379

By: Ronald Wood, Lic #7350

08/05/2017

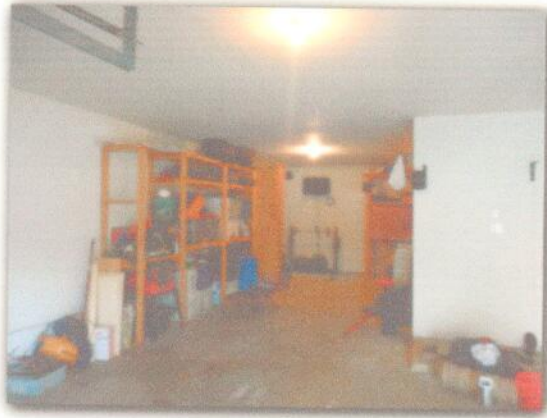
NOTE: There appeared to be undetermined repaired and/or repainted wall and/or ceiling areas noted at multiple home locations. (Sometime this is done to cover/mask possible issues/deficiencies.) If you, the buyer, have any questions and/or concerns regarding these areas, it is highly recommended that you, the buyer, obtain further information from the seller about the repaired and/or repainted areas prior to the end of the option period.

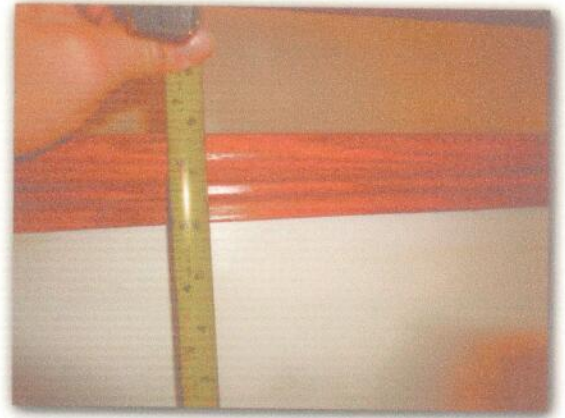
- The attic stairs are damaged and/or have loose parts - **SAFETY HAZARD.**
- The attic stairs are not properly secured/nailed - **SAFETY HAZARD.** (No screws allowed.)
- The attic stairs are not properly insulated.
- The attic stairs are not properly sealed when closed. Needs weather seal around opening.

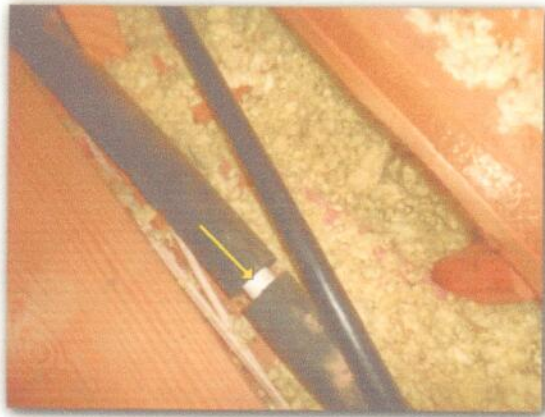
Air leaks at the evaporator housing.

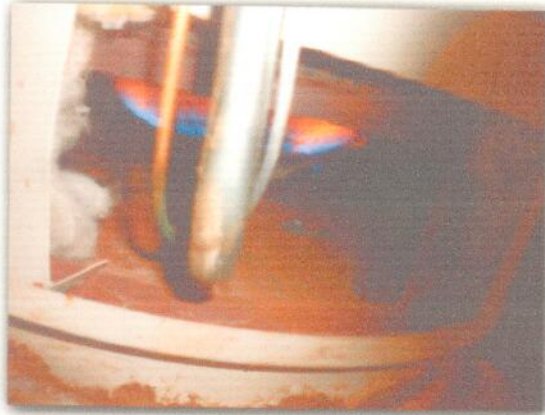
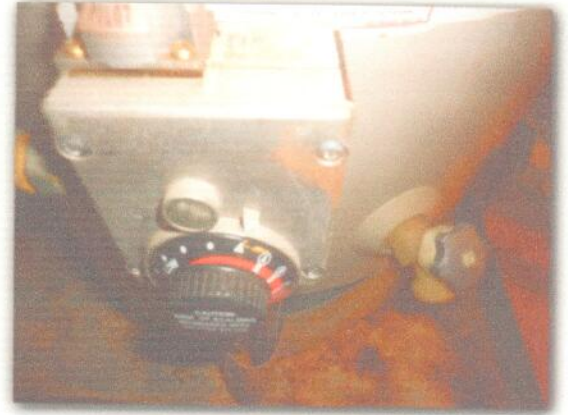
- ☑ The interior burner access cover was not properly secured - **SAFETY HAZARD.**
