## STRUCTURAL INSPECTION

4547 Bermuda Dr  
Sugar Land TX 77479

SEPTEMBER 2, 2020

REF: CONDITION OF PROPERTY SURVEY

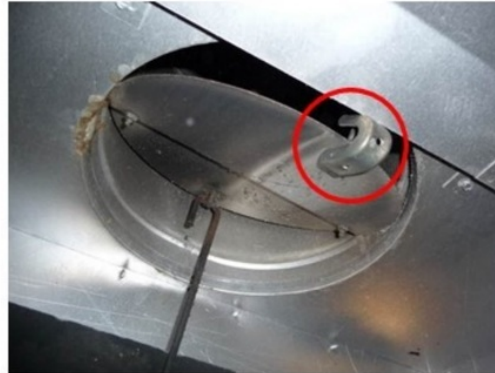
HEI file photo showing c-clamp in metal fireplace

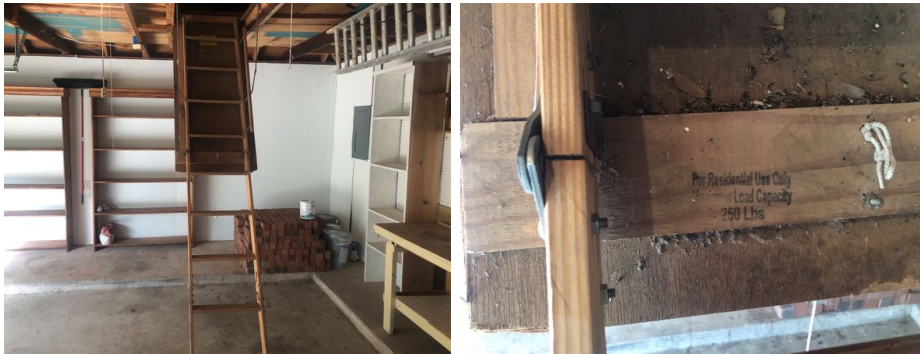
##### Ladder: 375 pound capacity

The access ladder was observed to be rated at 375 pound capacity.

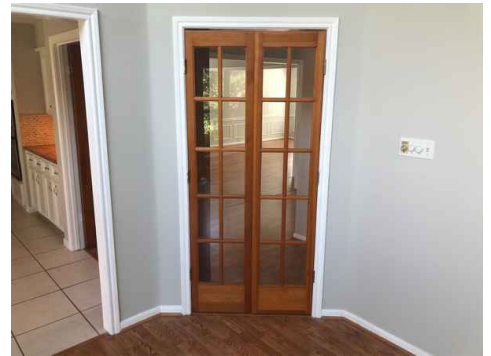
## 12.1.4 Doors

**GLASS NOT SAFETY GLASS**
