**A Home Inspection Report On
10915 Langdon Lane, Houston, TX
Sold by Sylvia Reyes, Listed By**

Sunday, December 27, 2020

PROPERTY INSPECTION REPORT

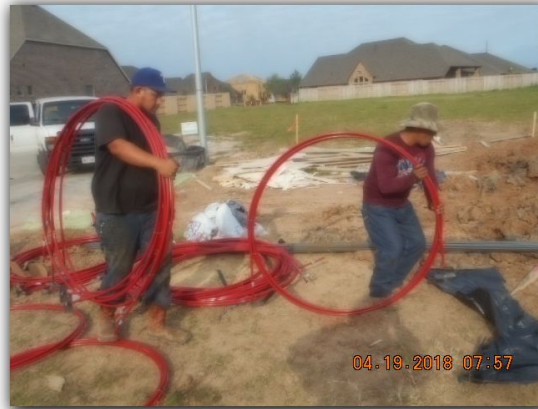
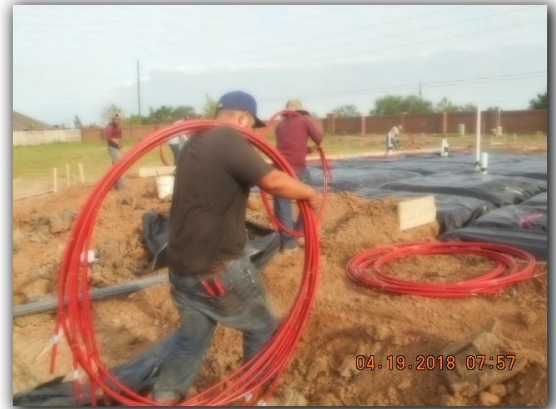
8. Post-tensioning is a method of reinforcing (strengthening) a concrete slab on grade with high-strength steel strands. These strands or cables are also referred to as tendons. High-tension steel tendons enable slab foundations to withstand the stresses of expansive and compressive soil conditions that are prevalent in Texas.

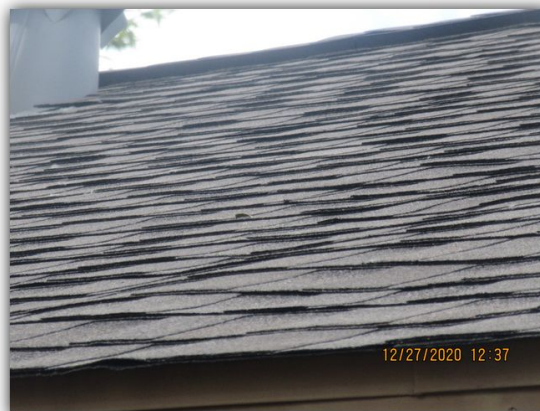
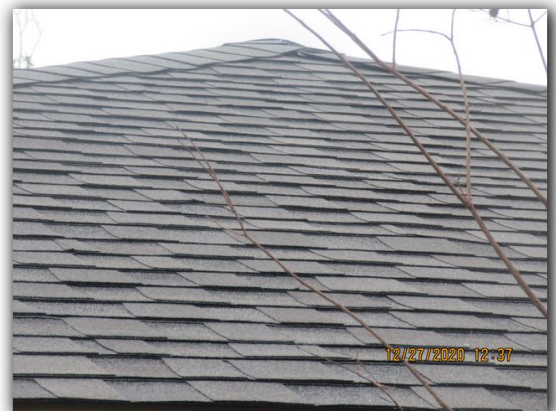
17. The home has a new laminated composition roof shingle covering over wood decking.

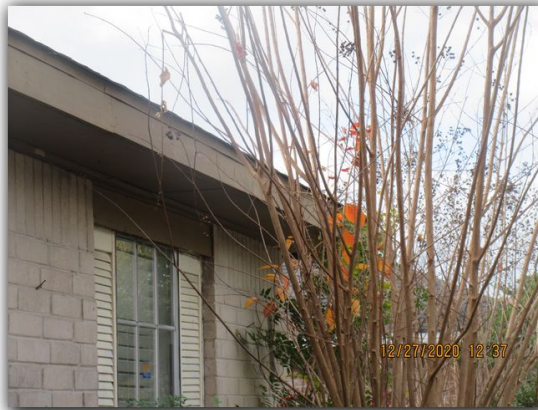
19. There are various tree limbs that are in contact with the roof covering, all tree limbs must be at least six feet from the roof/shingles to avoid damage.

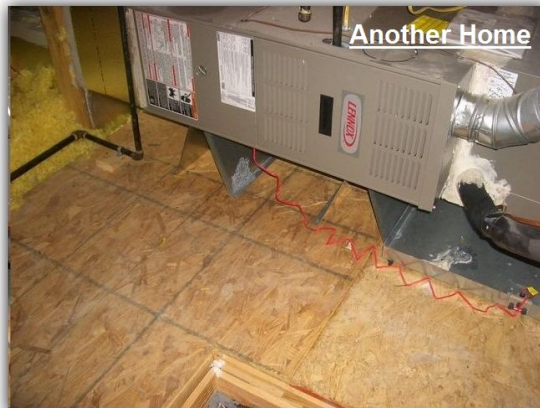
26. Improper decking methods, attic decking must be solid plywood with no obstructions in front of the furnace as per code and as seen on the left lower photo below.

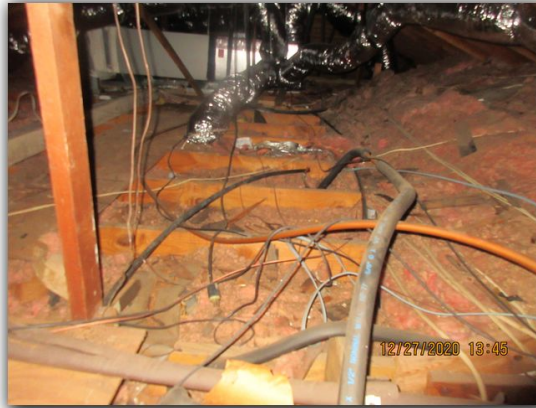
27. Improper decking materials, must have 3/4 inch plywood that is unobstructed to the furnace and at least 24 inches wide.

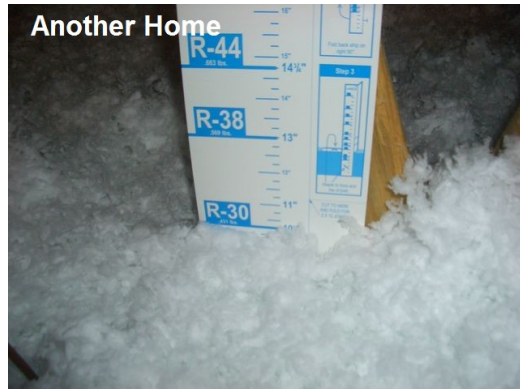
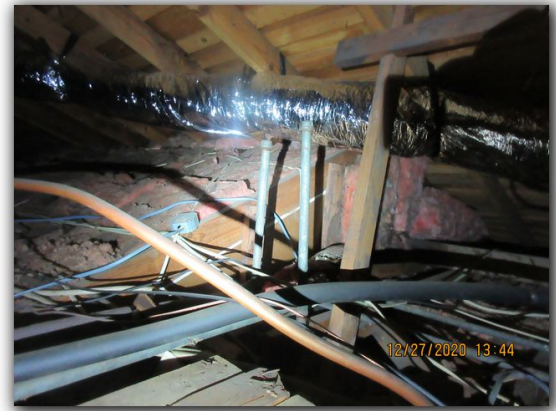
28. The insulation does not meet R-38 code requirements which is at least ten inches of insulation in all parts of the attic.

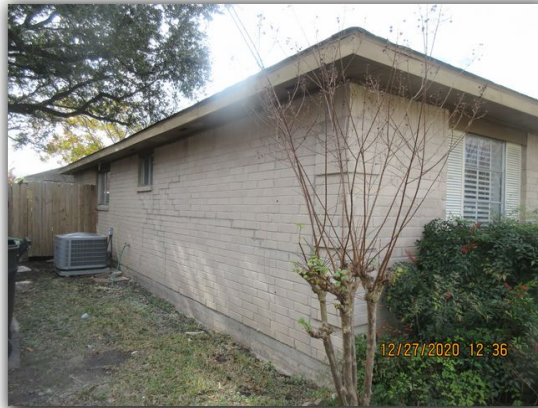
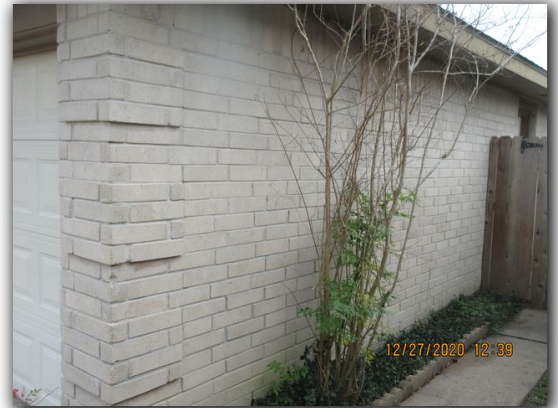
29. The home had the exterior finishes as follows:

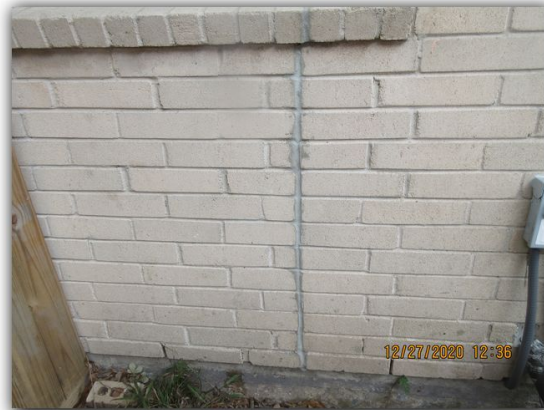
32. Expansion Joints are present and properly sealed.

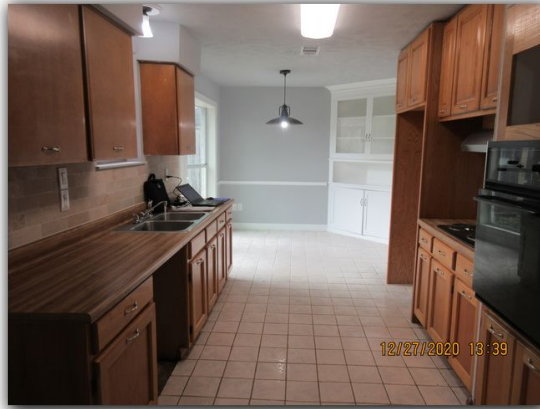
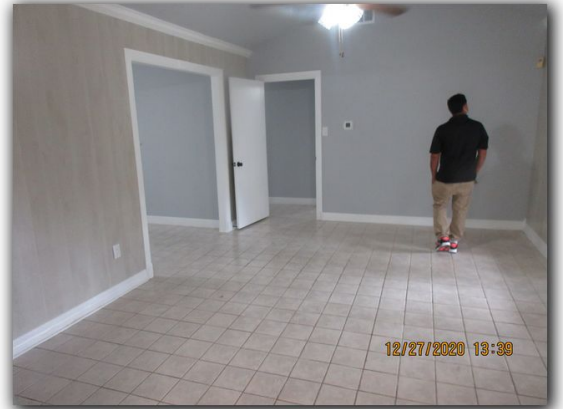
39. The flooring in the bedroom are also in fair condition as viewed at random.

40. The wood flooring in one room has been painted and looks like it has some water damage, the owner should disclose if the home has flooded.

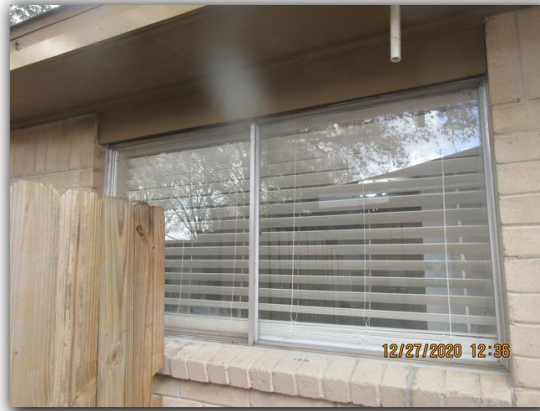
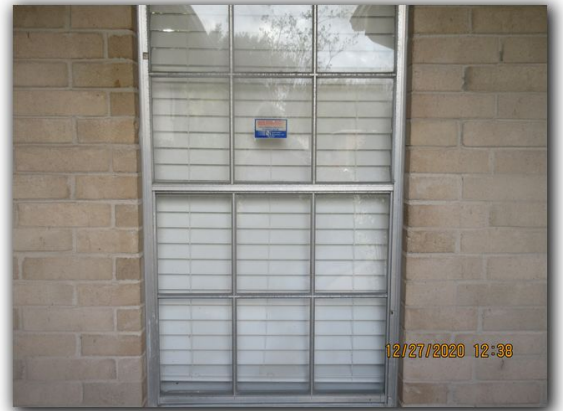
47. Home has most of the windows with a single pane.

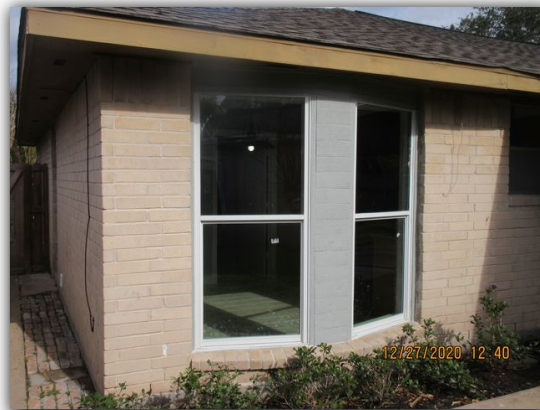
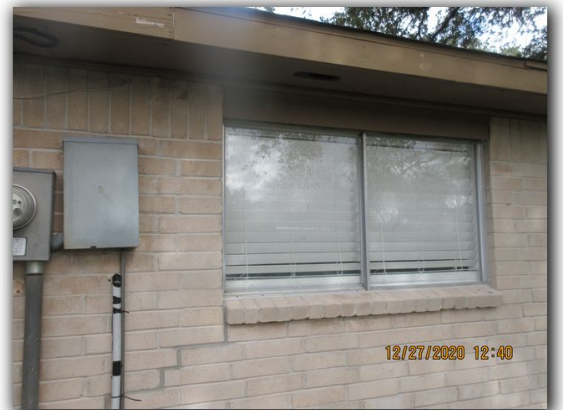
48. The home has some upgraded double pane windows and low e as per code.

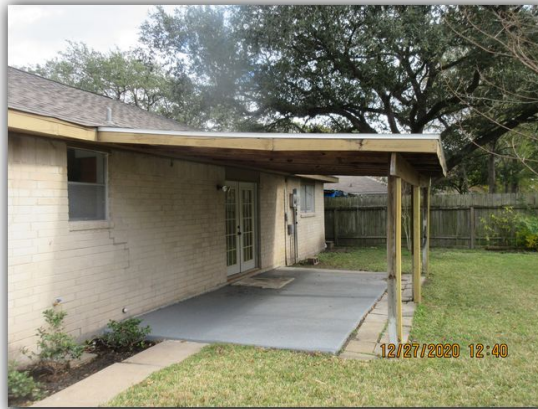
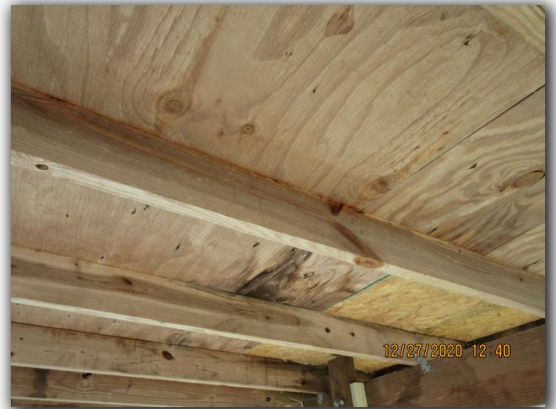
52. Home has a porch at the rear of the home.

53. The porch area is covered.

54. The porch has proper joist hangers.

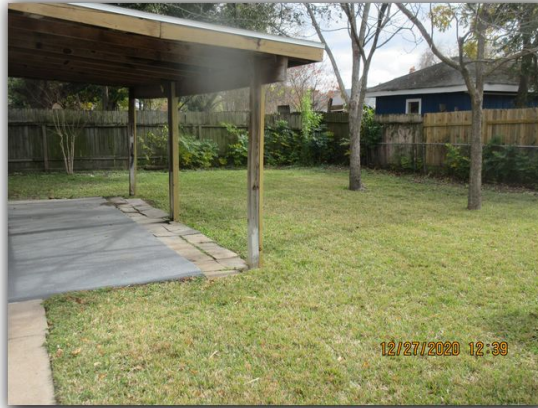
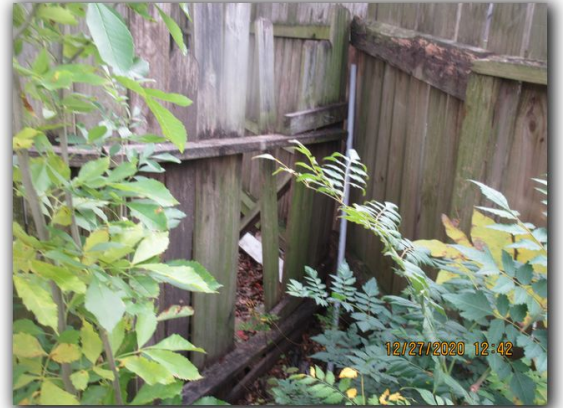
57. Some of the fence has minor wind damage.

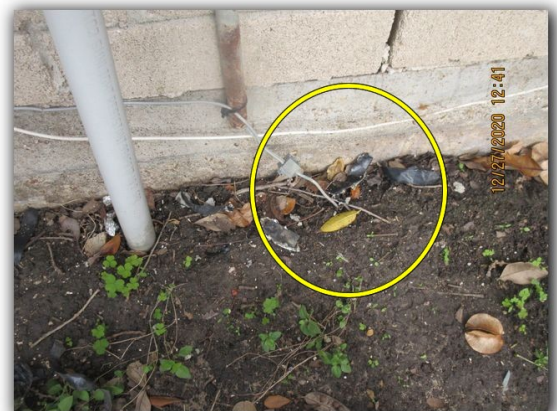
60. Ground wire is not properly secured to the ground rod clamp, it is not visible.

61. Ground rod must be above ground and visible, the ground rod clamp must be visible, the ground rod should extend at least six inches above the ground to be able to inspect and maintain the ground rod clamp, see photo below of another home with a properly installed ground rod.

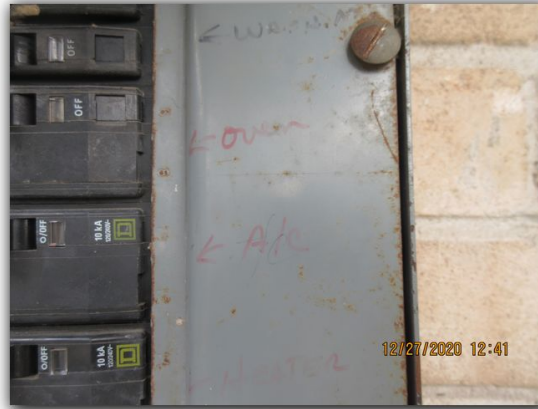
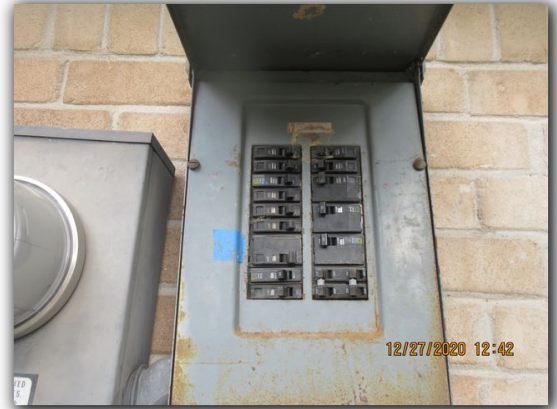
62. Main panel dead front cover is not fully labeled as per code.

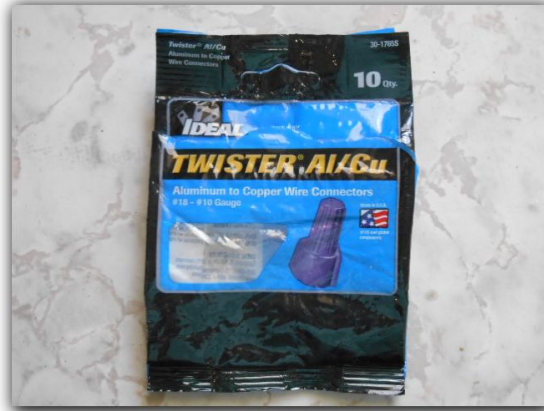
84. All of the connectors must be purple for use with aluminum wire, not red, black or yellow, see the photo below of the package as sold by hardware stores.

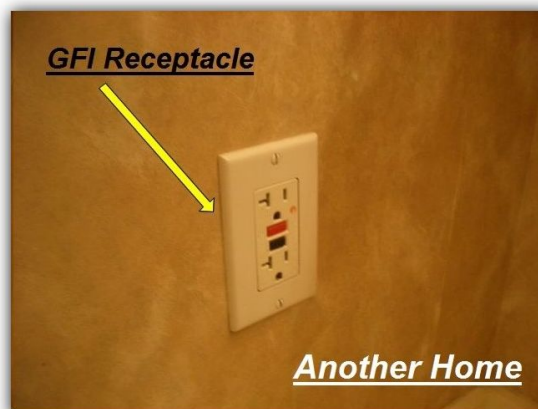
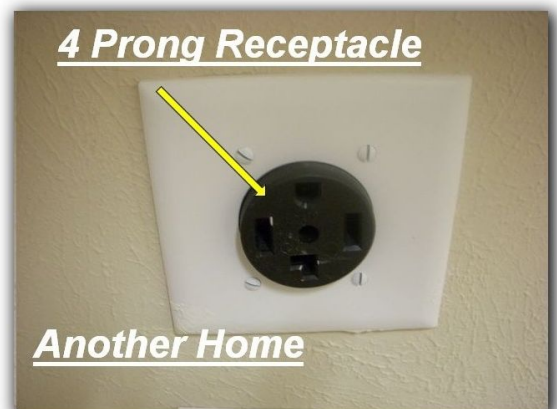
Other homes shown below:

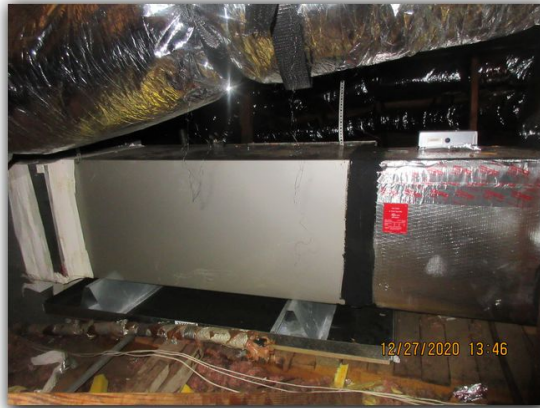
94. Home has an electric furnace located in the attic area.

95. The furnace was active at the time of the inspection.

96. ELECTRIC FURNACE: The furnace needs to be serviced prior to closing in order to validate most home owner's warranty requirement. The a/c technician must issue a certification that the system meet code and is heating properly and the heat strips are in good conditions.

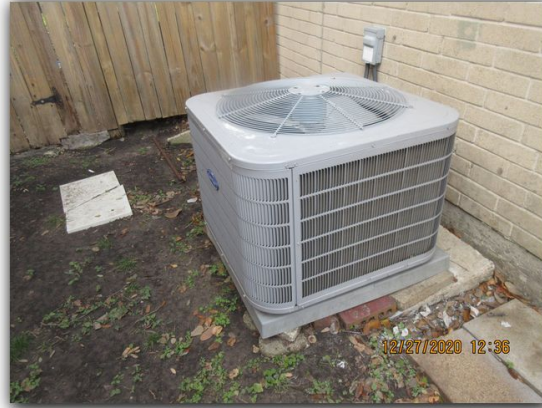
99. The system was not cooling properly at the time of the inspection.

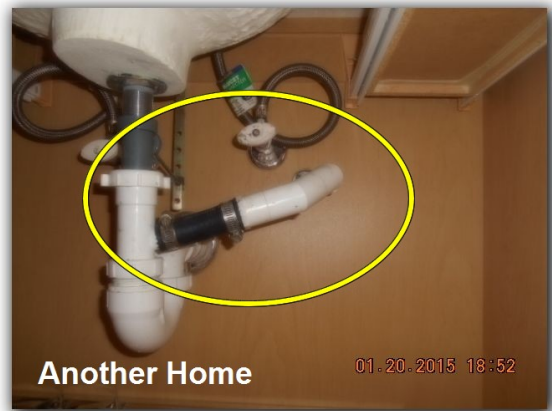
See other homes shown below:

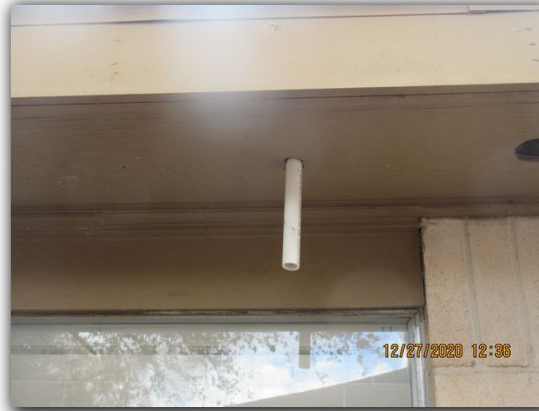
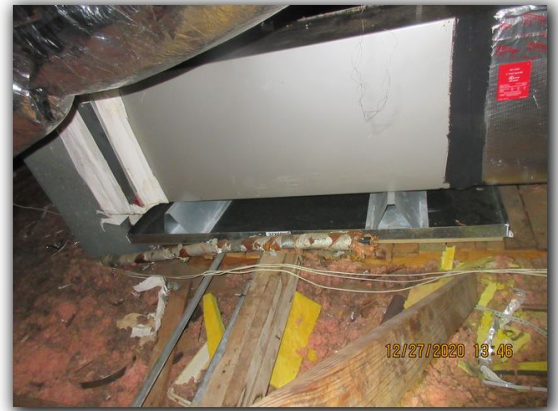
108The drain pan is missing an energy cut off switch as per code.

109The drain pan has a secondary drain line connected, termination not confirmed.

110The secondary drain line was viewed at the soffit as per code.

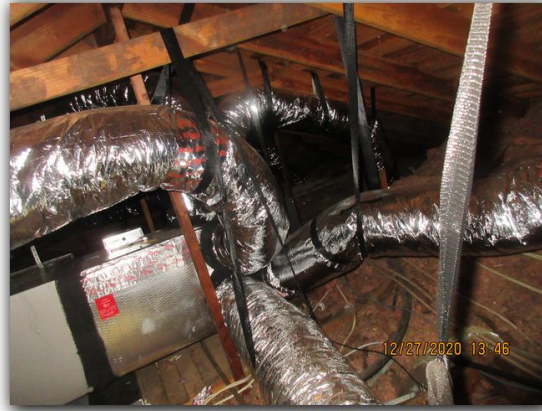
115 Ducts must not be in contact with each or lay on top of the joists other or they will create condensation that is prone to mold and mildew issues.

116 The ducts must be elevated and supported from the rafters.

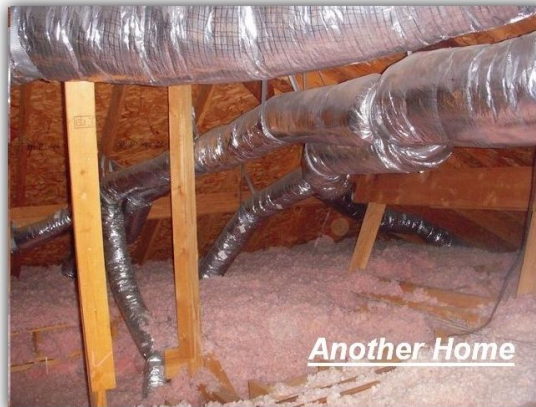
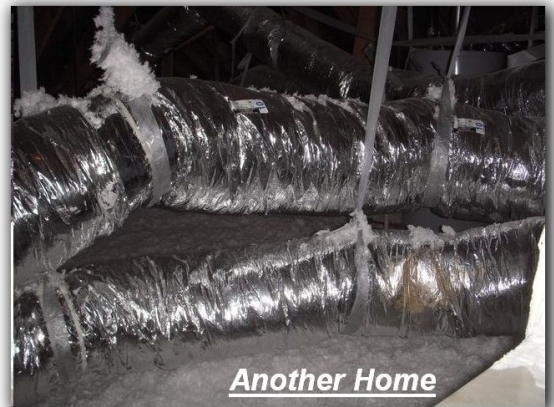
Other homes shown below;

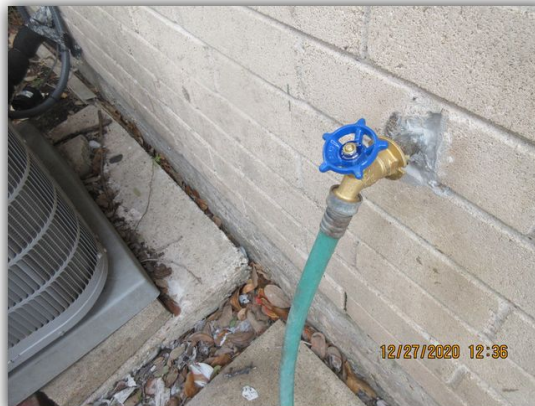
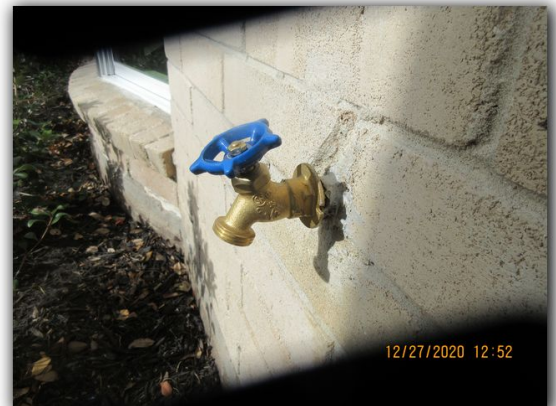
120Missing back flow prevention devices as required by code.

121Missing insulation on exposed hose bibs and/or other plumbing supply lines.

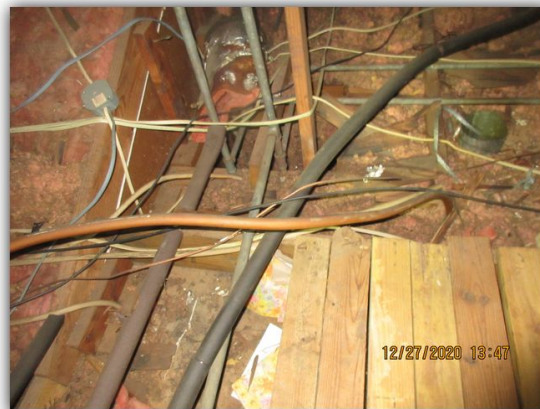
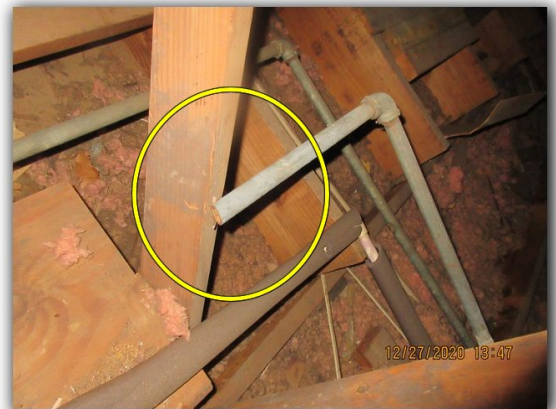
125 Some of the water lines have been replaced with copper and others abandoned in place as seen from the attic.

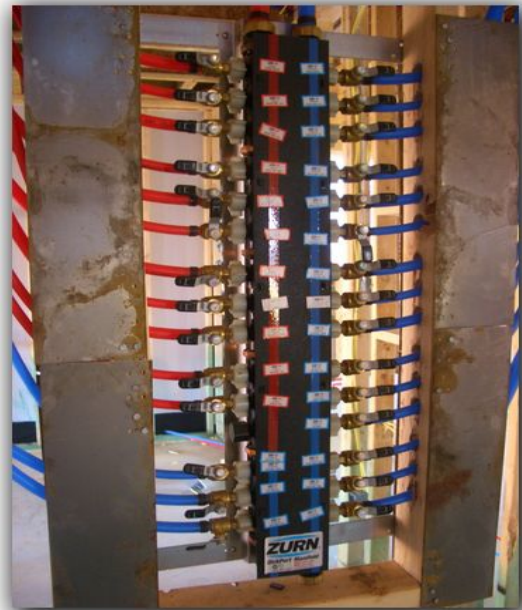
Another Homes shown below:

133It is recommended that a PEX water supply system be considered a qualified plumbing contractor should be consulted to determine the scope of work and cost of the replacement.

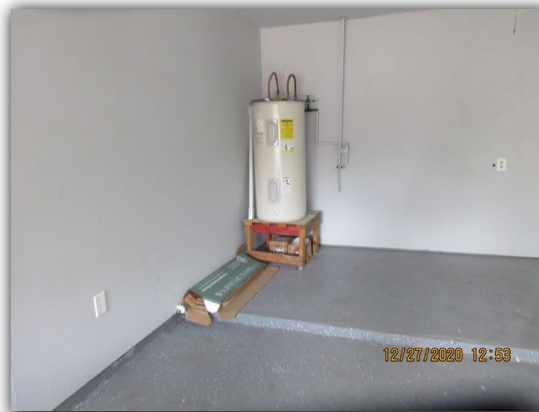
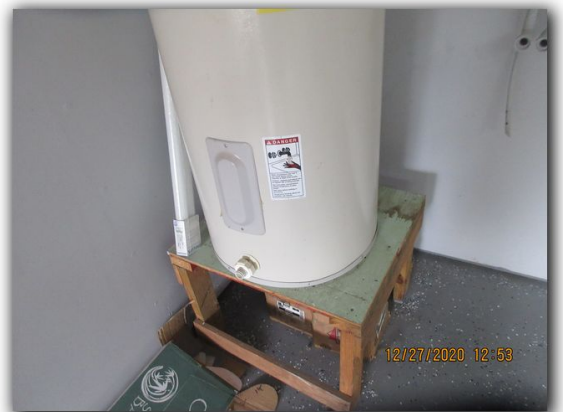
144The water heater is located in the garage.

145The water heater is electric and was active at the time of the inspection.

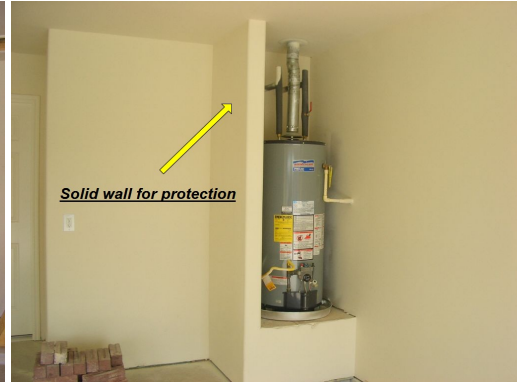
but it is missing protection from impact as required by IRC code, 2801.6, 1307.3.1, 2408.2 & 3 or raise the water tank SIX FEET above the ground.

Other homes shown below:

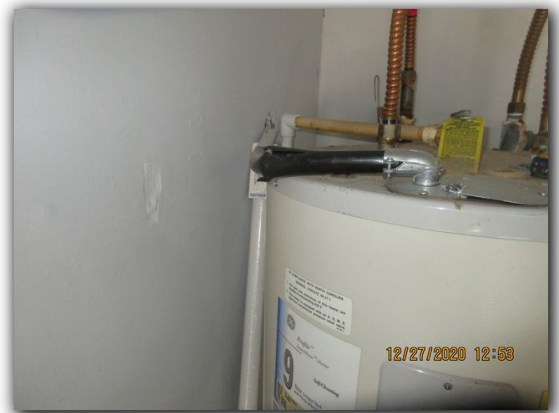
Electrical Disconnect:

149The water heater must have an electrical cut off as per code.

150Missing the electrical disconnect.

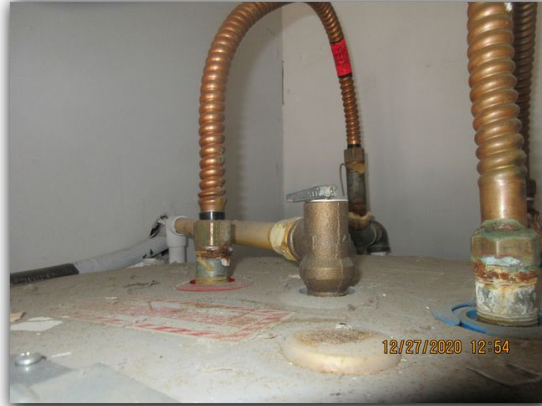
154 The drain line for the T&P valve meets current code, termination not confirmed.

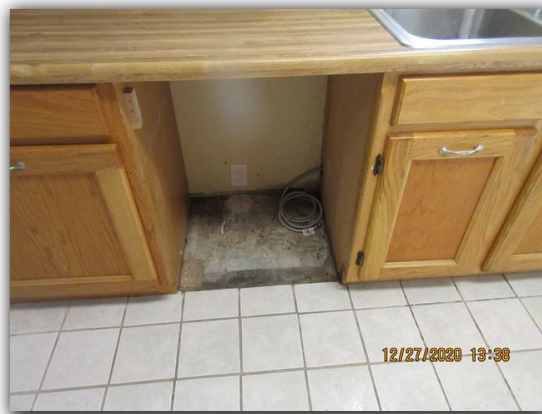
168The dishwasher was not present at the time of the inspection.

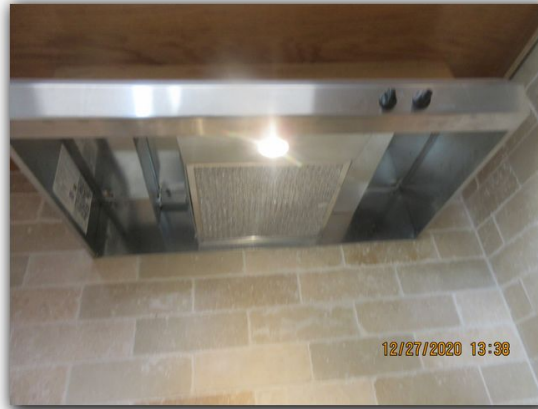
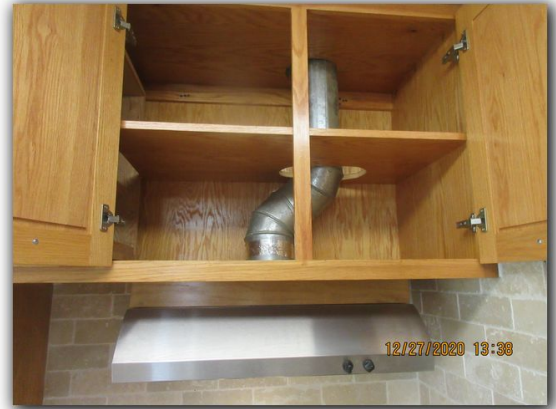
Vent Hood Termination:

182The vent hood terminates thru the cabinet.

183Improperly terminating vent to the attic, a fire hazard.

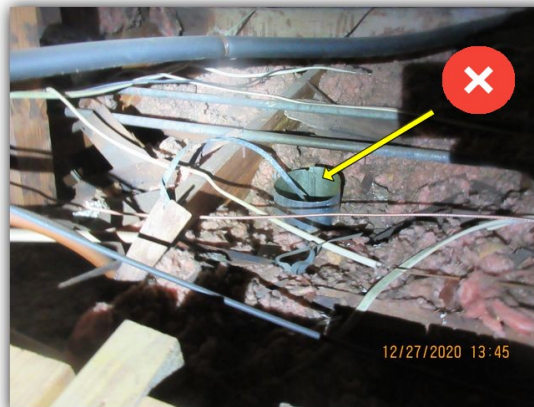
184Improper termination into the attic, it must terminate thru the roof.

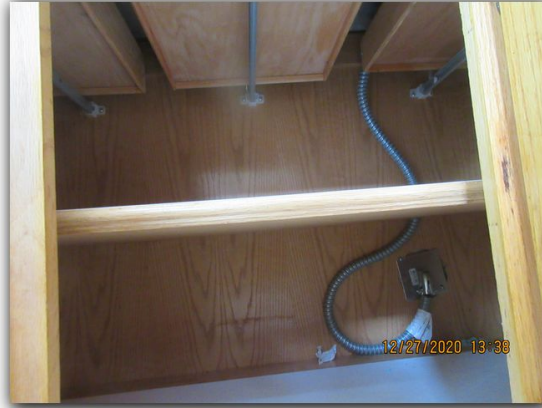
186The stove top has proper conduit under the cabinet as per code.

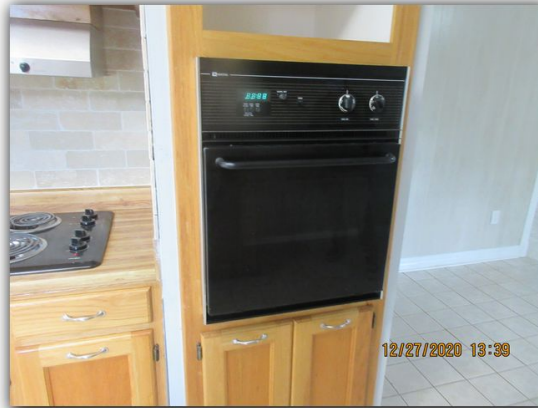
187The home has a wall mounted oven that needs service.

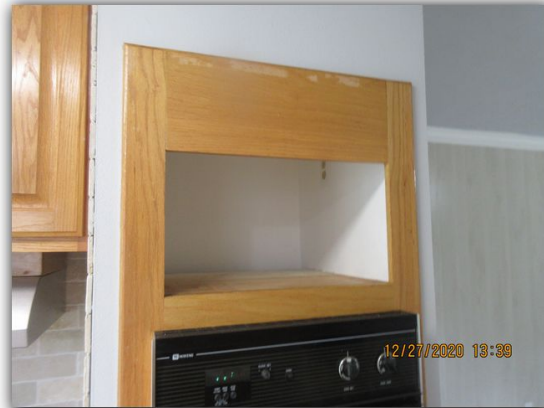
195 Improperly terminating flex vents into the attic, they must terminate to the exterior as per code.

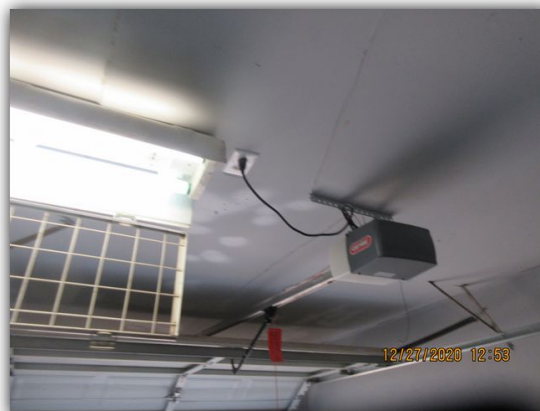
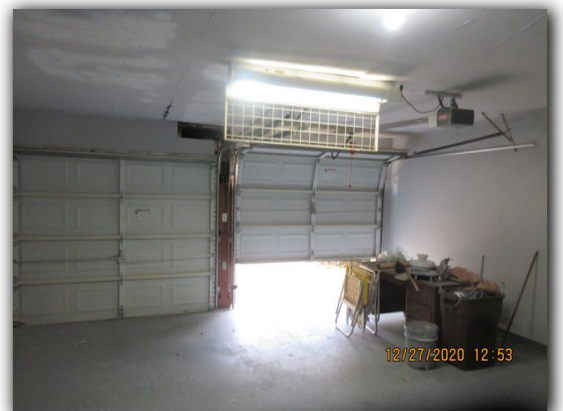
Garage Door Opener:

199The garage door opener was present and working properly at the time of the inspection.

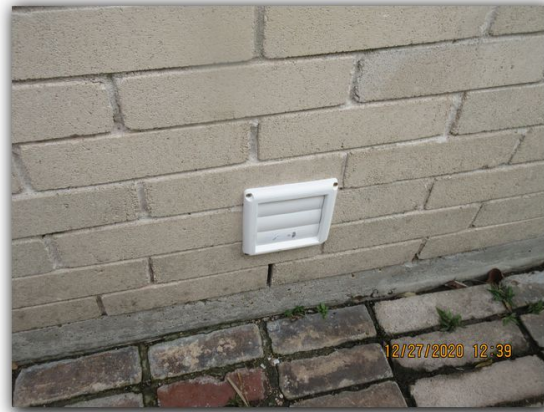
202The vent has a proper back draft damper as per code.

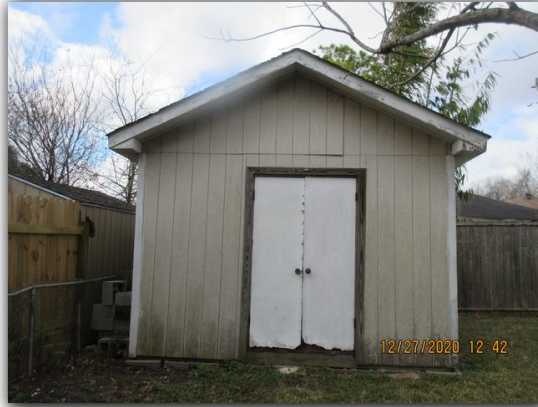
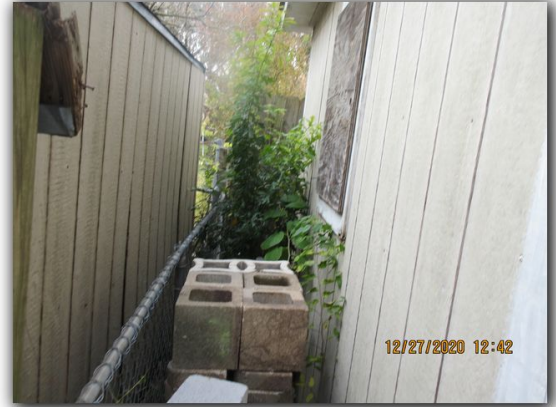
205The building was not inspected, beyond the scope of this inspection.

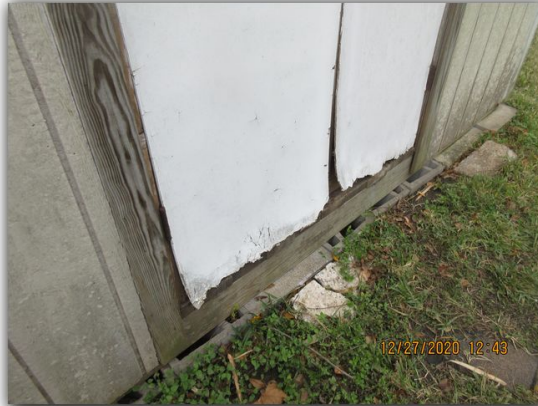
206The doors need to be replaced.

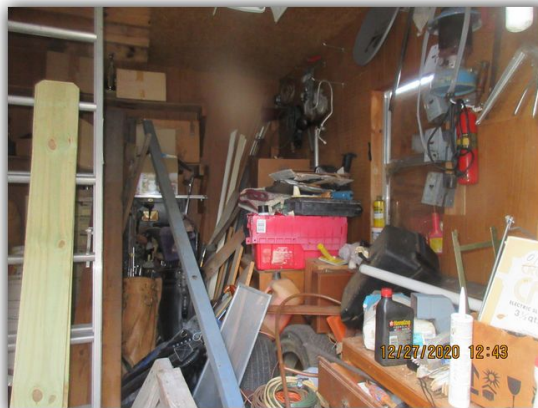
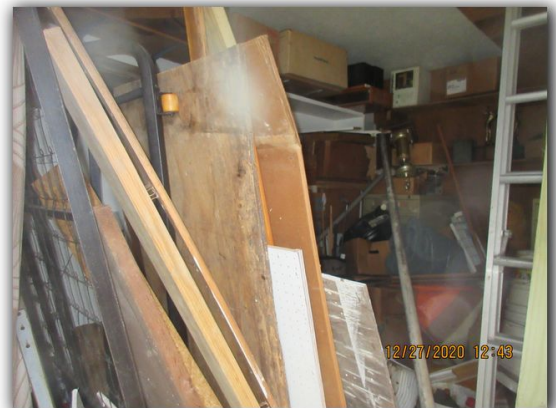
207The building was occupied.
