**North Star Inspections, Inc.**

**443 Oak Chase Dr. Conroe Tx 77304**

**PROPERTY INSPECTION REPORT**

**Concerning:** 443 Oak Chase Dr., Conroe, TX, 77304  
(Address or Other Identification of Inspected Property)

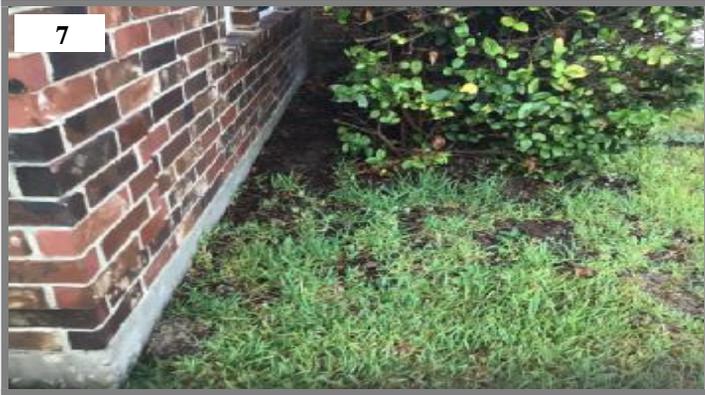
Low spot

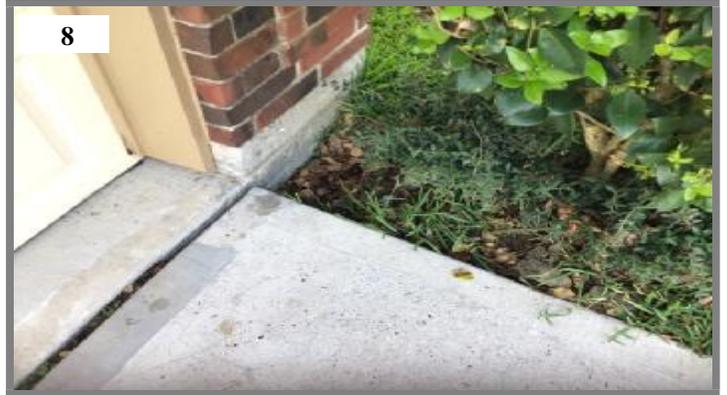
Low spot

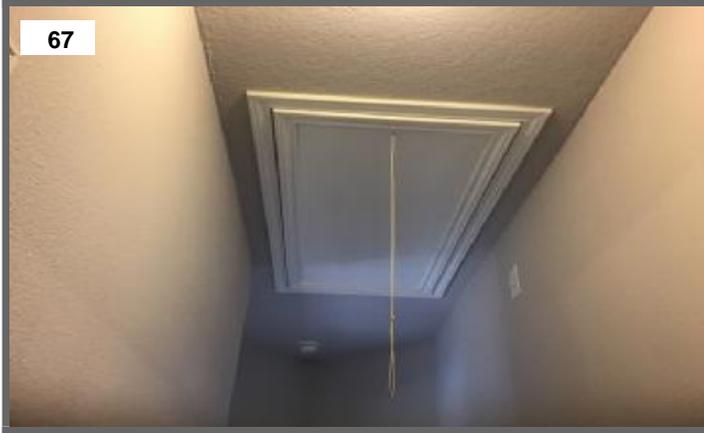
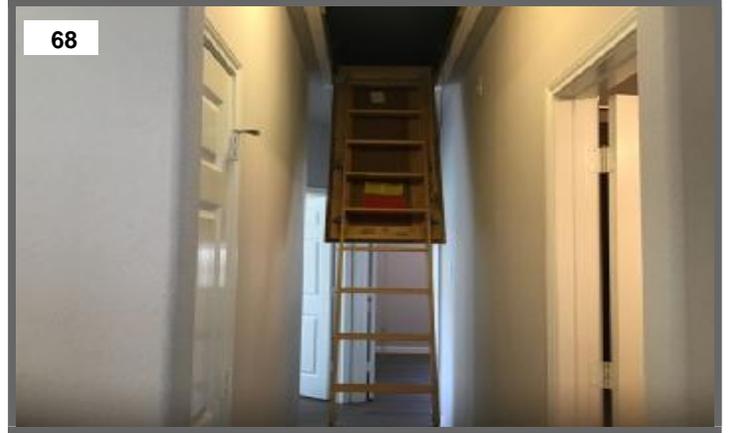
The attic stairs are missing nails in key locations in the steel plate at the top and sides of the stairs. These nails are needed for the manufacturers load capacity to be met .

Missing fasteners

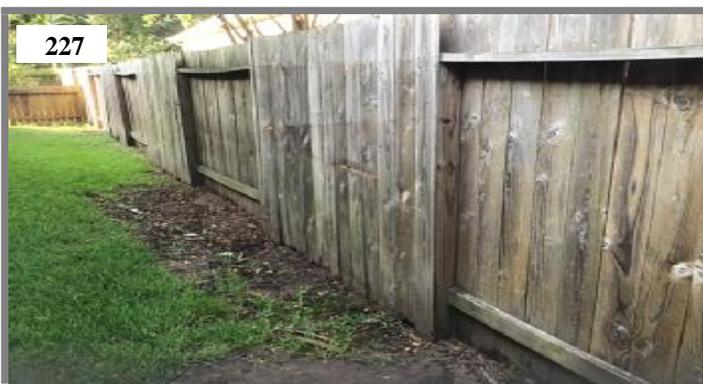
Fence right

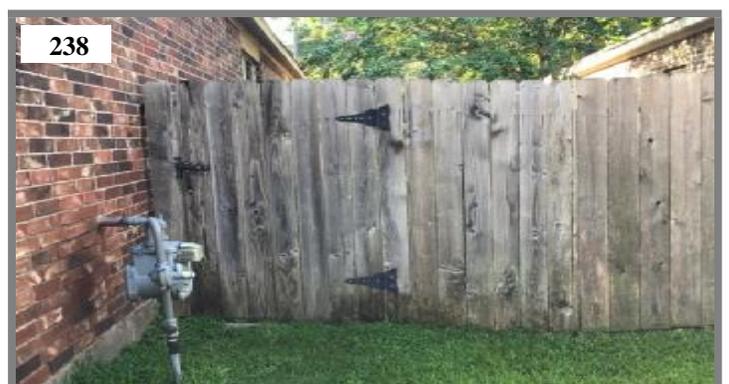
Fence front right

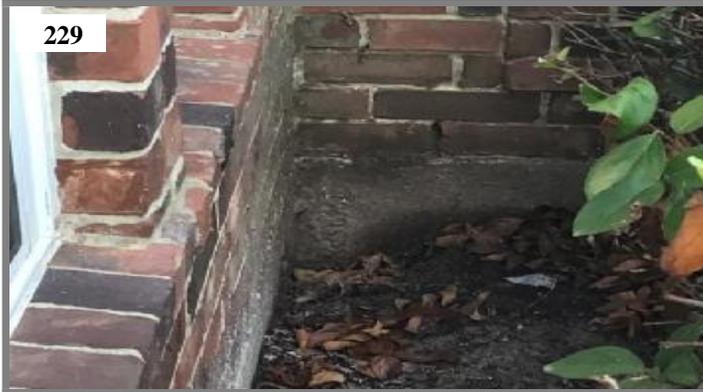
Low spot

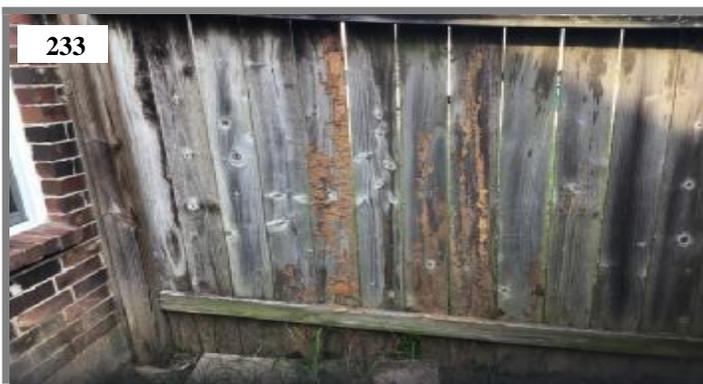
Termites on fence

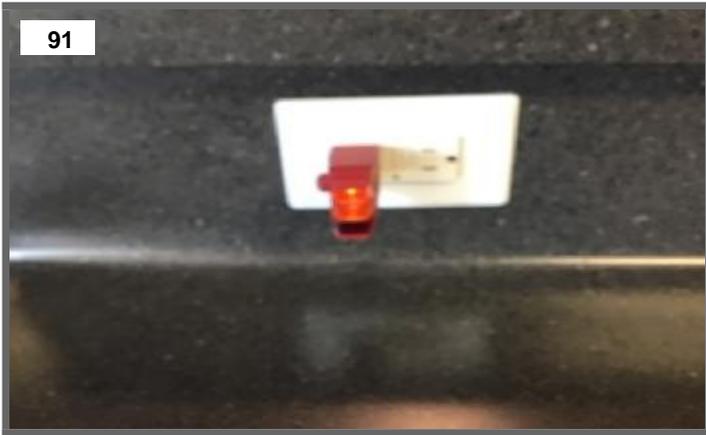
Yes GFCI

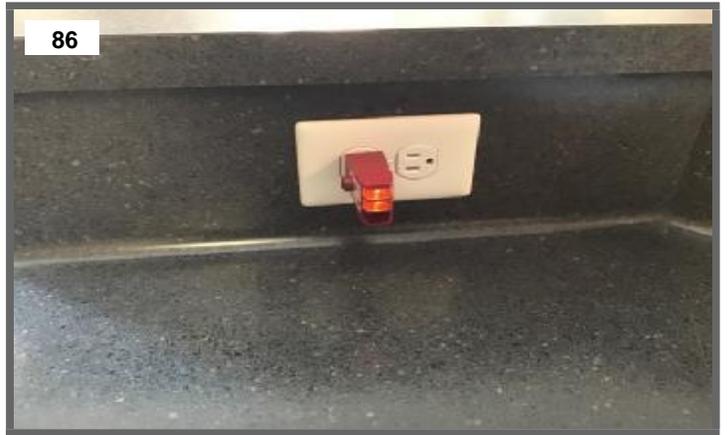
Yes GFCI

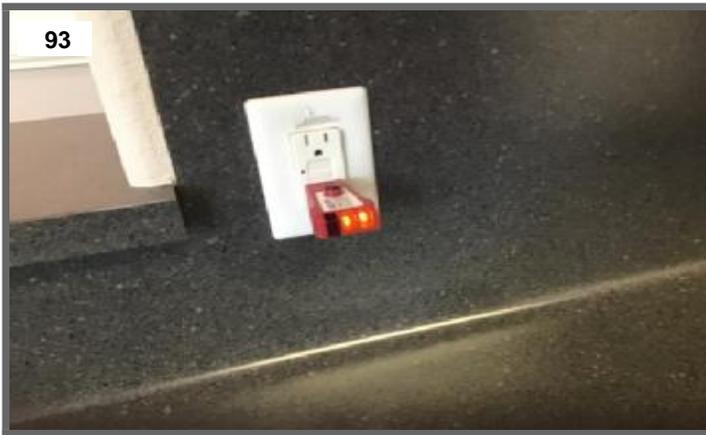
Yes GFCI

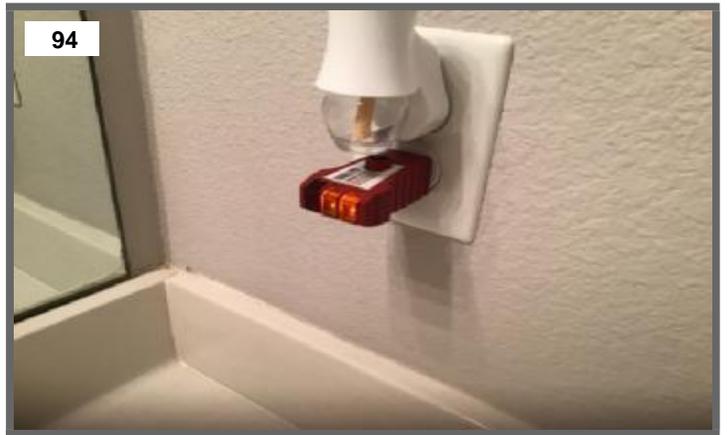
Yes GFCI

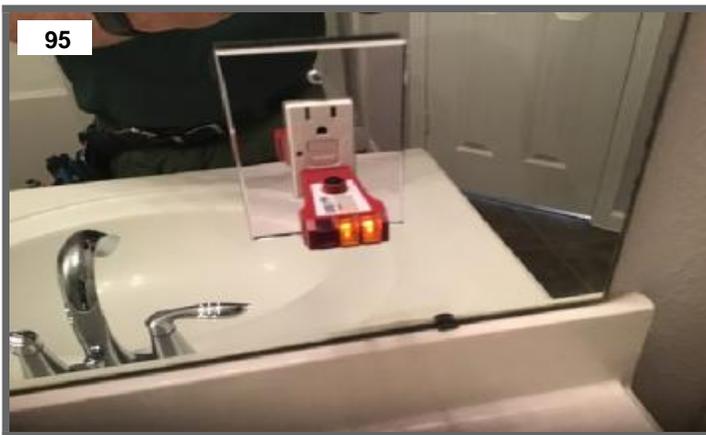
Yes GFCI

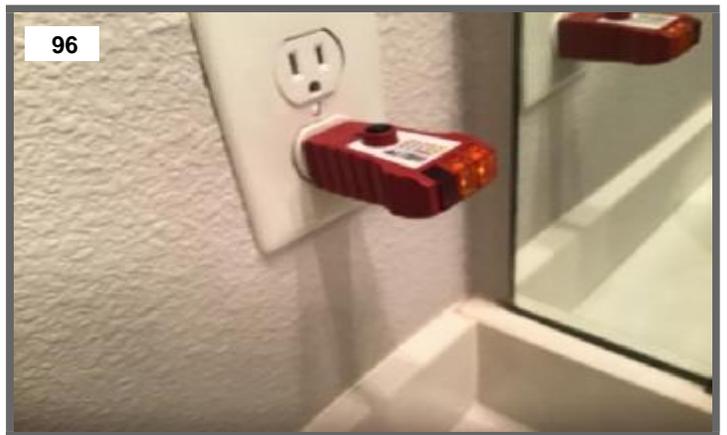
Yes GFCI

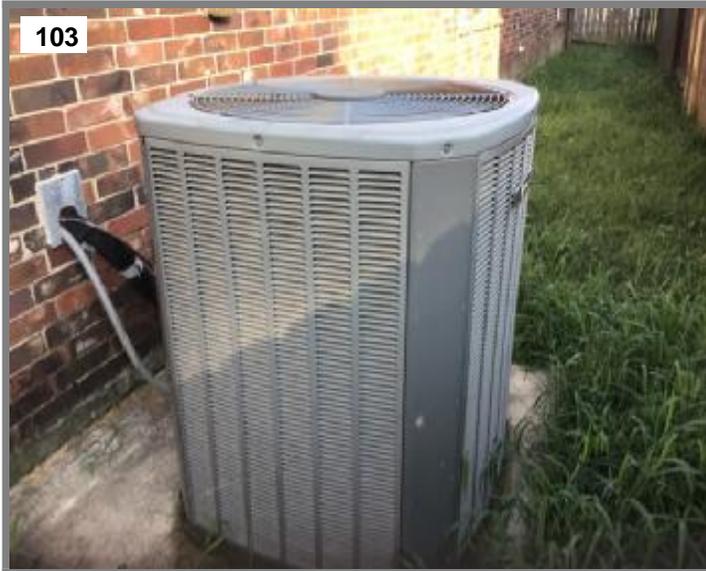
103  
3.5 ton  
R410A coolant

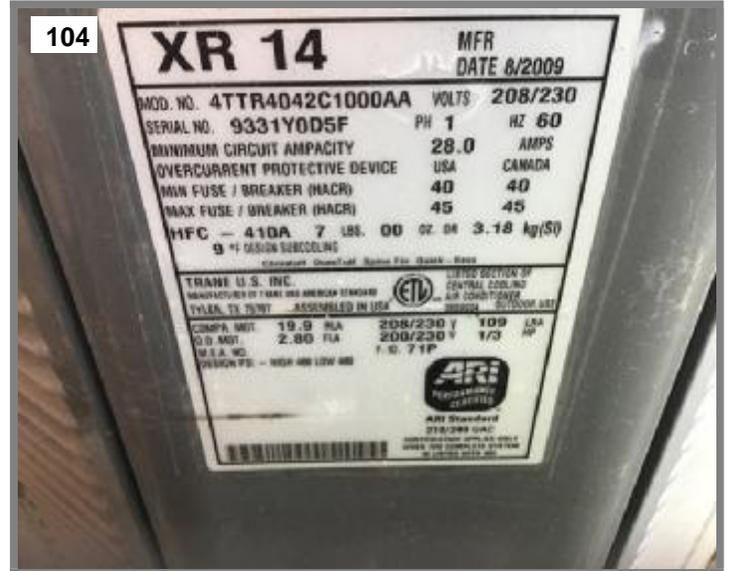
104  
4TTR4042C1000AA  
8-2009
