Inspection for Property located at 1406 Eberhard St
06/04/2019
Prepared for : Carol Y. Chung

PROPERTY INSPECTION REPORT

Concerning: 1406 Eberhard St, Houston, TX 77019
(Address or Other Identification of Inspected Property)

This inspection is a "Re-inspection" update as of 6/4/2019. This purpose of this inspection is to check the previously noted defects and their current condition as of the re-inspection date.

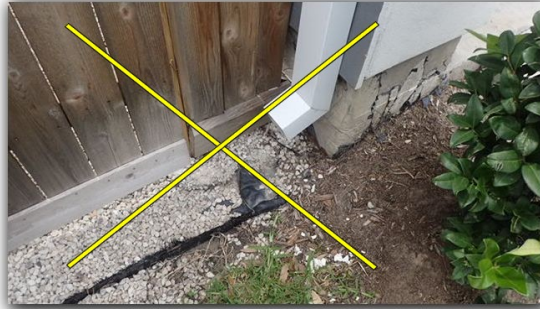
Downspouts need splash blocks at bottoms to prevent soil erosion.

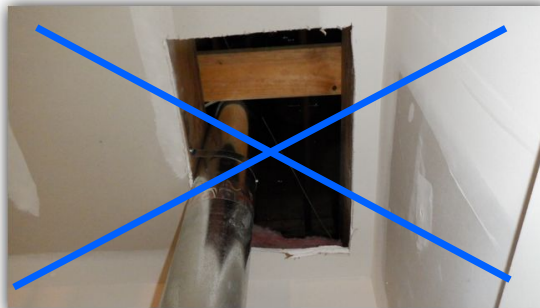
Questionable combustion air adequacy for HVAC and Water heating units.

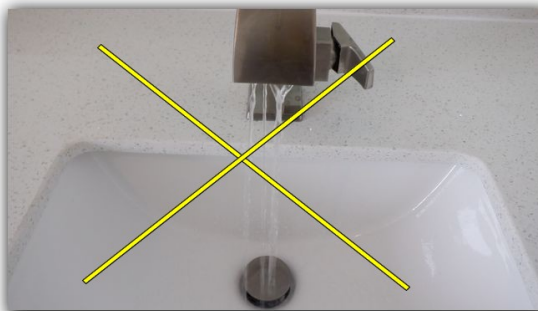
Very low water pressure at Master bath sink faucets.
