# Inspection Report

**Property Address:**  
9336 Old River Ct.  
Montgomery TX 77356

**JASE Home Inspections**

<b>Date:</b> 10/11/2020	<b>Time:</b> 09:55 AM	<b>Report ID:</b>
<b>Property:</b> 9336 Old River Ct. Montgomery TX 77356	<b>Customer:</b> Monte Gibbs	<b>Real Estate Professional:</b> Jeff Deutschmann

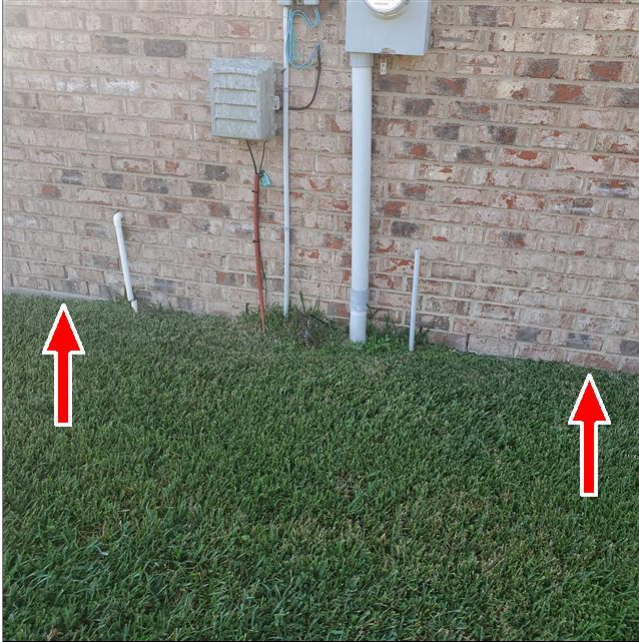
(1) High soil was observed at the left side of the home. It is recommended that at least 4-6 inches of slab be visible around the entire home to keep extra moisture out of the brick and to deter unwanted insects out of the weep holes. I recommend re-grading the areas where at least 4-6 inches of slab is not visible.

B. Item 1(Picture) High soil at the left side.

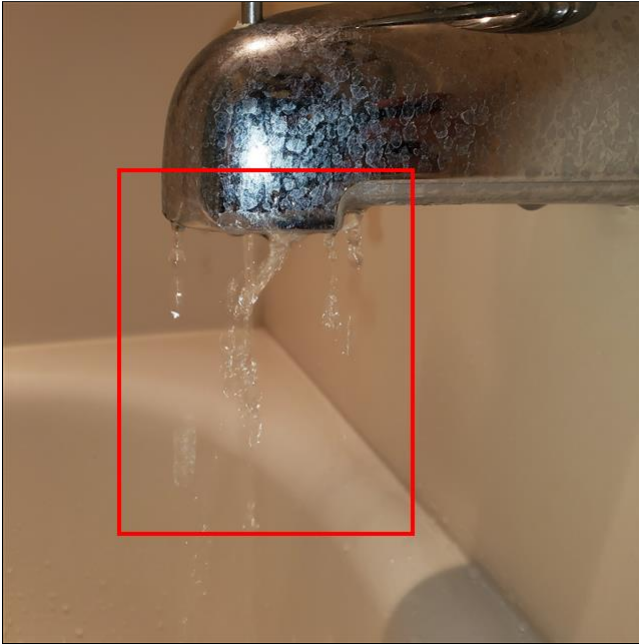
A. Item 2(Picture) Photo taken while shower was running.

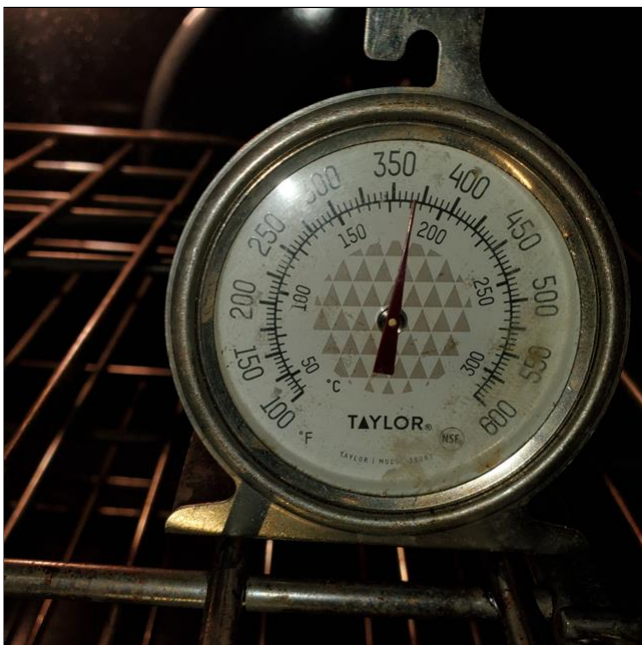
(2) The oven was tested at 350 degrees and bake. When the oven was finished preheating the thermometer placed in the oven read 365 degrees. This is not a defect. This is just information for the buyer.

D. Item 2(Picture) Temperature test

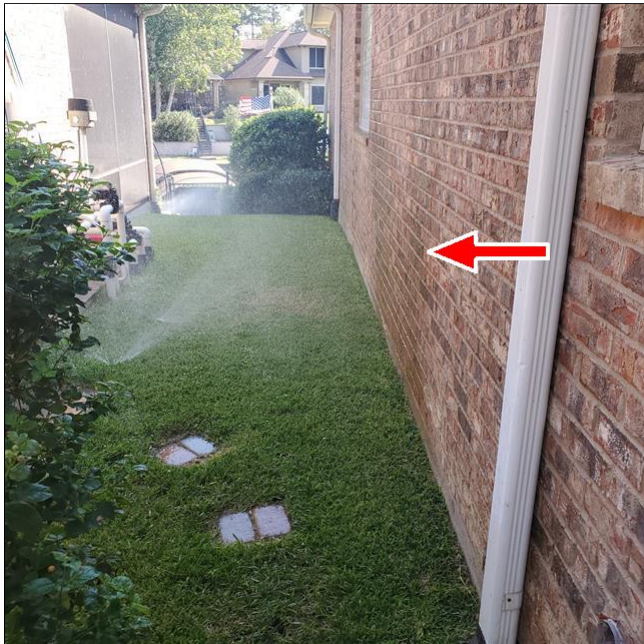
A. Item 4(Picture) Photo of neighbor's home getting sprayed.
