Home Inspection Report

24922 Cactus Sage Trail, Katy, TX 77494

Saturday, October 24, 2020

Performance Inspections
507 Saguaro Way
Richmond, TX 77469

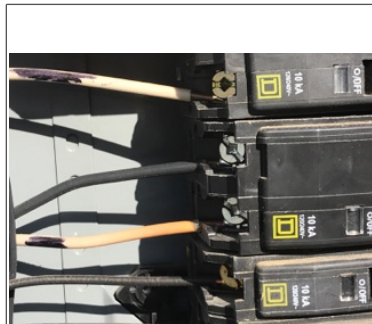
Wire shows signs of overheating

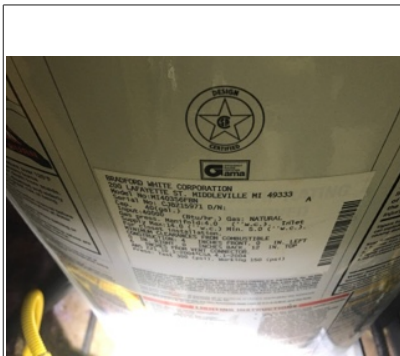
Ref photo

The Temperature and Pressure Relief (TPR) Valve serving the water heater is inoperative. This condition should be repaired.
