REXER Home Inspection Services

Property Inspection Report

5211 Eigel St. Unit C, Houston , TX 77007
Inspection prepared for: Omar Garza & Adolfo Garza
Date of Inspection: 2/20/2017 Time: 11:00AM
Age of Home: 2009 Size: 2219

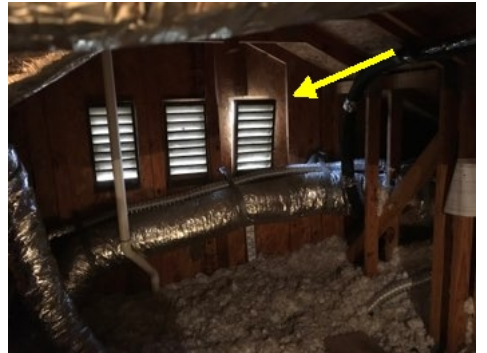
Not secured

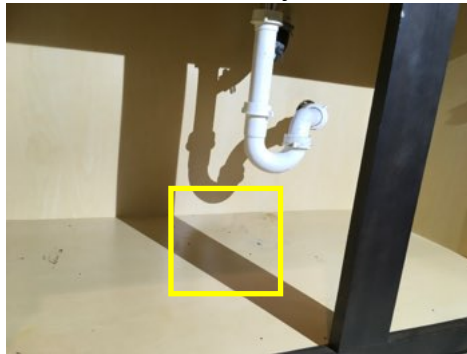
Previous damage

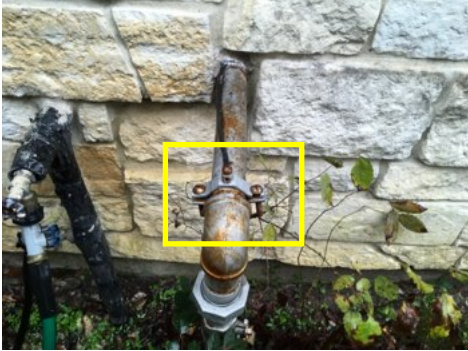
Clean connection

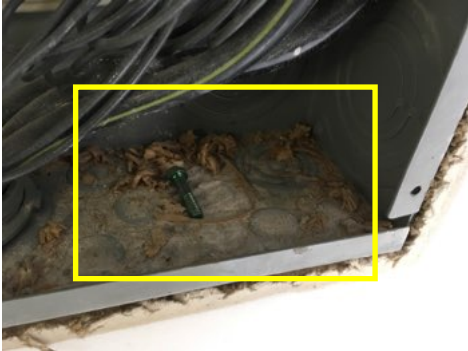
Debris
