STRUCTURAL INSPECTION

16230 Jersey Dr
Jersey Village TX 77040

FEBRUARY 8, 2021

REF: CONDITION OF PROPERTY SURVEY

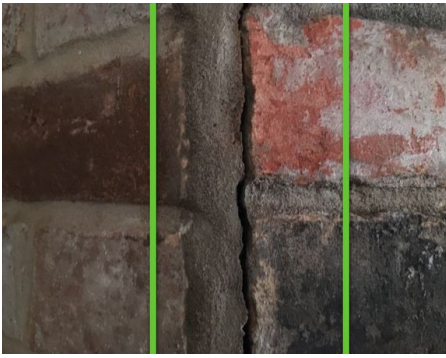
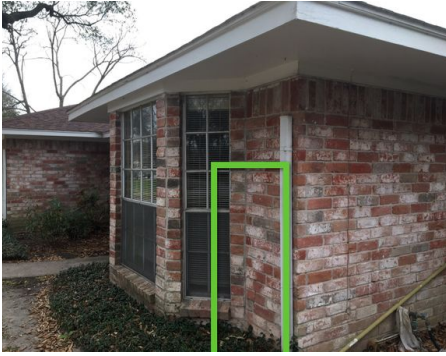
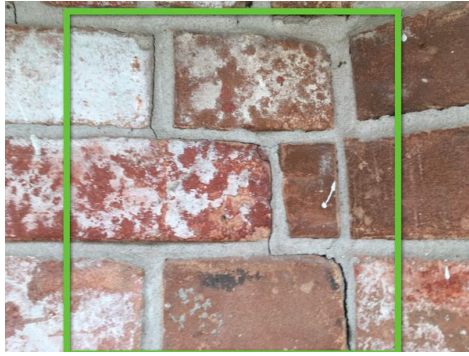
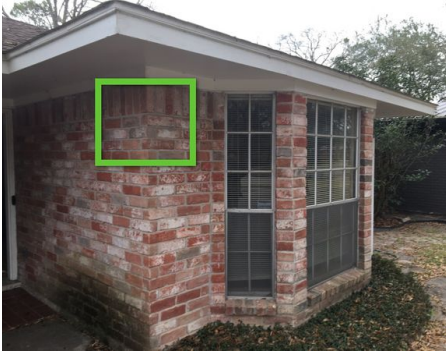
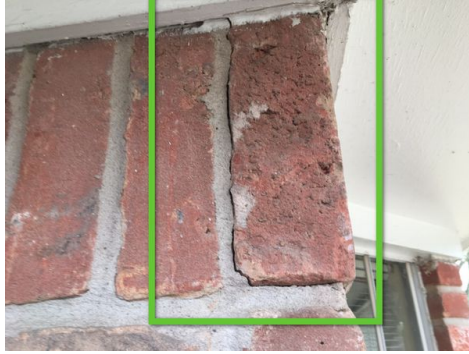
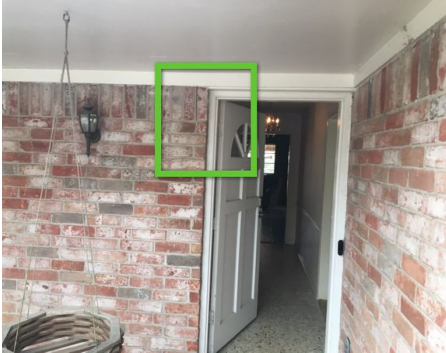
Differential Movement: Veneer - Cracks/Patches

Cracks and/or patches were observed in the exterior veneer at the time of the inspection.

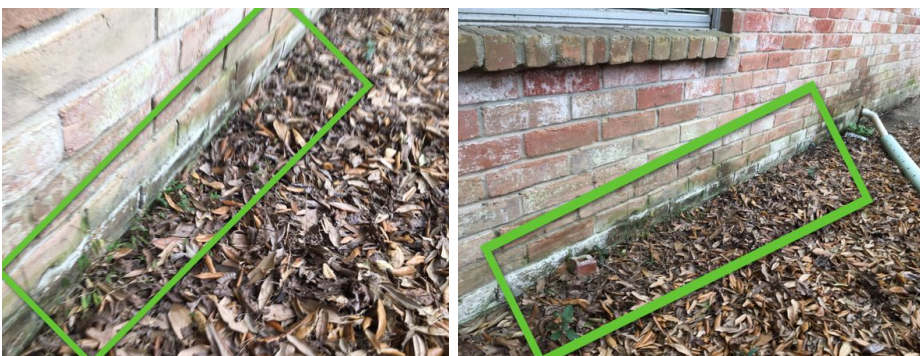
Differential Movement: Slab Not visible - High Soil

It is pointed out that a portion of the foundation concrete could not be viewed due to soil that was graded near or above the top of the foundation and/or heavy foliage growing against the house. The soil and/or foliage should be removed, and 3-4 inches of foundation concrete exposed.

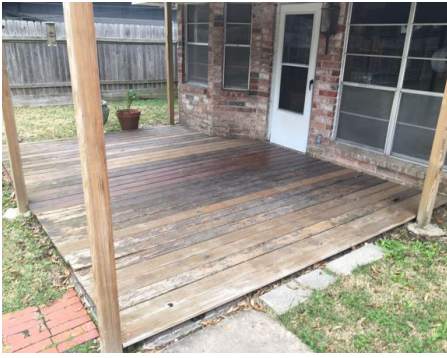
Differential Movement: Slab not visible - Wood Deck

It is pointed out that a portion of the foundation concrete could not be viewed at the rear of the house due to the wood deck that adjoined the foundation.

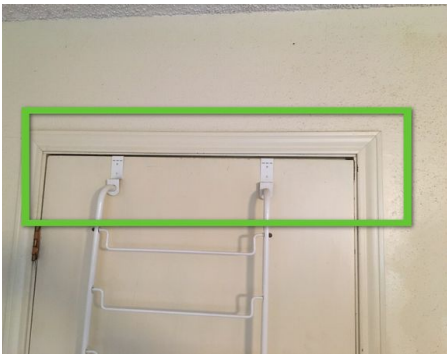
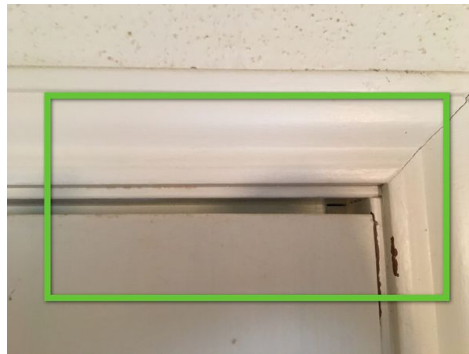
Master bedroom

Door frames that were out of square, leaving a triangular separation between the door and the door frame at the top of the door were observed where a separation was visible at the top of the door.

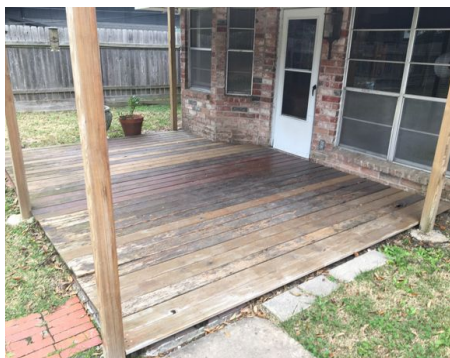
Perimeter Grading/Drainage: Wood Deck

We could not determine if any provision has been made at the rear of the house for drainage under the wood deck. It is recommended that you check with the owner to determine if there are any drainage problems at the deck area, and if any provision for drainage has been made.

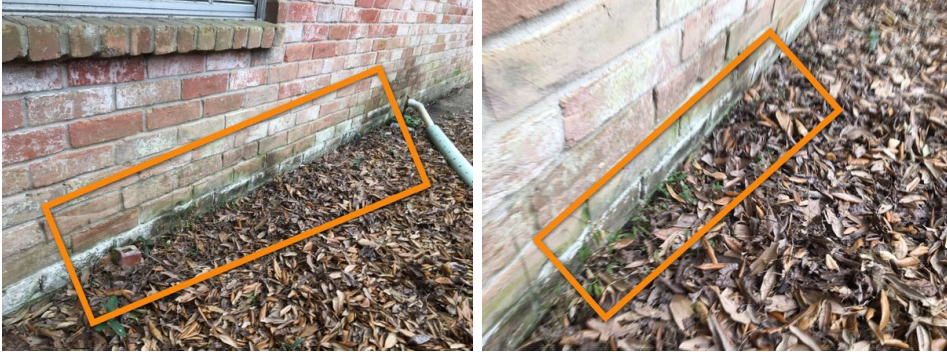
The perimeter grading and/or flower beds was too high at some areas, and was graded near or above the top of the foundation. It is recommended that the beds/soil be regraded as needed to prevent water penetration into the house, and to allow for proper drainage.

Contact a qualified landscaping contractor

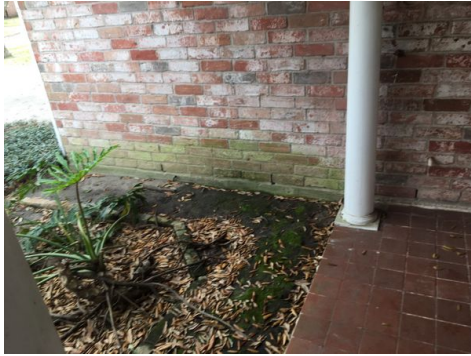
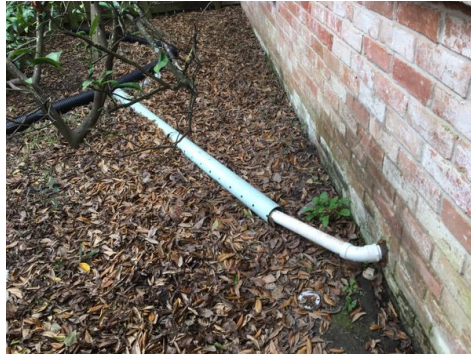
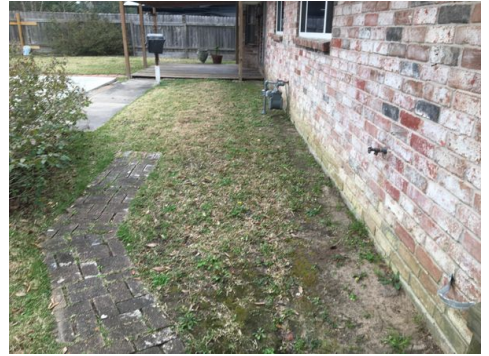
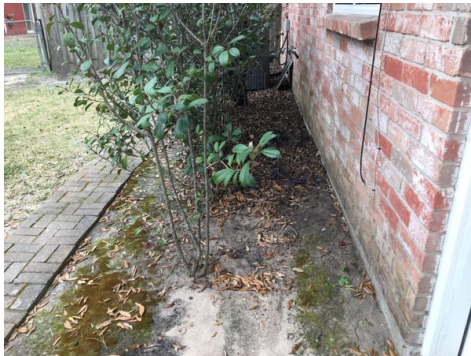
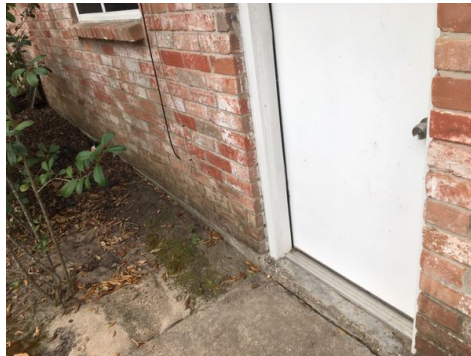
4.7.2 Perimeter Grading/Drainage

GRADING POOR

Contact a qualified landscaping contractor

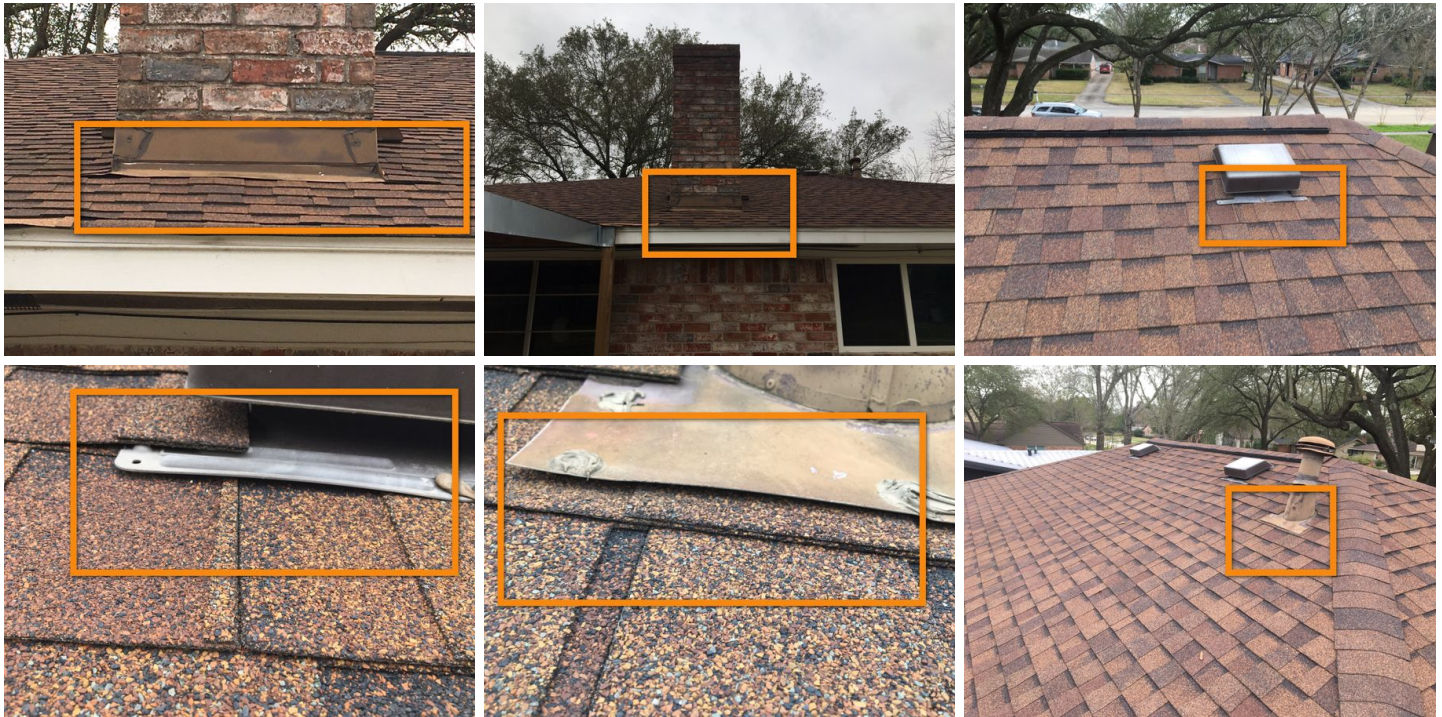
5.5.2 Roof Details

FLASHING/COUNTER FLASHING

Contact a qualified professional.

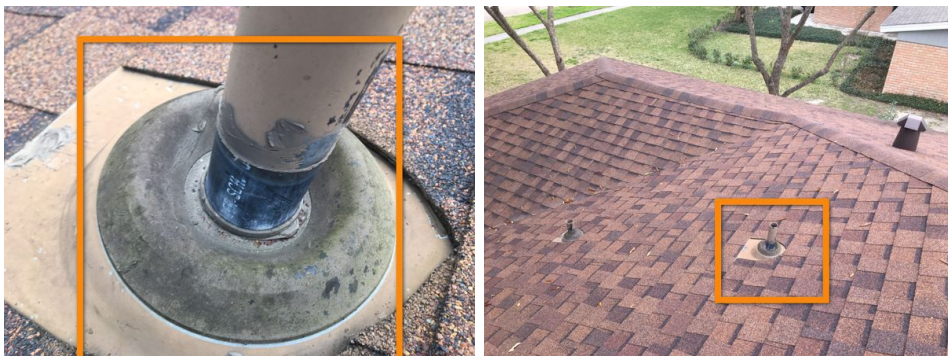
5.5.3 Roof Details

ROOF JACKS

Contact a qualified professional.

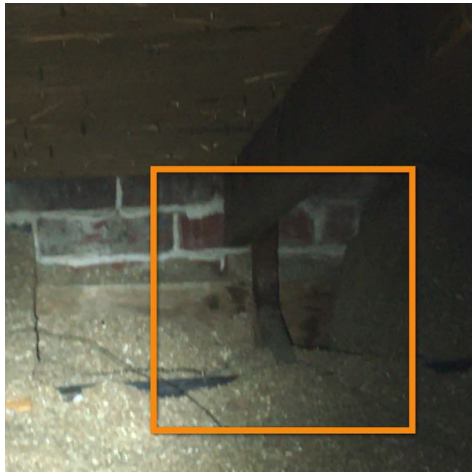
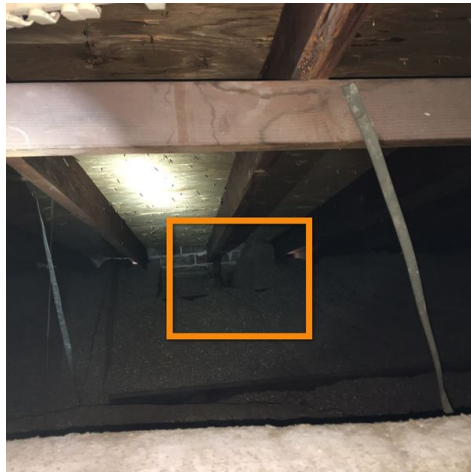
Chimney

ATTIC ROOF DECKING AND/OR FRAMING MEMBERS

Contact a qualified professional.

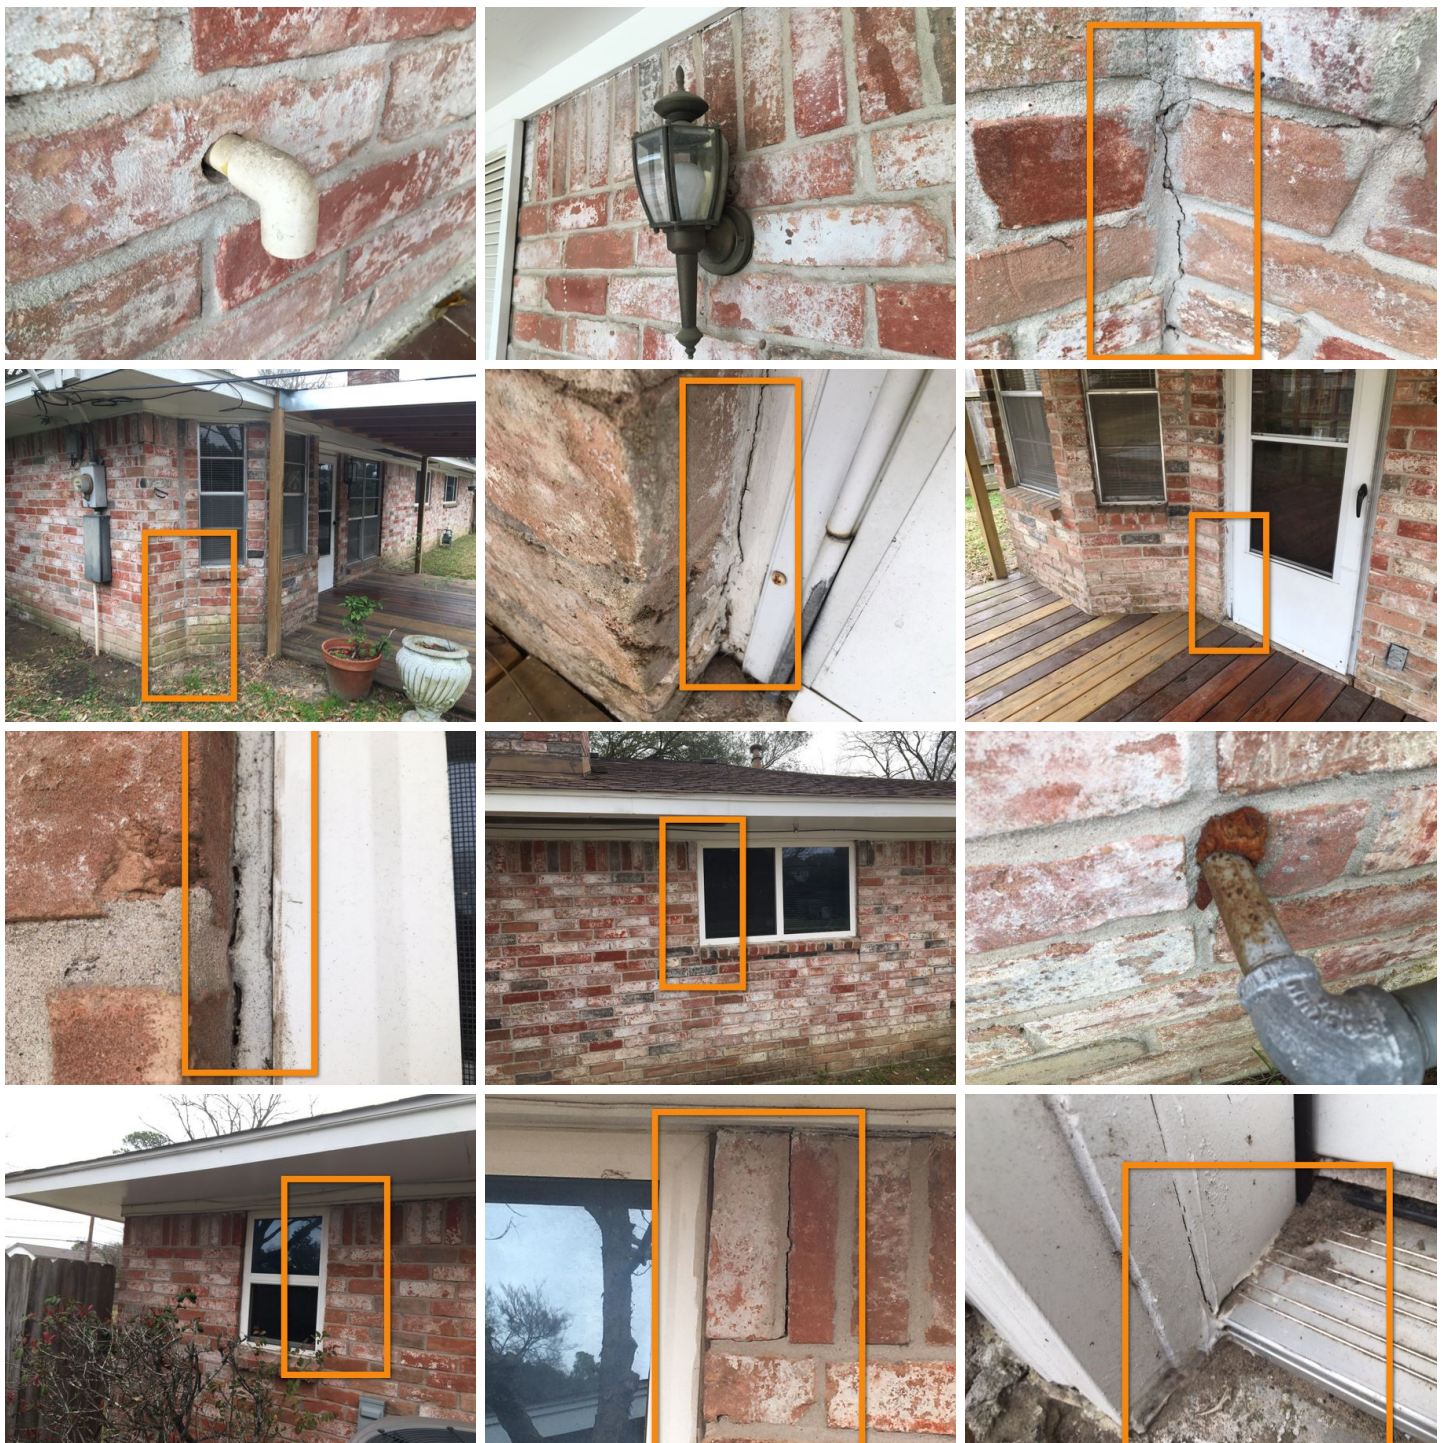
Deteriorated Sealants, Light Fixtures, Hose Bibb, Vent Caps, Brick Veneer, Piping, Grading, Lack of Gutters, Window sealants, Caulking Cracked/Missing, Sealants deteriorated/missing, Joints around the doors

A substantial vulnerability to water penetration was observed at penetrations/openings through the exterior building envelope, and it is recommended that all penetrations/openings be sealed against water penetration. Typical examples on a structure may include light fixtures, air conditioning refrigerant lines, water piping, gas piping, vent caps, windows, doors, expansion joints, etc. Below is a representative sample of locations and/or photographs showing some, but not necessarily all, locations where there is a vulnerability to water penetration. Have a contractor provide a cost estimate to seal all vulnerable areas on the exterior building envelope against water penetration.

Contact a qualified professional.

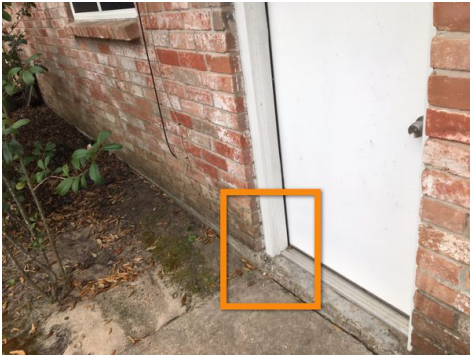
7.1.2 Water Penetration

WATER STAINS/WATER DAMAGE

Evidences of water penetration to the interior of the structure were observed, including water stains/water damaged materials. Further investigation is recommended with service companies to determine the source(s) of the water penetration along with any secondary damages, and also to provide a cost estimate for any needed repairs.

Water damage was observed on the wall near the front entry door. The source of the water penetration appeared to be related to a lack of proper sealant around the exterior joints of the door. Further investigation and repairs are recommended.

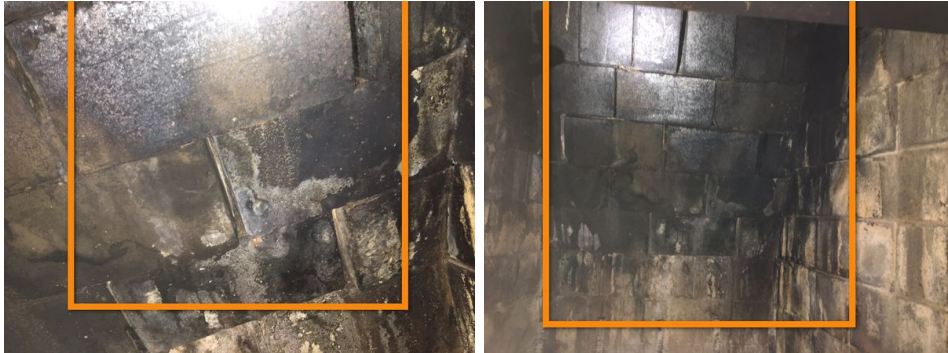
FIREBRICKS LOOSE

Some of the firebricks were loose and starting to fall out, and need to be repaired. Have a fireplace service company provide a cost estimate to make the needed repairs.

Contact a qualified professional.

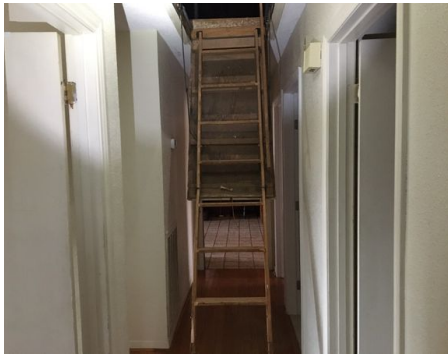
Ladder: Original ladder - Not rated

The access ladder into the attic appeared to be the original installation ladder, and the ladder was not labeled to indicate the rated capacity of the ladder. The ladder does not meet current code requirements for ladders into attics. Consideration should be given to replacing the ladder with a ladder that meets current code requirements.

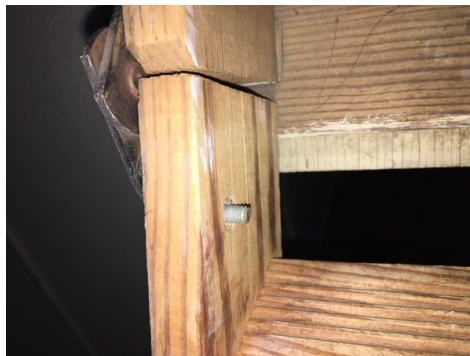
9.1.2 Ladder

LADDER NOT CLOSING PROPERLY

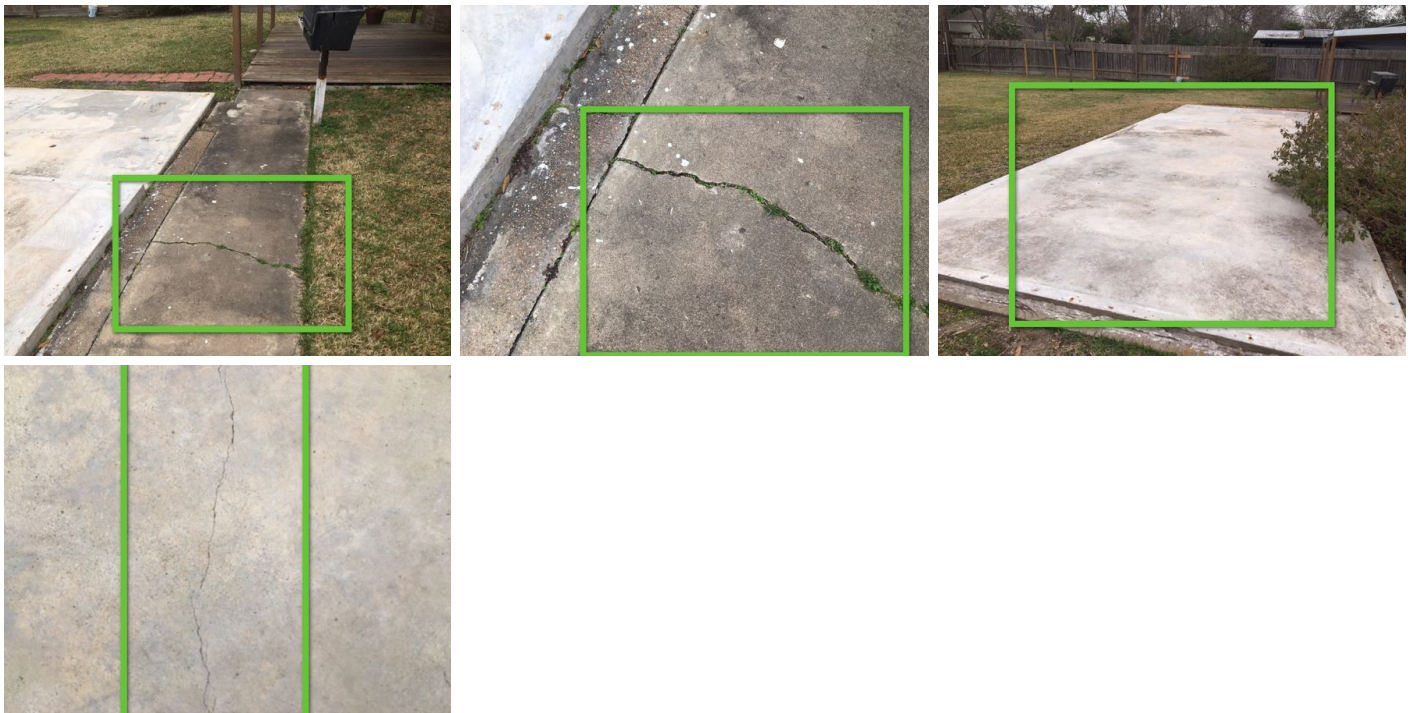
Flatwork Concrete/Patios/Walkways: Cracks Driveway

Cracks and some separations were observed in the driveway concrete. In our opinion, the driveway is still in serviceable condition at this time.

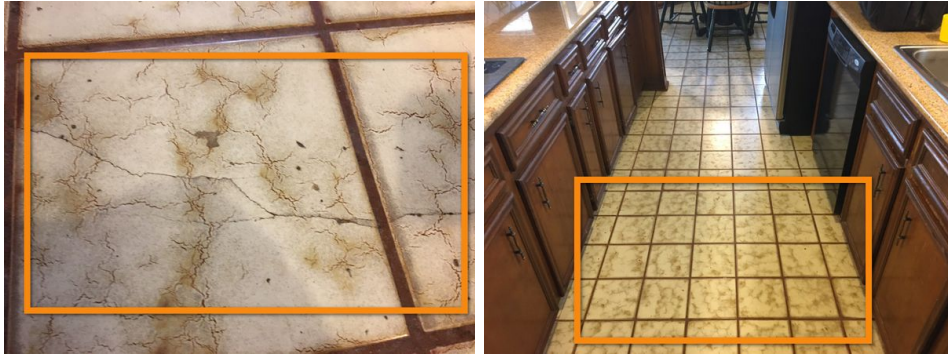
11.3.2 Floor coverings

TILES GROUT CRACKED/MISSING

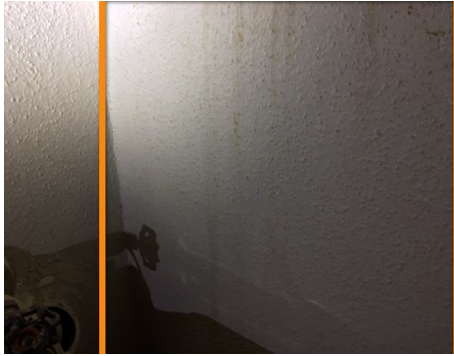
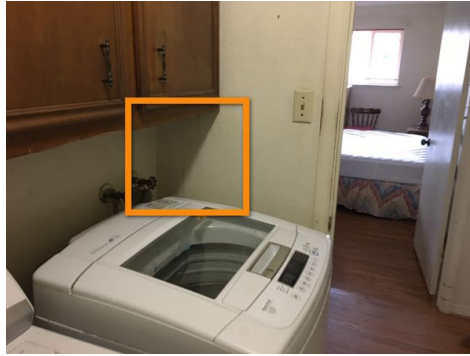
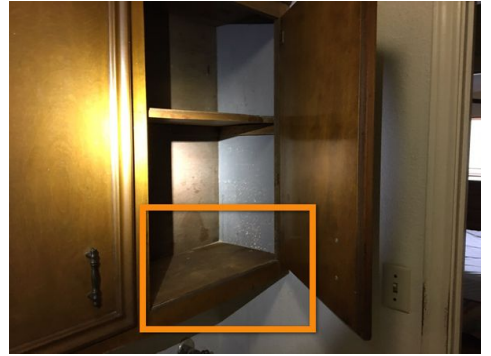
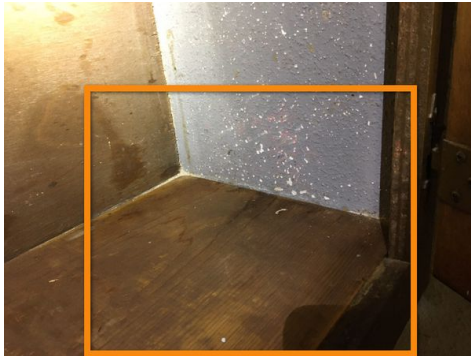
WATER STAINS- UNKNOWN

Water stains were visible on the utility wall near the cabinet. The source of the stains was not determined at the time of the inspection. However, the stains start from the cabinet and they appeared to be related to some liquid spill on the cabinet. Further investigation and repairs are recommended.

Contact a qualified professional.

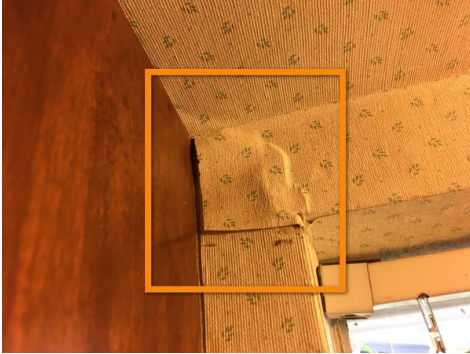
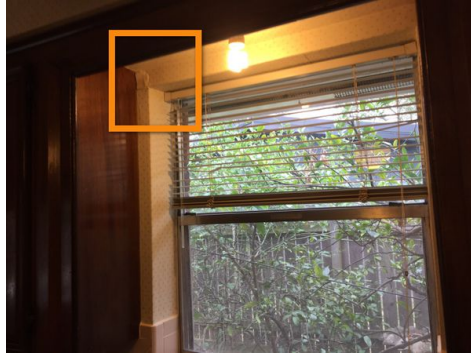
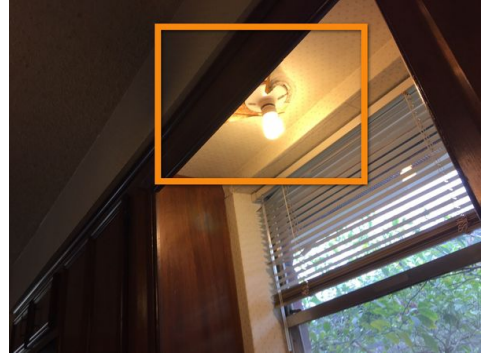
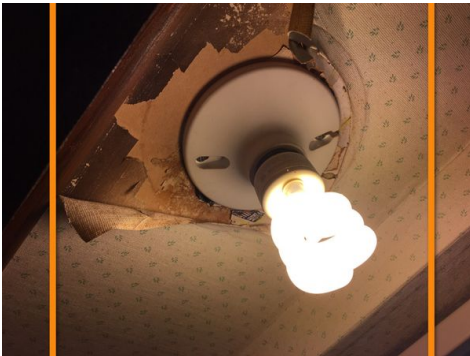
WALL PAPER

Some of the wall paper was loose and damaged.

Contact a qualified professional.
