Property Inspection Report

241 Lake Livingston Blvd., Livingston , TX 77351
Inspection prepared for: Dori Rhodes
Real Estate Agent: Sara Jimenez - RE/MAX Signature The Mosely Team

Date of Inspection: 3/29/2021 Time: 9:00 am
Age of Home: 46 yrs - 1975 yr built - Size: 816 sq ft
Weather: Clear and Sunny

One story pier & beam frame house built on grade having 2 bedrooms, 1 bathroom and detached Carport.

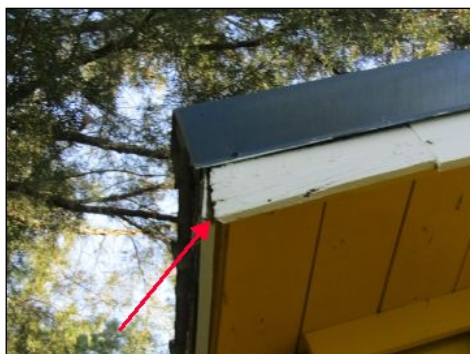
Cosmetic.

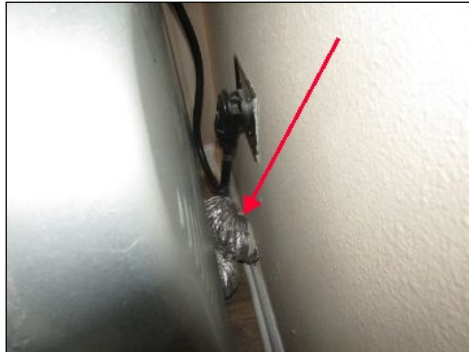
Comments: Appears functional. • Venting is not tested for proper draft. Inspected at visible and accessible areas. • Mylar foil tubing is not approved for use as a clothes dryer vent material.

Mylar foil tubing is not approved for use as a clothes dryer vent material.

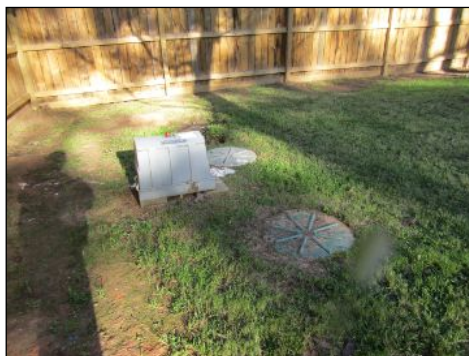
Type of System: Observed an aerobic system present.
 Location of Drain Field: Unknown. It appears to be in the backyard area.
 Recommending ask owner for location and all related information.
 Comments: Inspection was limited to stress test. Tanks are not opened. • Septic system was stress tested by running water for approximately an hour and observing exterior areas. • Toilets continued to flush after stress testing. No problems observed. • Aerobic Septic systems must be serviced at regular intervals recommend inquiring about last inspection.
