HOME INSPECTION REPORT

Prepared For:	Ken Valka <small>(Name of Client)</small>
Concerning:	6878 Kingston Cove Ln, Willis, TX, 77318 <small>(Address or Other Identification of Inspected Property)</small>
By:	Mickey Oetken - SI <small>(Name and License Number of Inspector)</small>
	2-23-2021 <small>(Date)</small>
	Jeff Oetken Trec License Number 23908 <small>(Name, License Number of Sponsoring Inspector)</small>

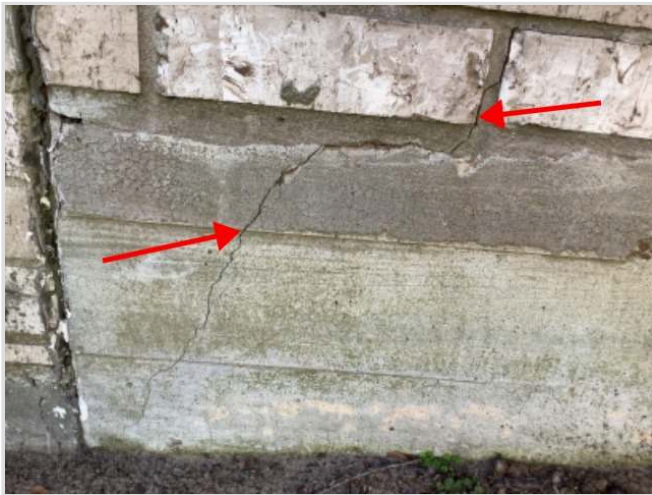
corner pop on right back side of home

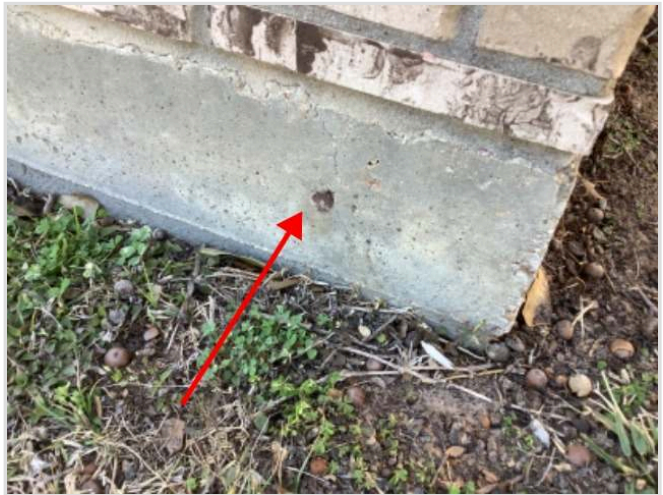
Exposed post tension cable right front of house

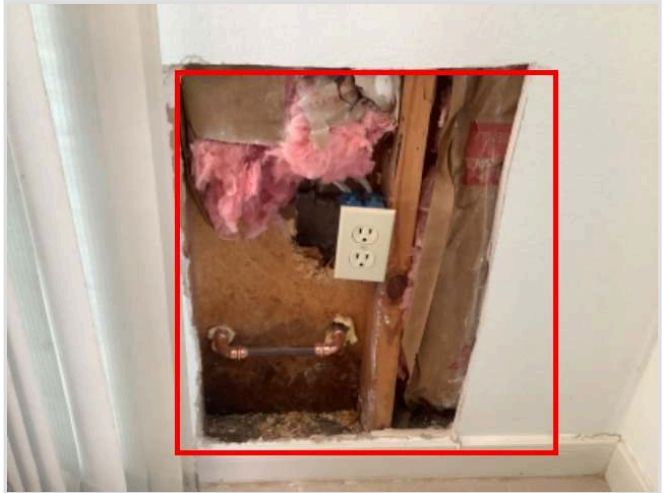
Breakfast nook

Trim board around flooring in kitchen is rotten.
Recommend replacement

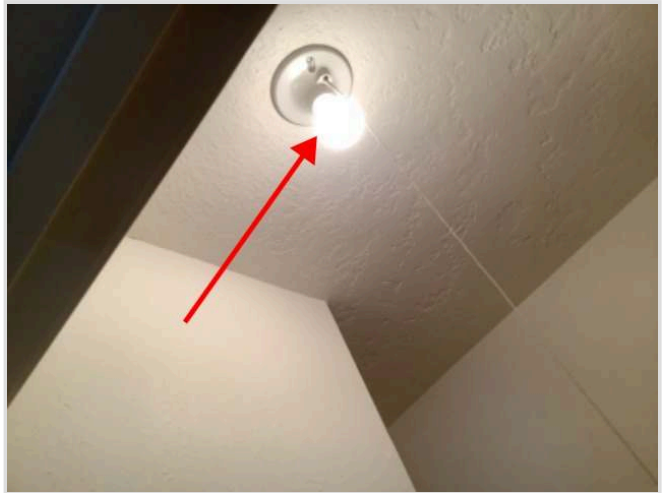
Hall bathroom

Unprotected lightbulb and secondary all

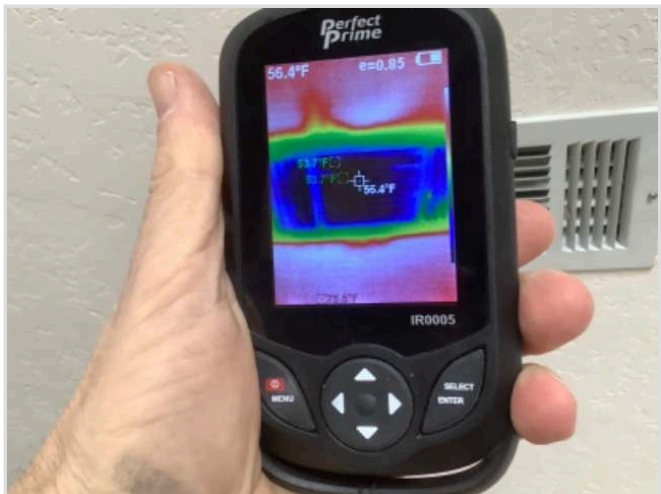
UNIT #1: The condenser unit was manufactured by Rudd in 10/2005. Temperature differentials were taken and were within an acceptable range of 15 - 22 degrees. Supply was 56.4 degrees and return was 72.8. The unit had quite a bit of leaf debris and should be cleaned. The dryer filter at the condenser was rusted. The unit should be checked by an HVAC technician for maintenance.

Rusted dryer filter at condenser

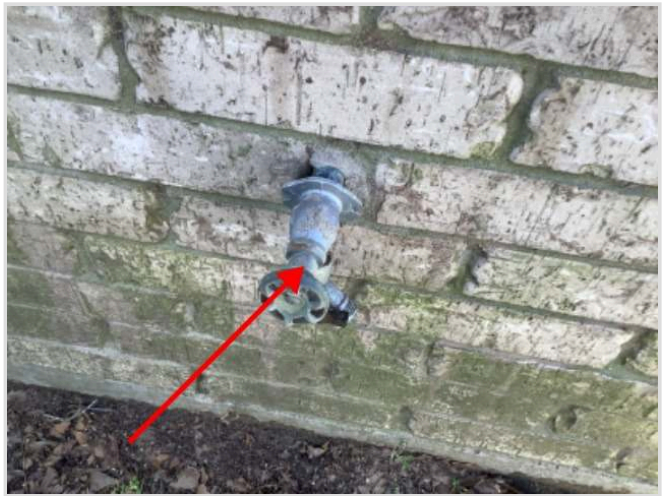
Area around faucet needs to be sealed to prevent intrusion of insects left side of house

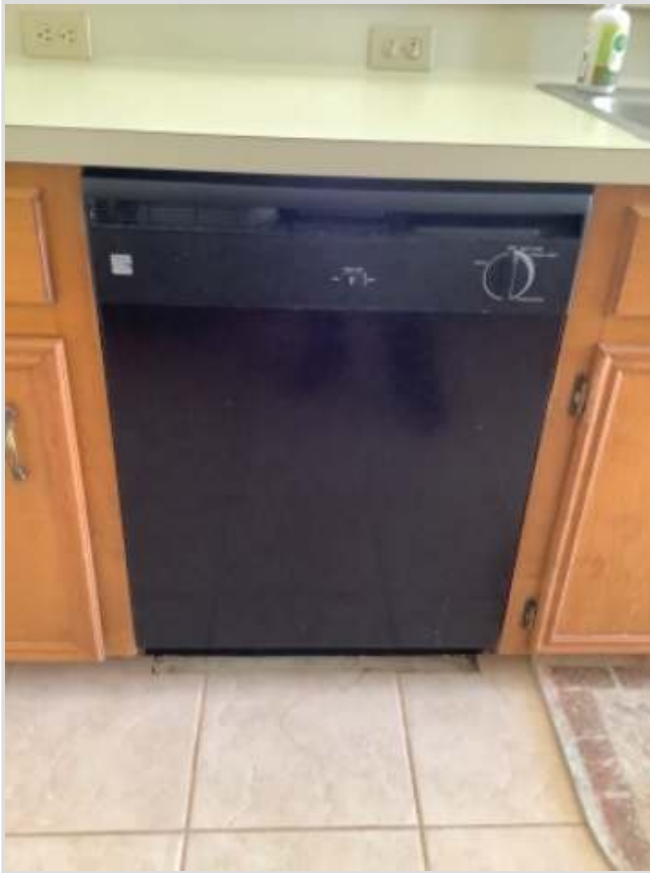
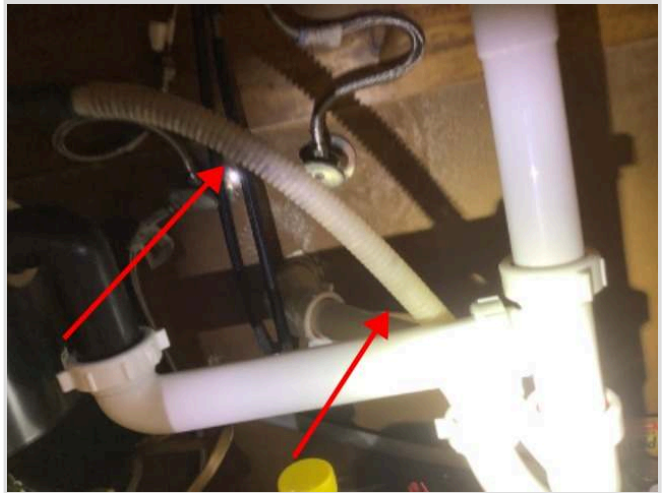
The dish washing unit was operated in the normal setting, and inspected to determine if the unit filled with water and properly drained the water upon completion of the cycle. The dish washing unit performed as intended at the time of the inspection. The drain hose from the dishwasher to the garbage disposal needs to be a high loop in which the drain line loops up under the sink base cabinet to a point above the dishwasher water level to prevent possibility of dirty drain water being siphoned into the dishwasher filled with clean dishes, thereby contaminating them.

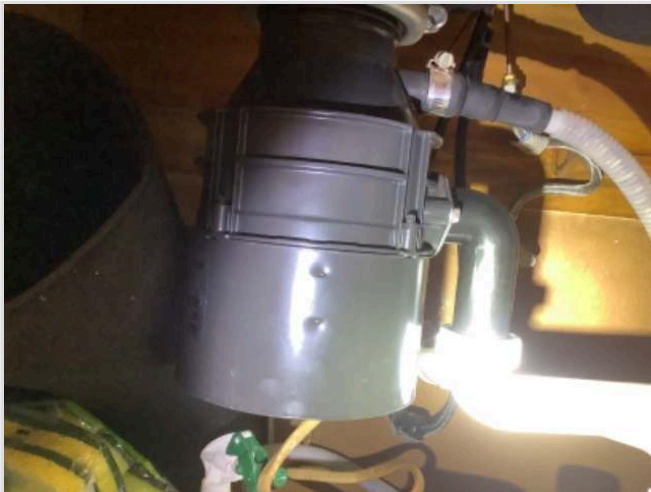
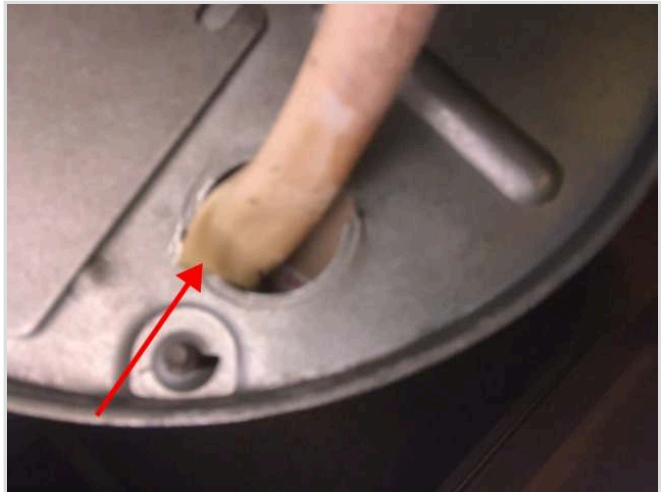
The garbage disposal was inspected and was working as intended at the time of inspection. No wire clamp was installed underneath the garbage disposal to secure the electrical wire.

Not secured electrical wire not secured underneath garbage disposal.

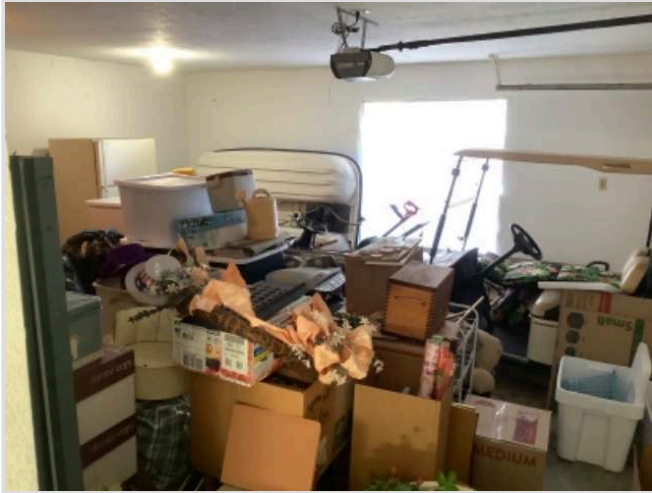
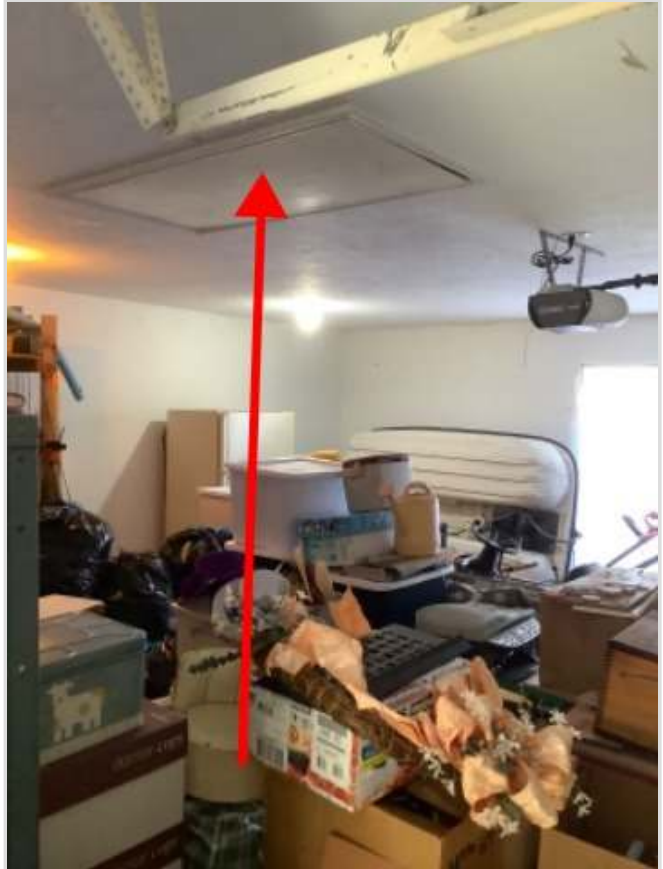
Garage door was inspected and did not operate at time of inspection, safety sensors were not present. Unable to inspect walls of the garage due to personal items. Unable to access the stairway to the attic due to personal items.
