Web Presentation

Property Address: 12511 Wickwild Circle, Montgomery, TX 77356

JASE Home Inspections

**Jason Autrey T.R.E.C. #20981
15529 Queen Elizabeth Ct.
Montgomery, Tx. 77316
281-906-7168**

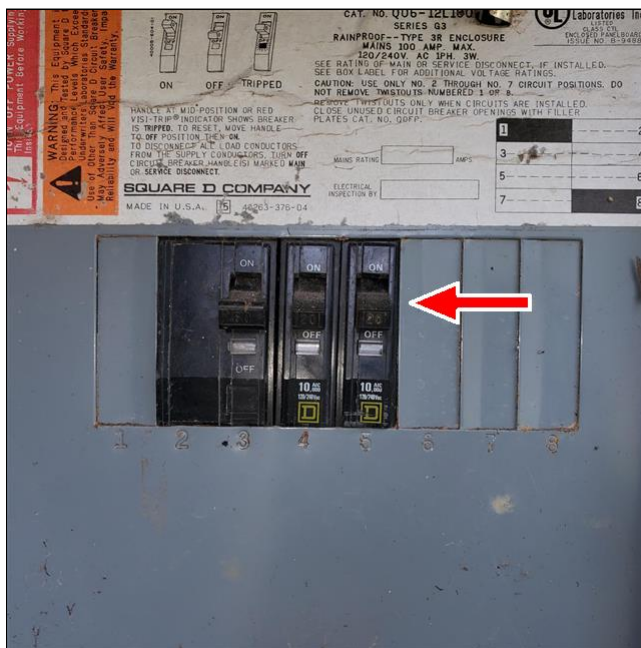
(1) All breakers at a sub panel at the right side of the home were shut off prior to the inspection. The inspector was unable to determine the circuit that these breakers protect as the breakers were not labeled.

A. Item 1(Picture) All breakers were turned off.

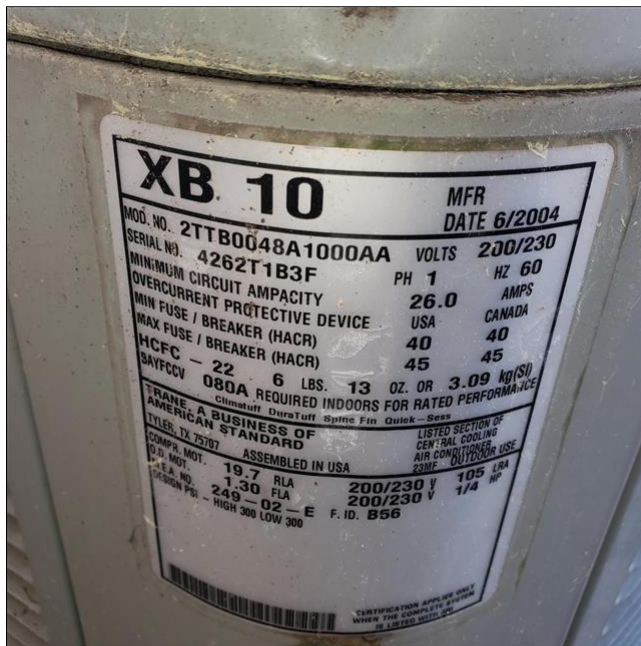
B. Item 2(Picture) AC for the main home manufactured in 2004.

(2) Both air conditioners are not installed on a pad that is elevated 3" above the ground. Repairs are recommended.

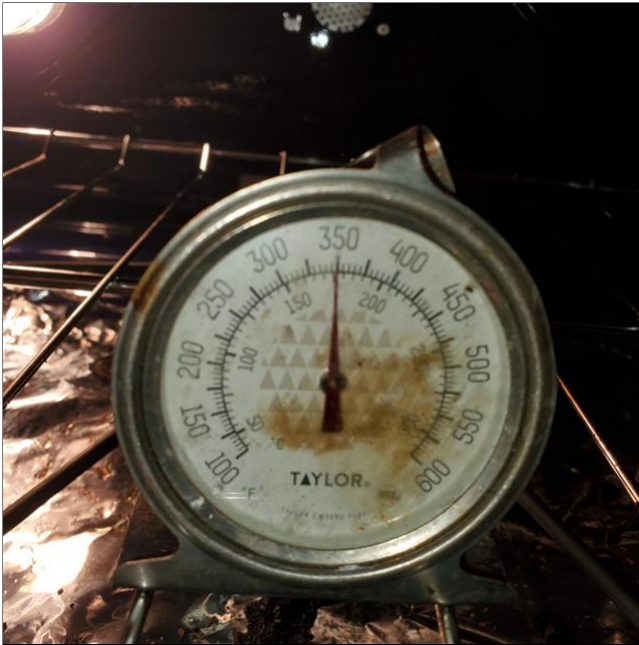
(2) The UPPER oven was tested at 350 degrees and bake. When the oven was finished preheating the thermometer placed in the oven measured perfectly at 350 degrees.

D. Item 2(Picture) Upper temperature test.

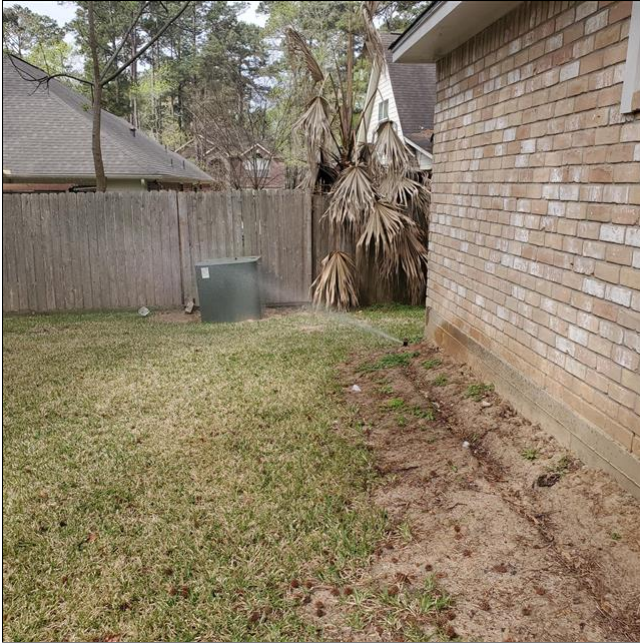
A. Item 1(Picture) Photo of back yard zone running.
