Property Inspection Report

18511 Purdy Court, Houston, TX 77084
Inspection prepared for: Raed
Date of Inspection: 4/4/2021 Time: 8:30am
Weather: Cloudy
The outside temperature is 57°.

Inspector: Zachary Hernandez
License #24019
Houston, TX
Phone: 832-557-5624
Email: hernzachary@gmail.com

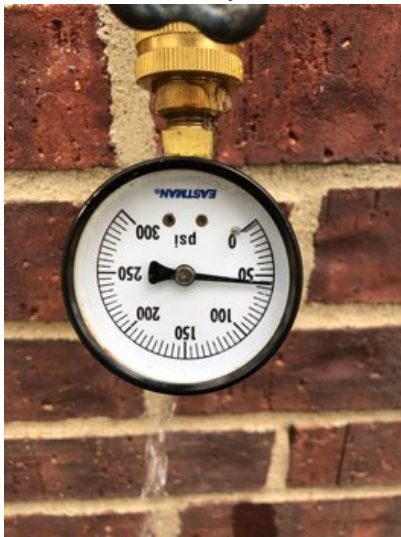
Static water pressure: 55 psi.

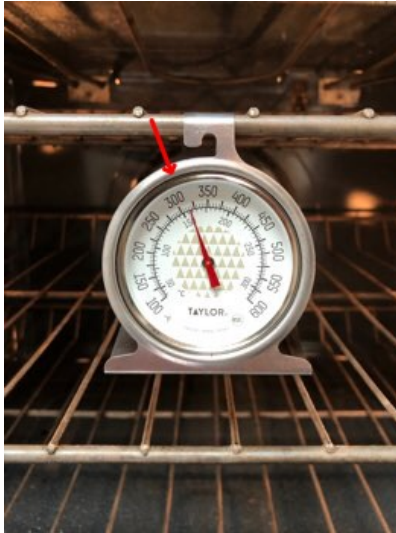
The lower oven temperature was inaccurate.
