RedFish Inspections

Property Inspection Report

10 Bishops Ct, Sugar Land, TX 77479
Inspection prepared for: Lenre Ikpeekha
Real Estate Agent: Jane Lam - RE/MAX Southwest

Date of Inspection: 5/24/2021 Time: 1:00 PM - 5:00 PM
Age of Home: 30 years old Size: 3890 sqft
Weather: Cloudy

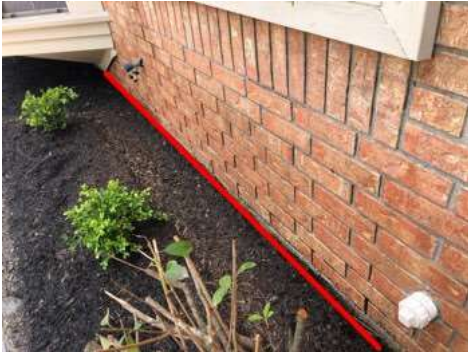
Left: high soil

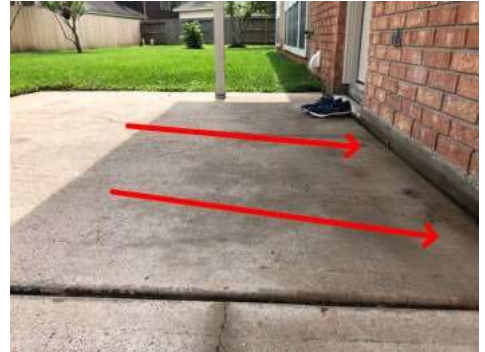
Rear: walkway slopes toward house

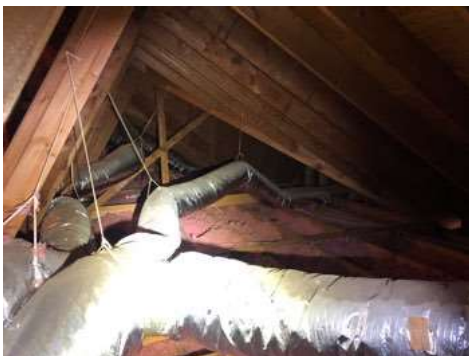
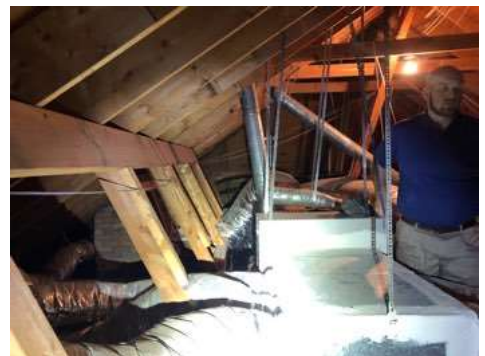
Per today's standards, insufficient insulation was observed in the attic space. Insulation improvements may be cost effective, depending on the anticipated term of ownership.

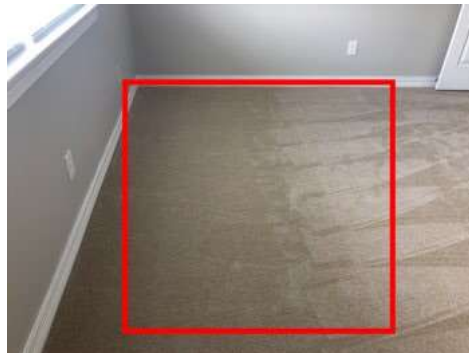
Bedroom 3: squeaky floor

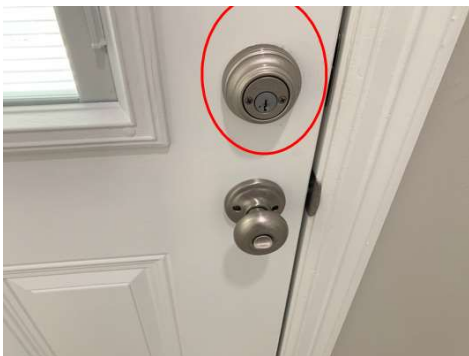
Back Door: Deadbolt key operated only

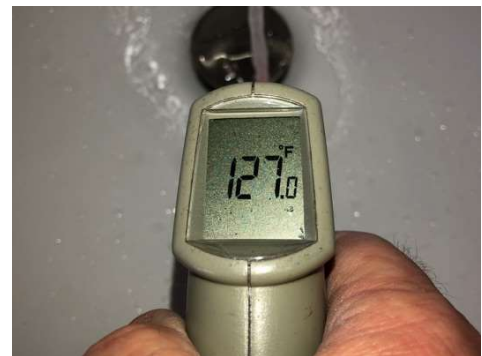
The 1st floor water temperature was measured at 113 degrees. The 2nd floor water temperature was measured at 127 degrees . This is scalding. We recommend reducing the temperature at the 2nd floor water heater to maximum 120 degrees.

2nd floor: Hot water temperature: Scalding
