## PROPERTY INSPECTION REPORT

**Prepared For:** WEI LIU SHEN  
(Name of Client)

**Concerning:** 10 BISHOP COURT, SUGARLAND, TX 77479  
(Address or Other Identification of Inspected Property)

**By:** Jayant Patel, Lic #Texas Real Estate Commission # 8050 05/31/2021  
(Name and License Number of Inspector) (Date)

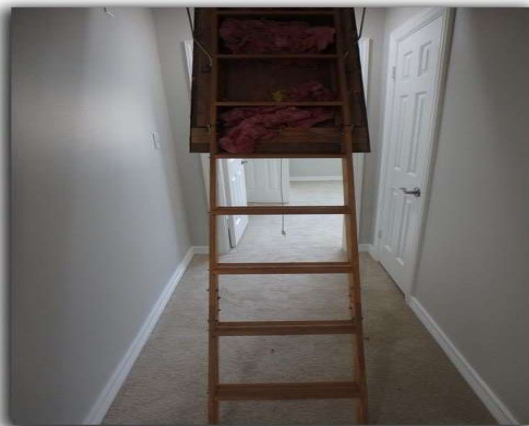
*Comments:* Pull Down Ladder: The ladder was not sturdy, and may not carry heavy weights.

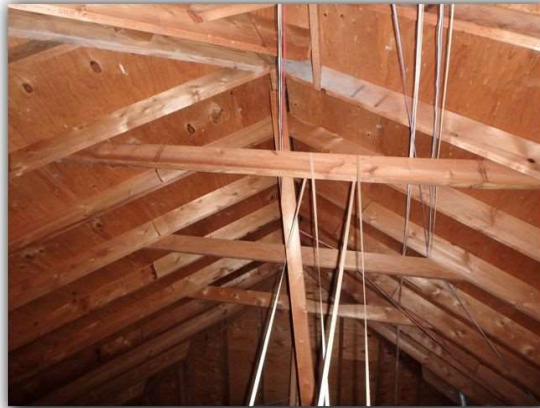
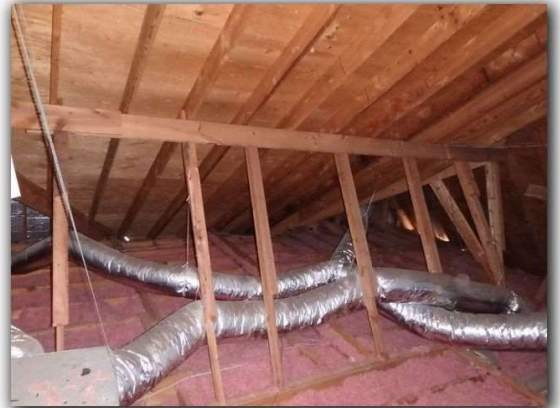
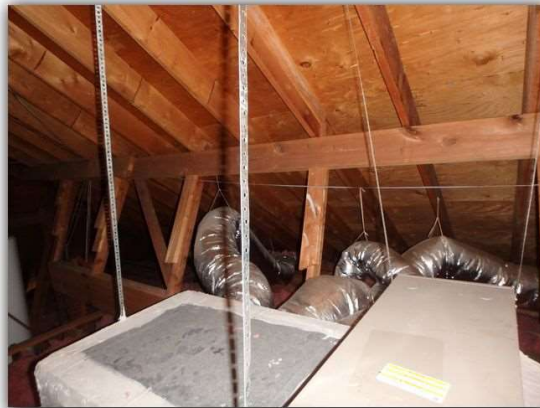
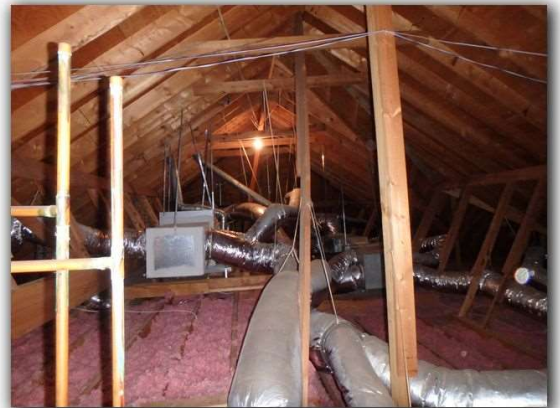
Attic was dry and ventilated with soffit vents and ridge vents. Most areas of attic in far off sides could not be observed due to the lack of walkway access.

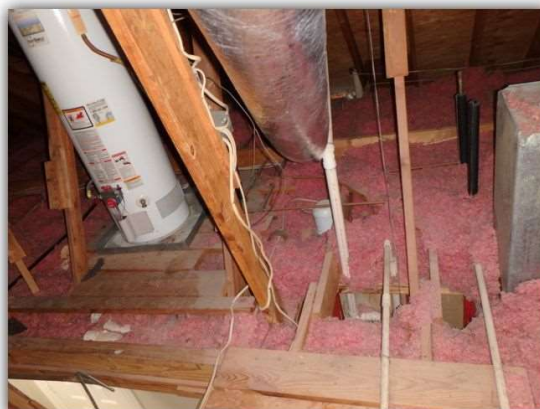
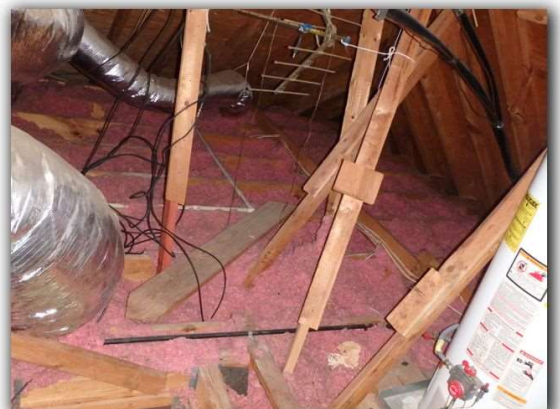
Attic was insulated with loose fill insulation which appeared to be shrunk due to age and was filled in attic floor joist cavities.

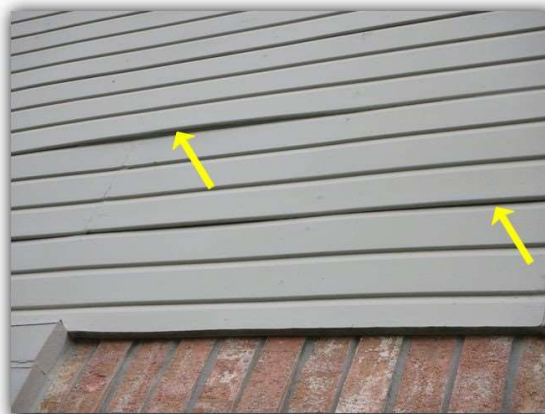
Wood sidings: Back side: Some sidings need attention.

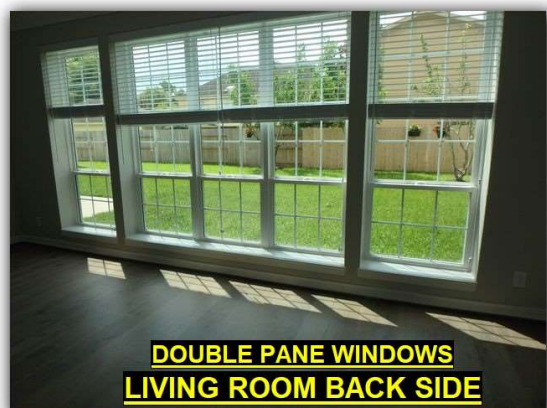
*Comments:* Windows were double pane on living room (back windows) back side. Windows were single pane in other areas.

All windows were operational.

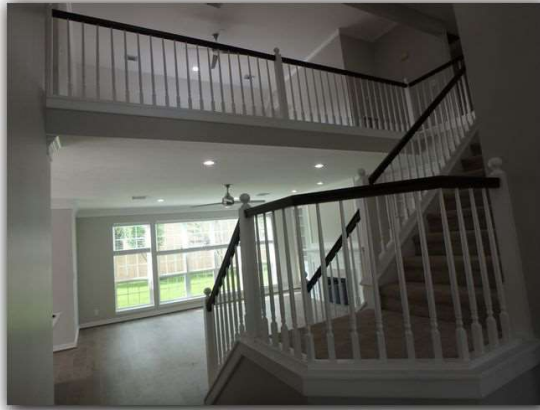
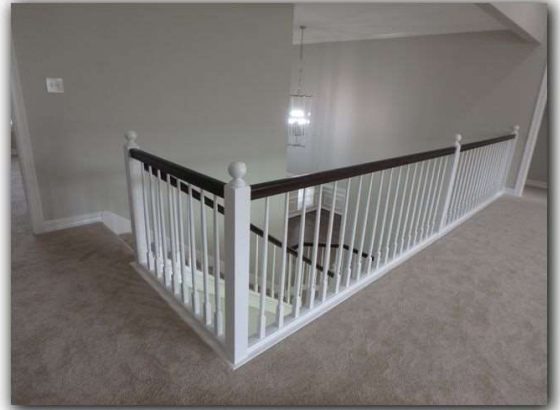
*Comments:* Stairways and handrails were in good condition. No structural deficiency was observed.

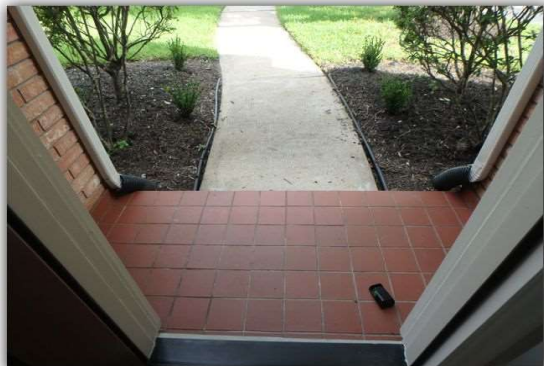
*Comments:* Front Porch: No significant deficiency was observed.

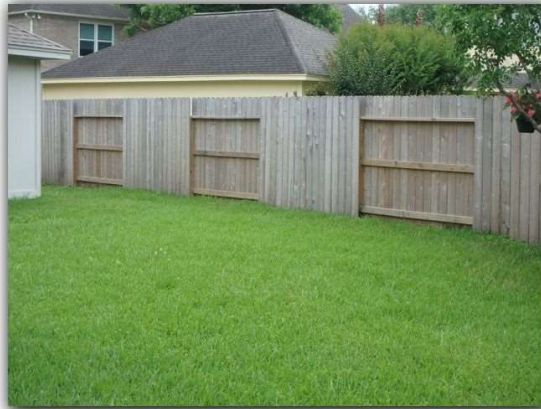
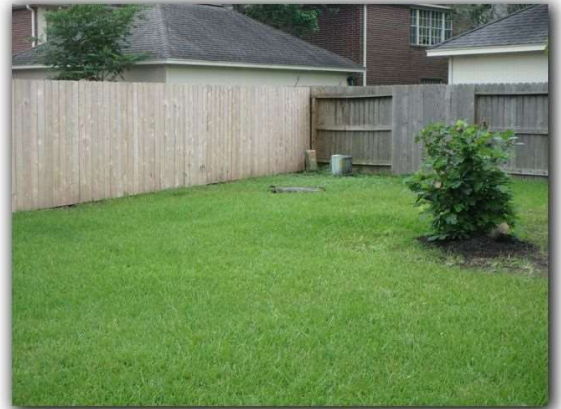
Fence: No significant deficiency was observed.

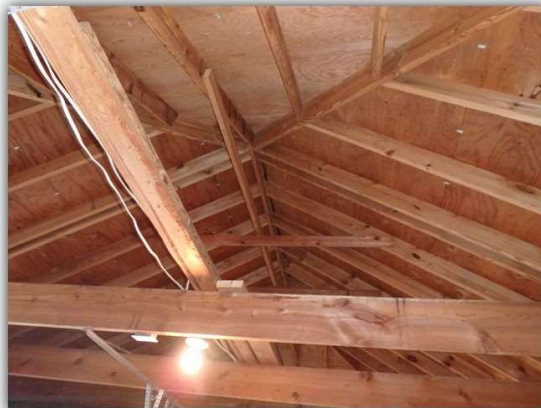
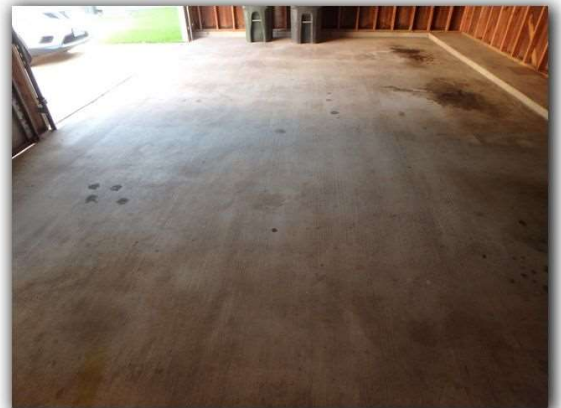
*Comments:* Garage: No structural deficiency was observed.

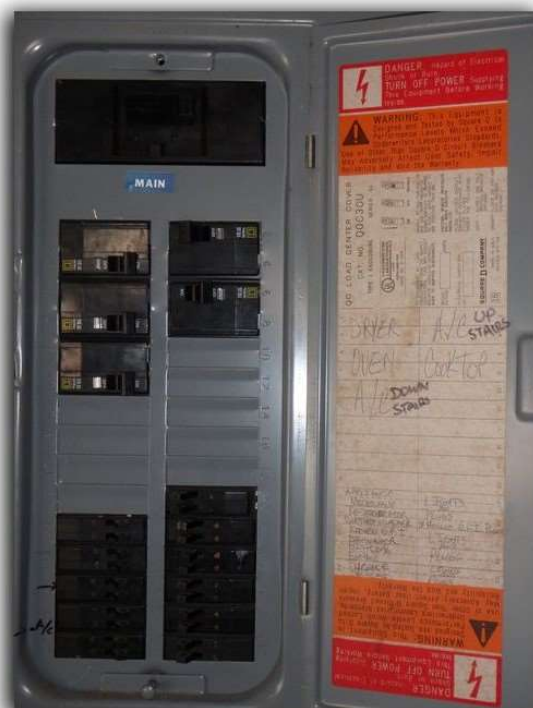
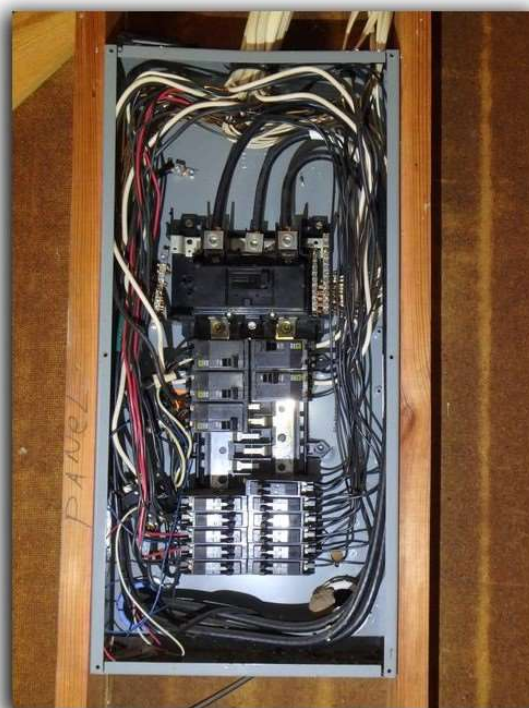
Electrical Service Panel: Make: SQUARE D

Location: Left / Right / Back side exterior walls.  
Detached Garage: Back side wall.

The electrical service panel was rated for 150 AMPS.  
Main Disconnect - Circuit Breaker was 150 AMPS.  
Maximum circuit breaker rating was 40 AMPS.

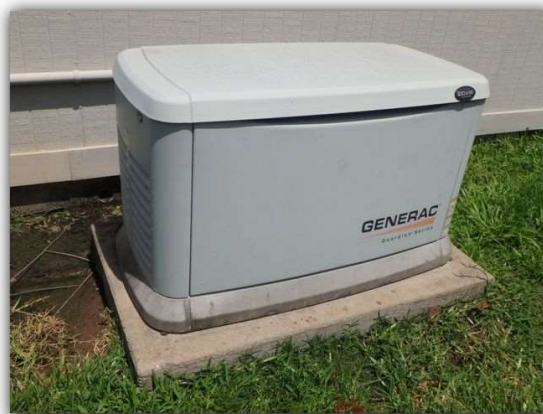
There was a Power generator installed on back side of the garage. Inspection of Power Generator is beyond the scope of this inspection. This unit was not inspected.

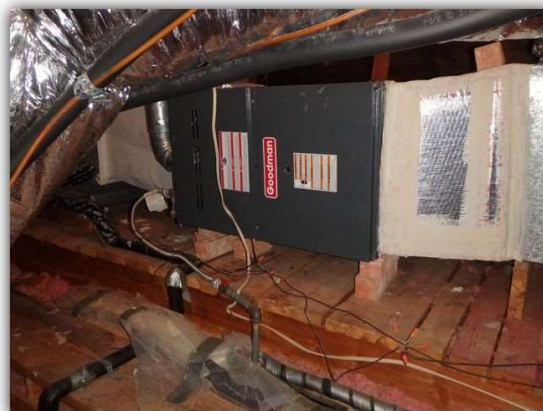
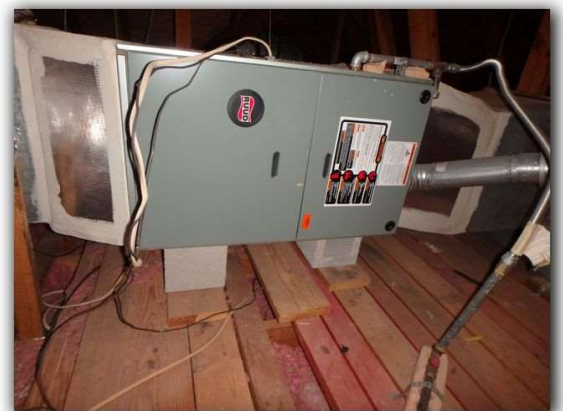
Make: GOODMAN COMPANY, and RUUD. Location: Attic

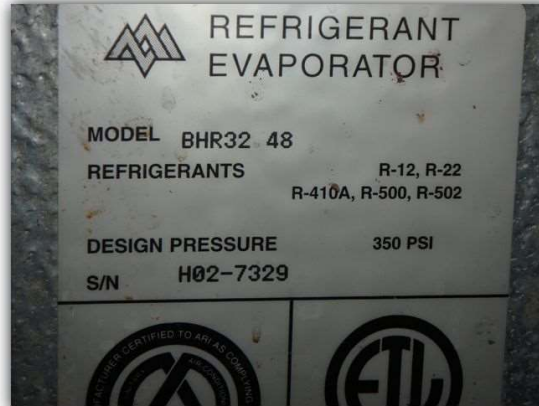
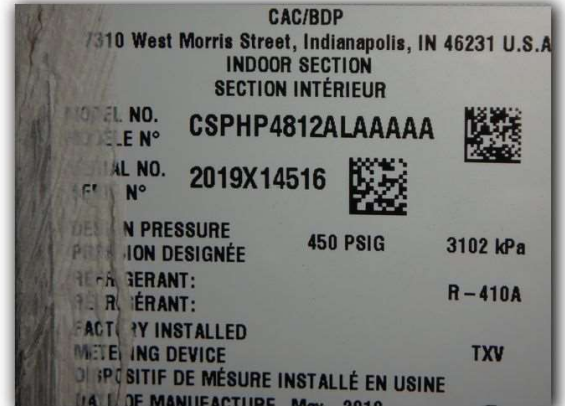
Evaporator Coils: The coils were located in the attic HVAC units.  
MFG DATES: August 2002, and April 2019

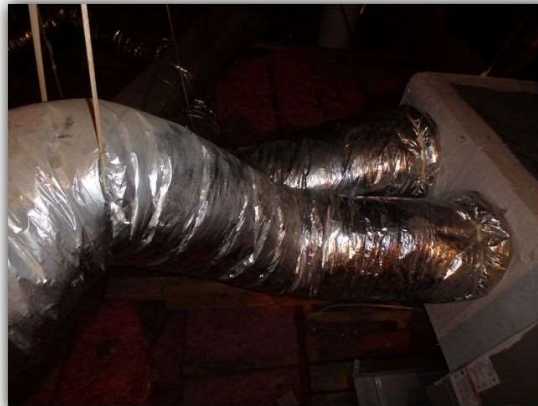
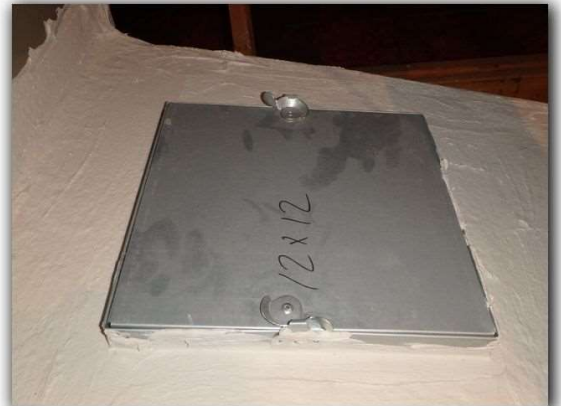
Return Air Filters: To be replaced as needed, typically every one to three months.

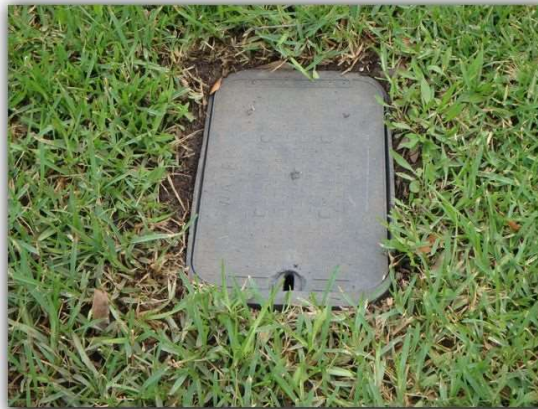
*Location of water meter:* Front curb side.

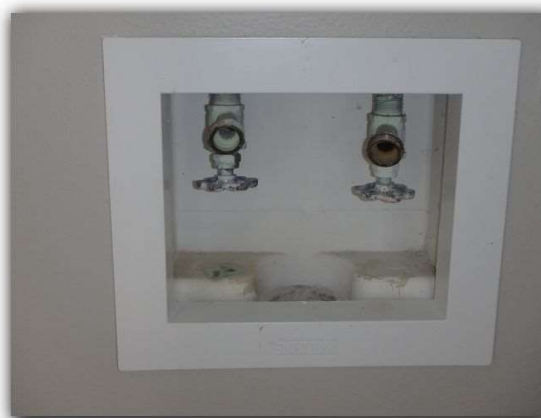
Washer Connections: No deficiency was observed.

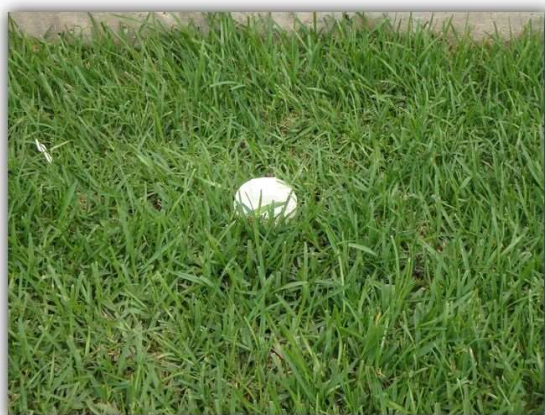
Main Clean Out: Located on back side of the house.

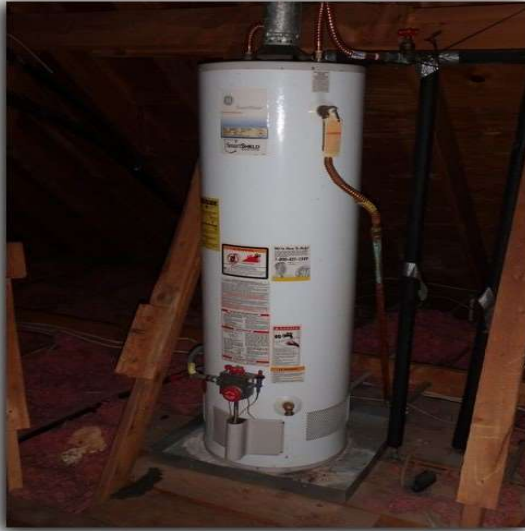
Temperature and Pressure Release valve: The TPR valve was jammed and was not operational. Please also note that a leaking TPR valve could significantly damage the property especially if the Water Heater units are located in the attic.

Exhaust duct: To be strapped / fastened to the roof structure. (the strap was broken)  
Please note that this is a safety requirement.

Exhaust duct: To be strapped / fastened to the roof structure. (the strap was broken). Please note that this is a safety requirement.

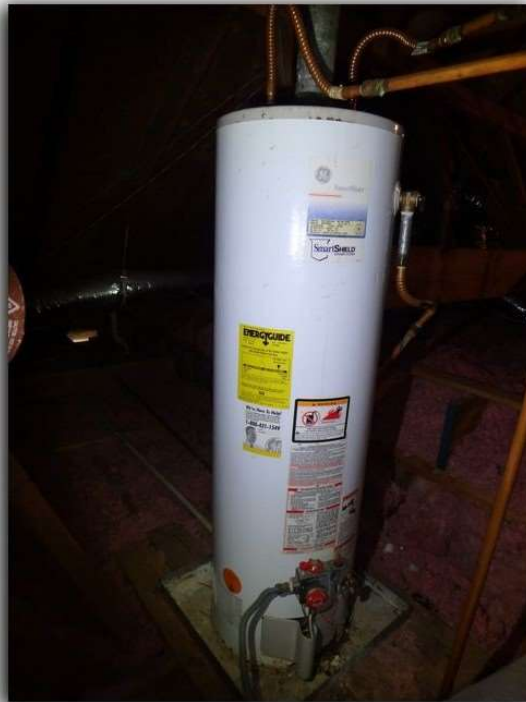
Temperature and Pressure Release valve: The TPR valve was jammed and was not operational. Please also note that a leaking TPR valve could significantly damage the property especially if the Water Heater units are located in the attic.

Exhaust duct: To be strapped / fastened to the roof structure. (the strap was broken)  
Please note that this is a safety requirement.

Bottom of the unit was corroded.

Exhaust duct: To be strapped / fastened to the roof structure. (the strap was broken). Please note that this is a safety requirement.

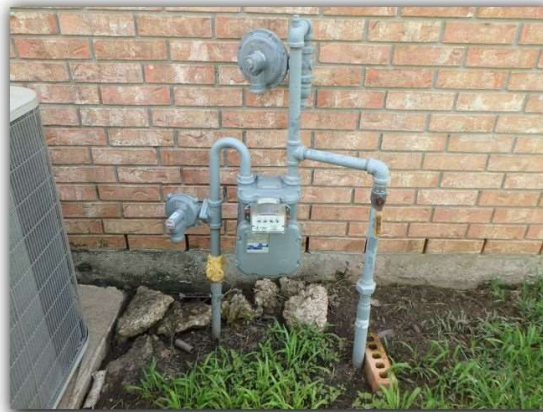
*Comments:* Gas Meter and Gas Supply: Gas meter was located on side of the house. Natural gas supply was available at the time of inspection.

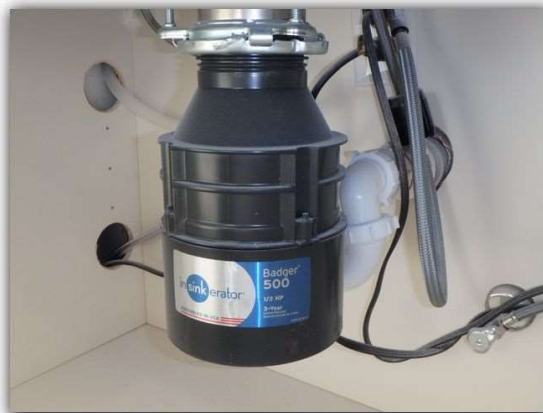
*Comments:* Make: BADGER 500  
The unit was operational.

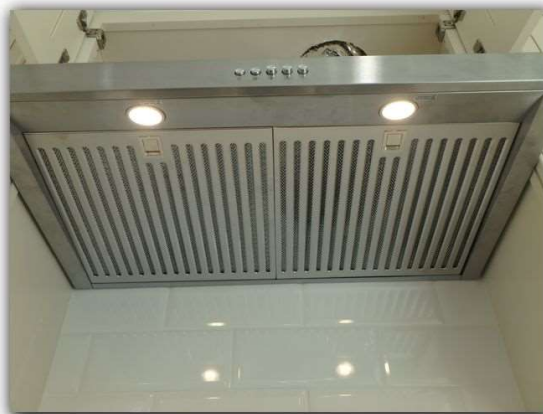
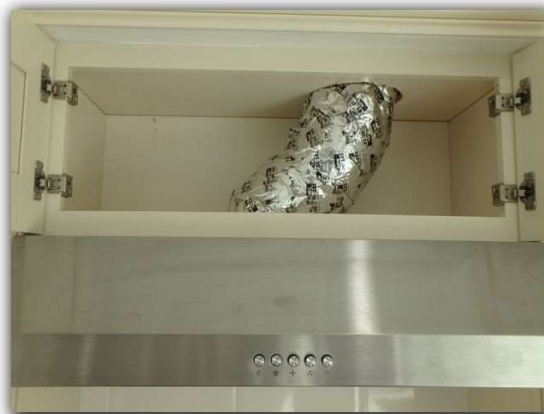
*Comments:* Range Hood: Range Exhaust System: Present and was operational.

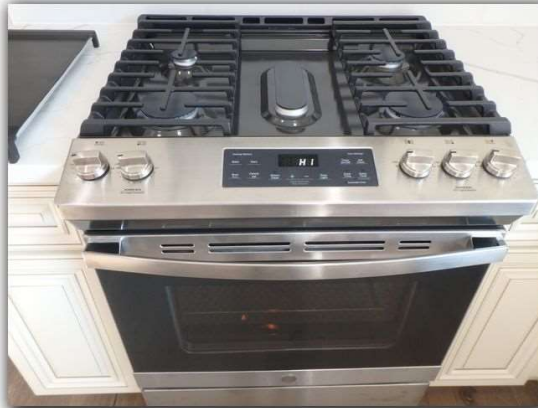
Model		Serial	
JGSS66SEL3SS		DS939651P	
INPUTS – BTU/HR		NATURAL	PROPANE
RIGHT REAR		9 500	9 500
RIGHT FRONT		15 000	15 000
CENTER		10 000	8 000
LEFT REAR		5 000	5 000

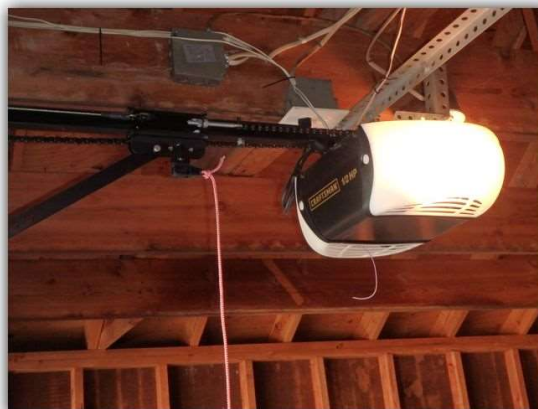
Number of units: One. One door was manually operated. No garage door operator installed.

The one installed unit was operational and was performing the functions as intended. .

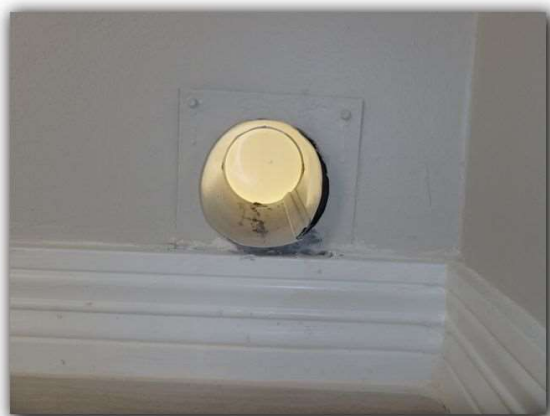
*Comments:* Dryer Exhaust System: The dryer exhaust system appeared to be installed as intended.

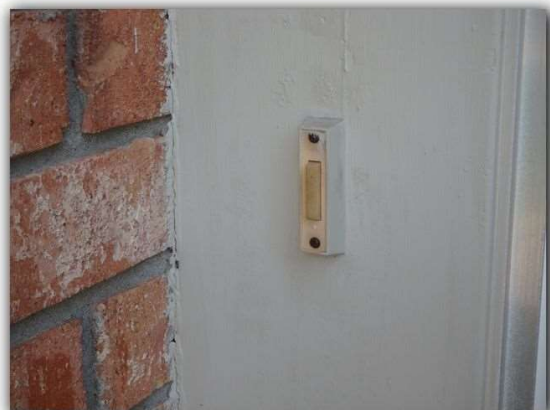
*Comments:* There was a door bell installed at the front door. The door bell was operational.

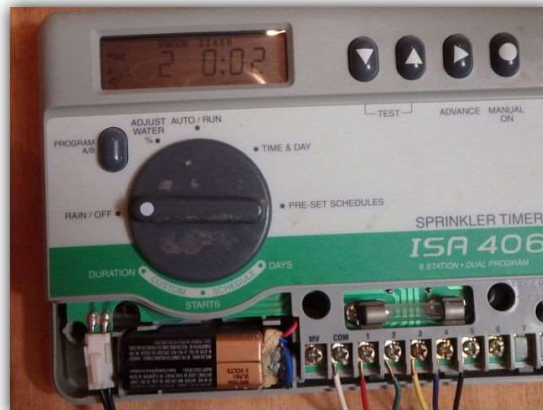
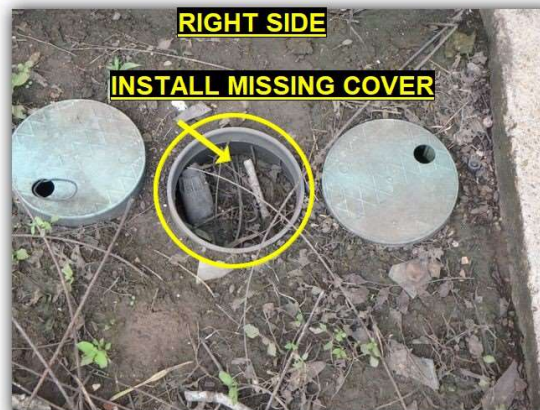
The unit was attempted to operate in manual mode. The sprinkler system did not start. The sprinkler system was not operational.

Install the missing sprinkler sensor enclosure cover on right side perimeter.
