HouseCheck

Property Inspection Report

5331 Dumfries Dr, Houston, TX 77096
Inspection prepared for: Jim Sherry
Real Estate Agent: -

Date of Inspection: 12/4/2019 Time: 2:00 PM
Age of Home: 1960 Size: 2315
Order ID: 1572

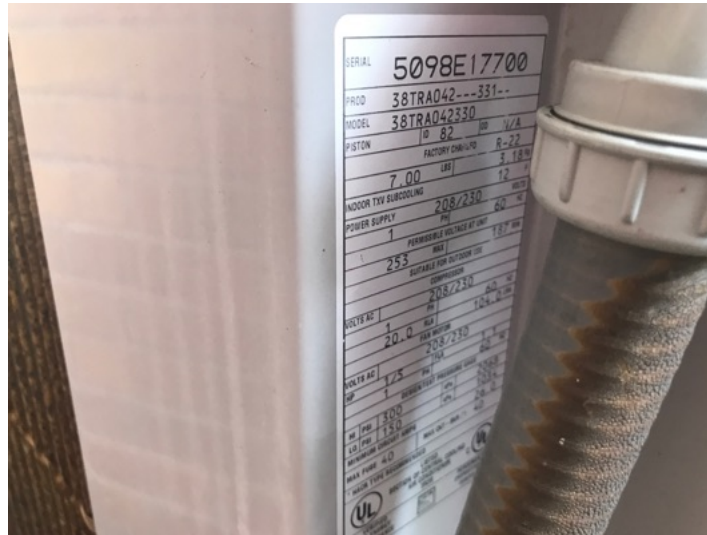
A/C condenser label: 1998 model, 3 1/2 tons

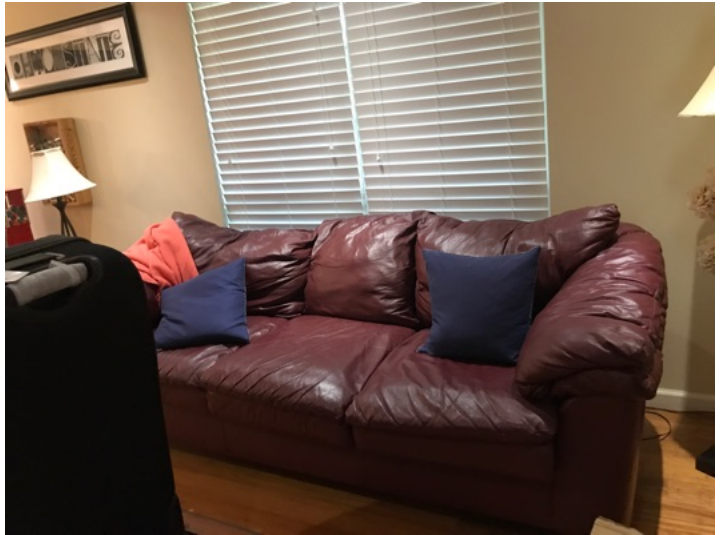
Furnishings restricted inspection of windows

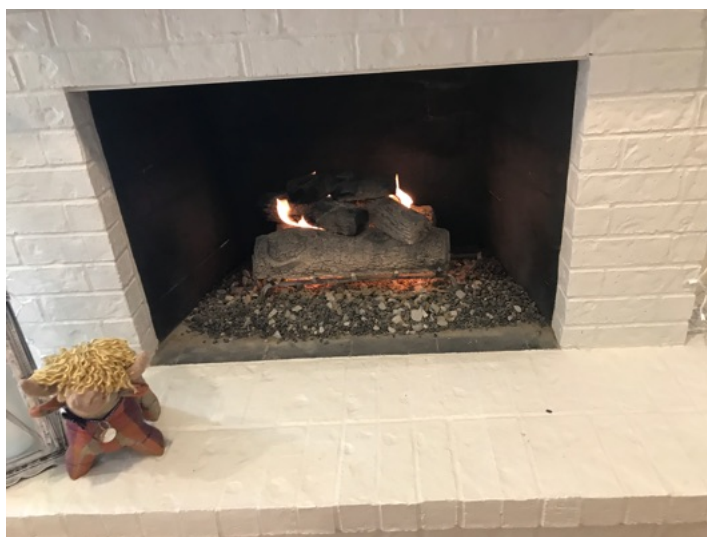
- Missing damper clamp on the fireplace flue. A damper clamp is required for a gas-fueled fireplace.
- Master bedroom entrance door is not functional and does not catch when door is closed.

Fireplace

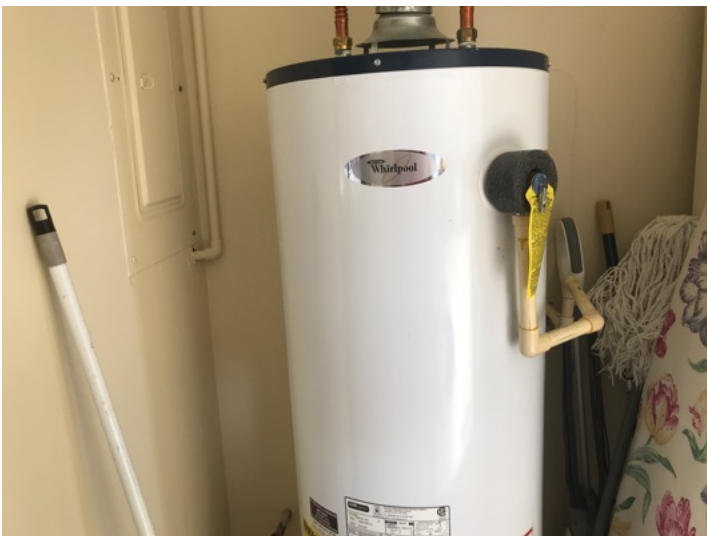
Water heater

- Brand: Whirlpool // Year Manufactured: 2014
- Excessive hot water was measured at plumbing fixtures in the following bathrooms/locations: kitchen. Standard hot water temperature should be measured between 90-120 degrees throughout the residence.
- The water heater is missing an emergency drain pan as required.
- All deficiencies noted should be evaluated and repaired by a licensed plumber.

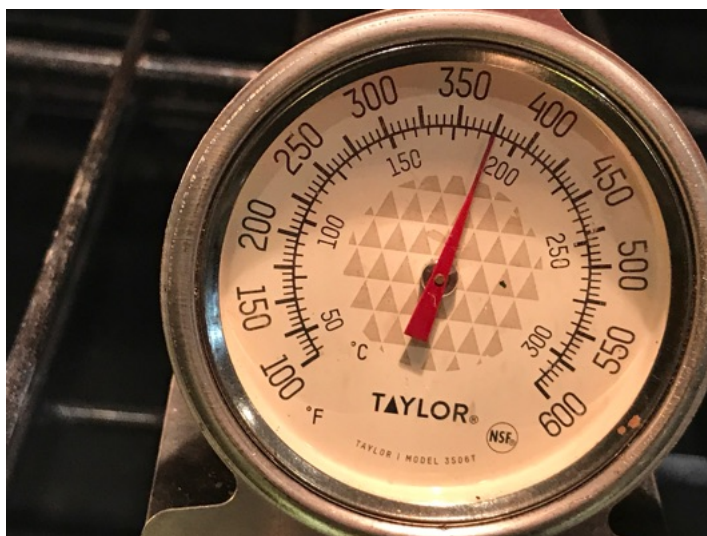
- Cooktops: natural gas
- Oven : electric
- Oven operated when tested. Tested at 400 degrees, registered at 375 degrees.

Oven temperature: 375 degrees

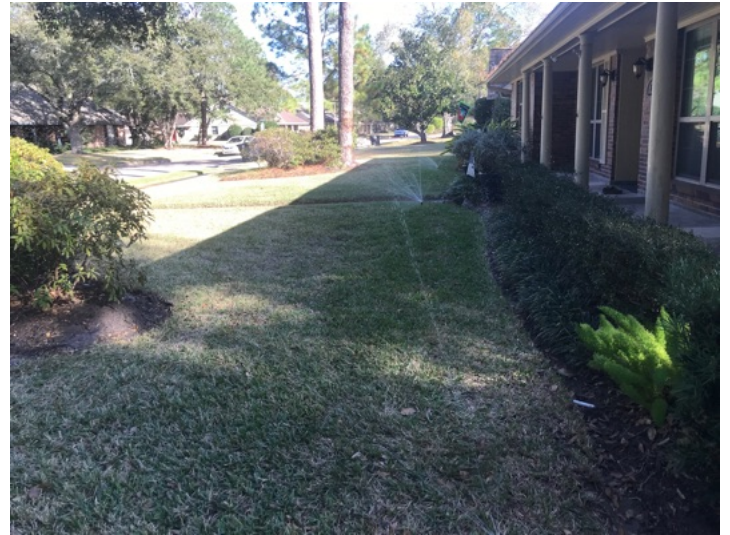
Zoned two

- Excessive over-spray present to the following Zones: 2, 4, 5
- Observed sprinkler head on zone #2 would not oscillate.
- All deficiencies noted should be evaluated and repaired by a licensed irrigation professional.
