Inspection Report

Property Address:
14202 Grand Manor Ln
Humble TX 77396

Counter Home Inspections

PROPERTY INSPECTION REPORT

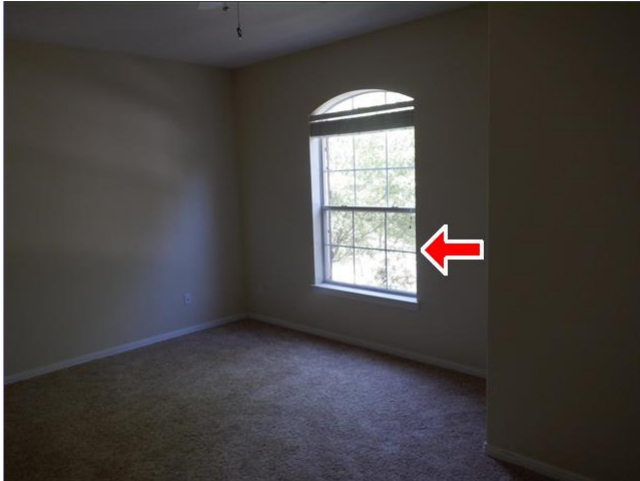
H. Upstairs front left bedroom window, broken hardware

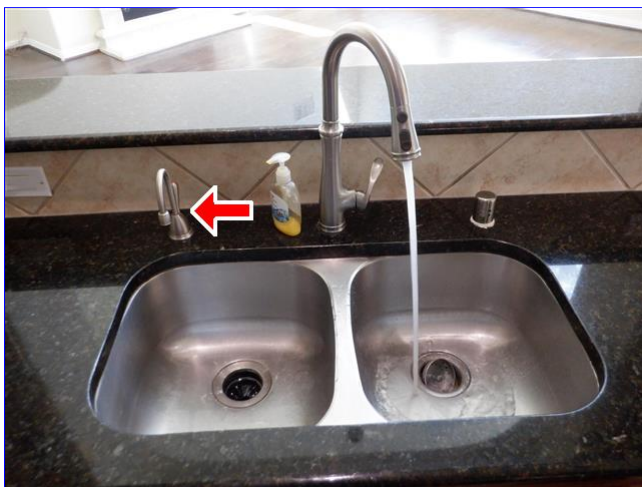
A. Kitchen sink

(1) The filtered water spout at the kitchen sink did not work.

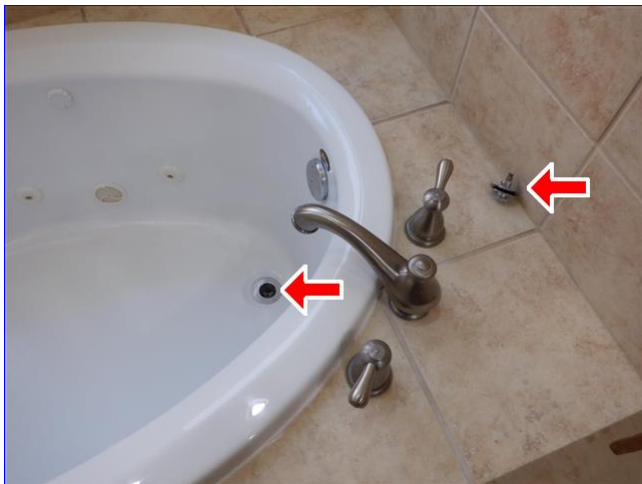
A. Master bath tub

(2) The stopper at the master bath tub was not installed.

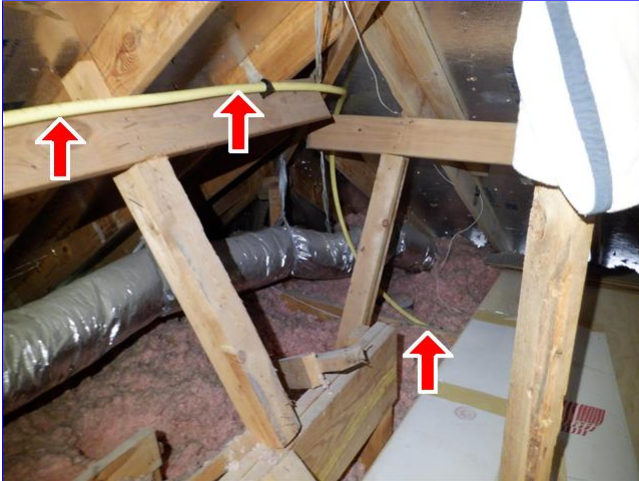
E. Upstairs back attic, CSST gas supply line

In the upstairs back attic a CSST gas supply line was observed. The gas line appears to have been installed to supply the home generator. I recommend replacing the CSST gas supply line with black iron gas pipe. I recommend further evaluation and repair by a licensed plumber.
