True Grit Home Inspection

Property Inspection Report

20523 Shadow Mill Ct, Katy, TX 77450

Date of Inspection: 5/7/2021 Time: 11:00 AM

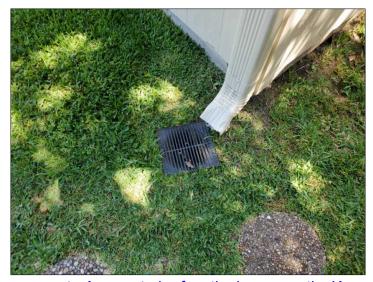
French drains present. Appear to be functioning correctly. Keep cleaned out.

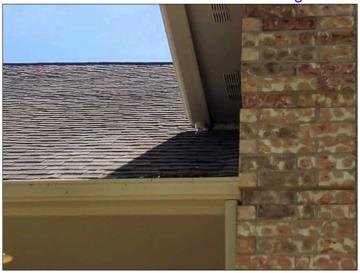
Sealing around flue suggested.

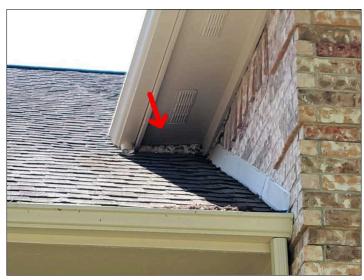
Pest foam noted.

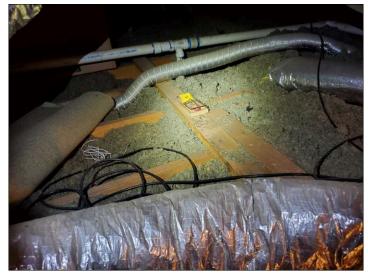
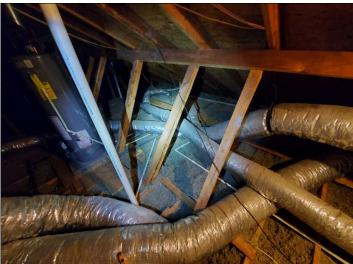
Rat and pest traps noted in attic.

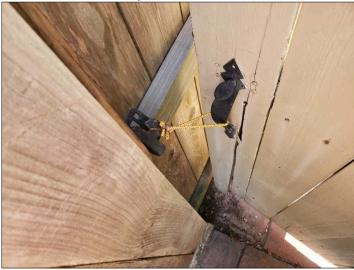
Gate not latching.

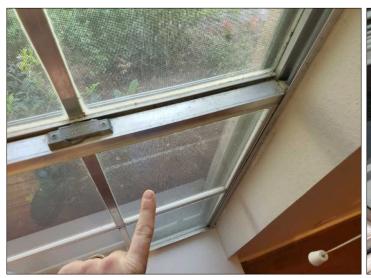
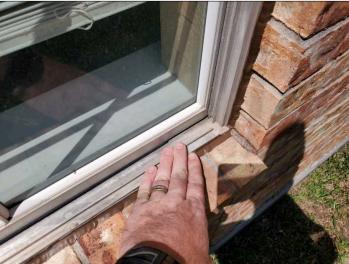
Dry shrinking seals.

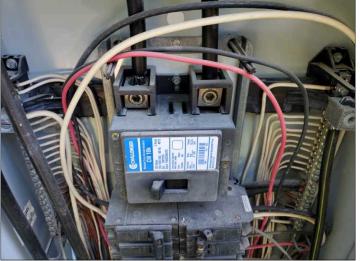
There is aluminum wiring present that does not have anti-oxidant grease

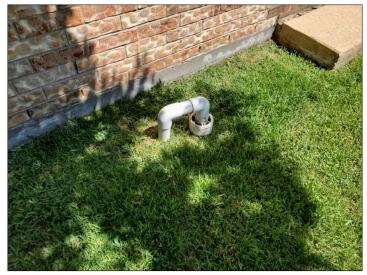
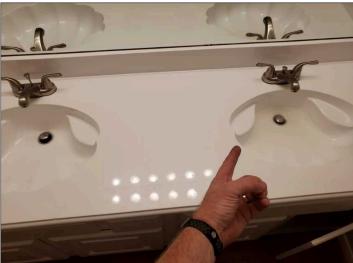
- Drains slow. Suggest having plumber to snake drains.
 Pool drain needs to have a 1" air qap.

Drains slow. Suggest having plumber to snake drains.

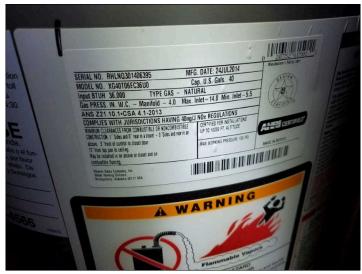
Temperature an pressure relief valve should discharge less than 6" from ground to prevent possible scolding.

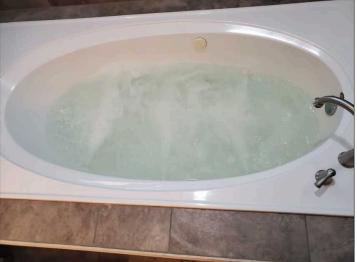
No access panel to pumps or receptacle.

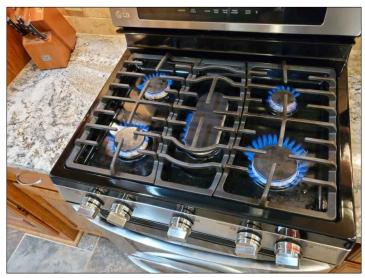
SAFETY CONCERN: Free standing range missing anti-tip bracket/device. Should be installed.

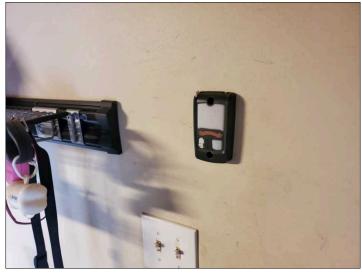
Missing safety test instructions on wall next to the operators.

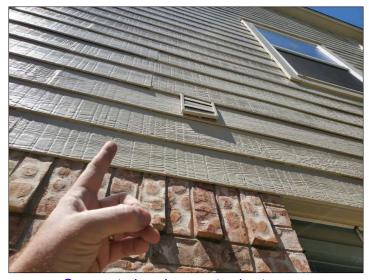
- Could not fully inspect the dryer vent, due to access.
 Suggest cleaning vent prior to use.

Suggest cleaning vent prior to use.

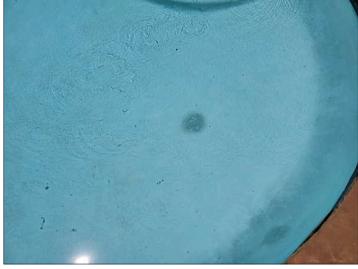
Stains noted in pool surface. Cleaning suggested, Stains noted in pool surface. Cleaning suggested, no cracks noted.

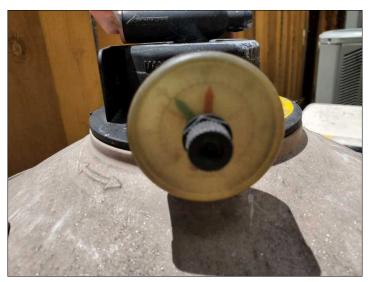
Chlorine missing

Chlorine levels need PROFESSIONALLY adjusted.

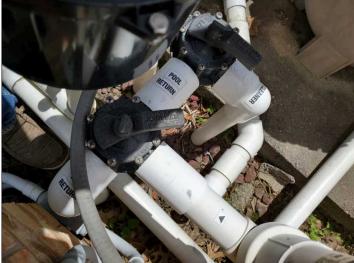
Spray valves are stuck / difficult.
