# Home Inspection Report

4111 Avenue T, Galveston , TX 77551

Wednesday July 14, 2021

# PROPERTY INSPECTION REPORT

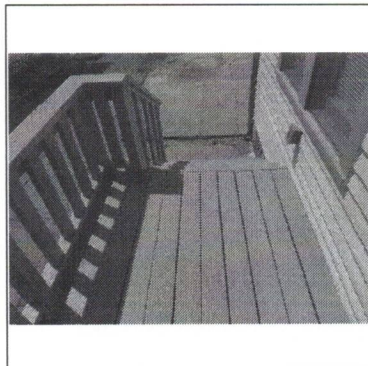
*Comments:* The front and rear stairways were both functioning properly on the day of the inspection. The stairways both had graspable handrails for safety.

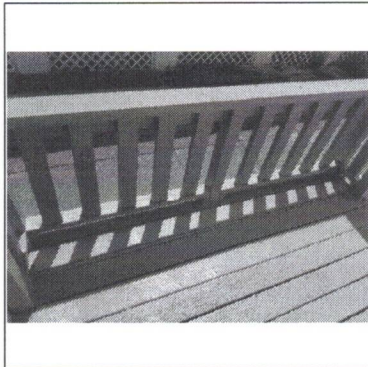
*Comments:* The small back porch appeared to be in good shape and functioning properly on the day of the inspection. It had secure railing with the proper spacing between the pickets as to not allow an object or sphere 4" or greater to fit between.
