1st Rate Inspections

Property Inspection Report

10511 Windriver Dr, Houston, TX 77070

Date of Inspection: 6/12/2019 Time: 8:30 AM

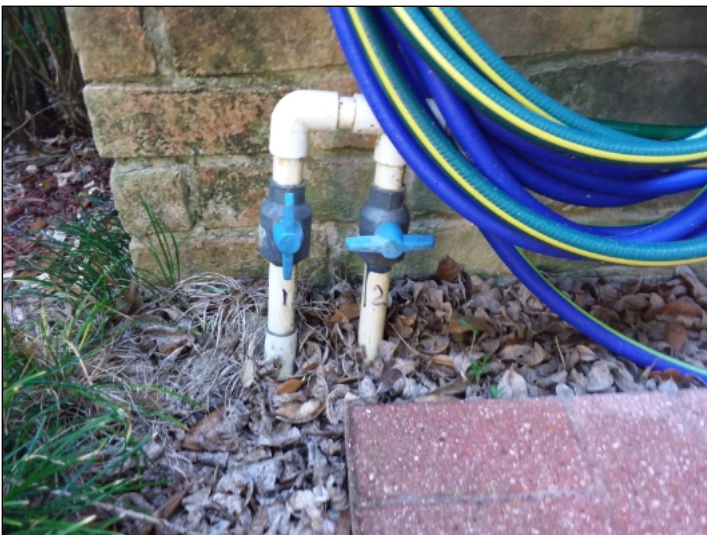
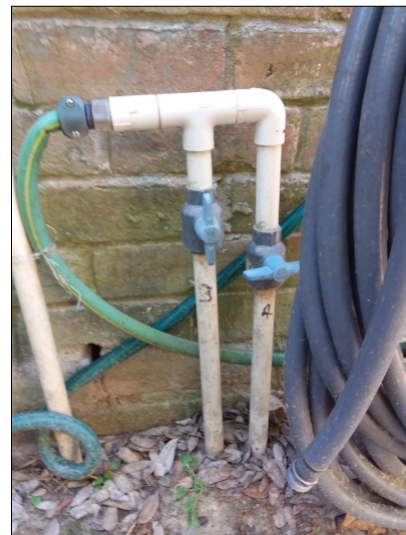
Zones 1 and 2 manual control located front/right, Zones 3 and 4 manual control located rear/right.
