North Star Inspections, Inc.

**72 Palos Verde
Panorama Village , TX 77304**

PROPERTY INSPECTION REPORT

Concerning: 72 Palos Verde, Panorama Village , TX, 77304
(Address or Other Identification of Inspected Property)

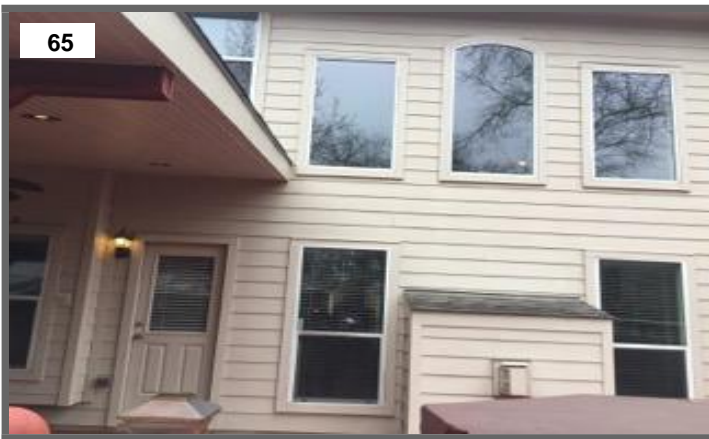
Lost seal
Top Middle

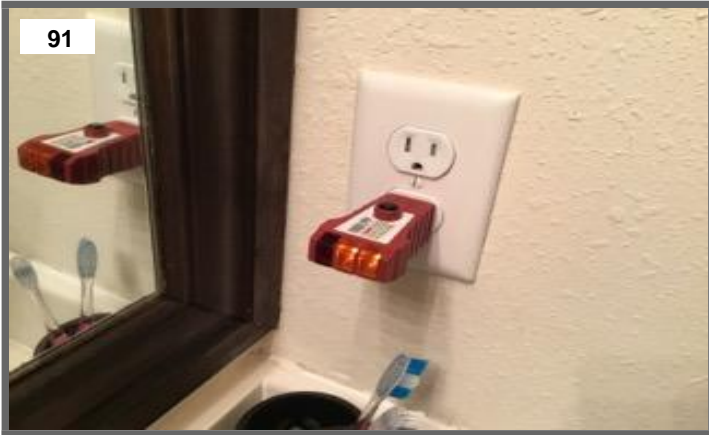
Yes GFCI

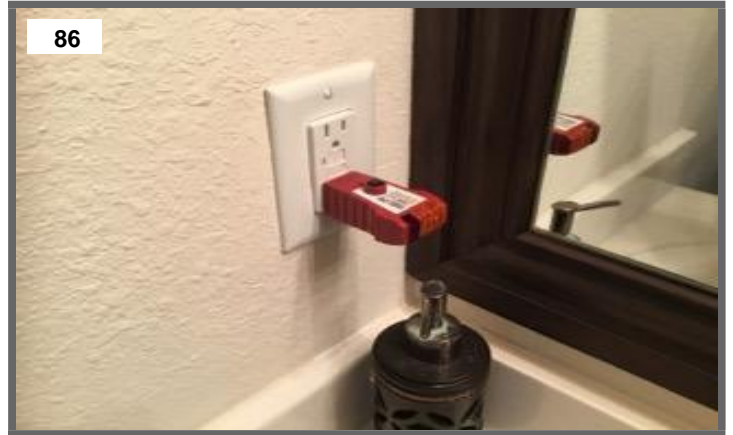
Yes GFCI

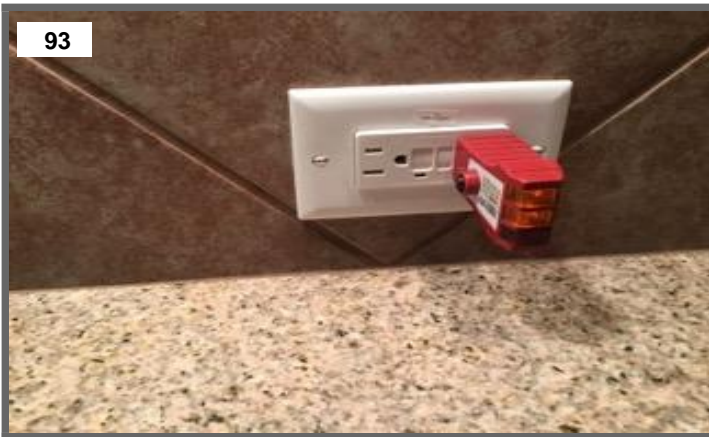
Yes GFCI

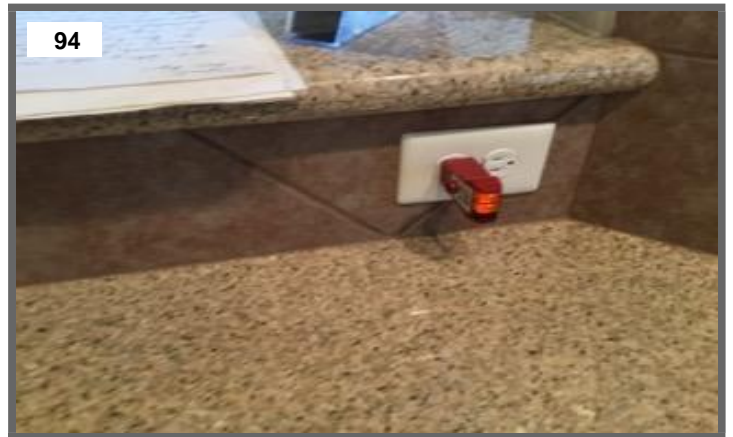
Yes GFCI

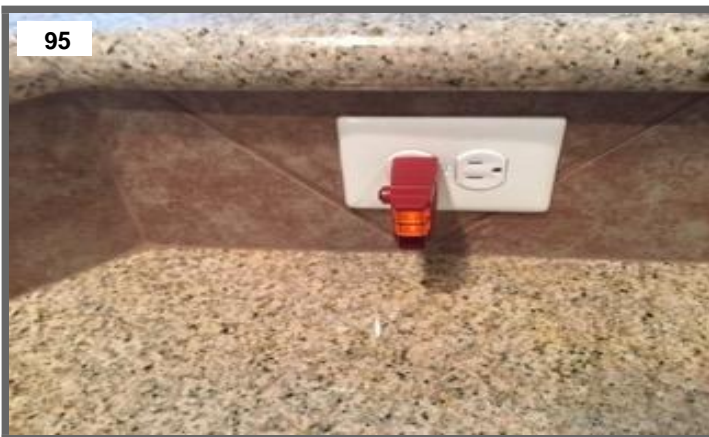
Yes GFCI

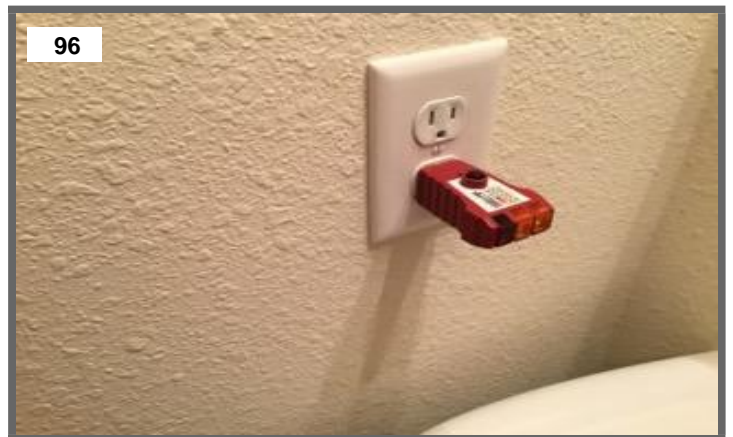
Yes GFCI

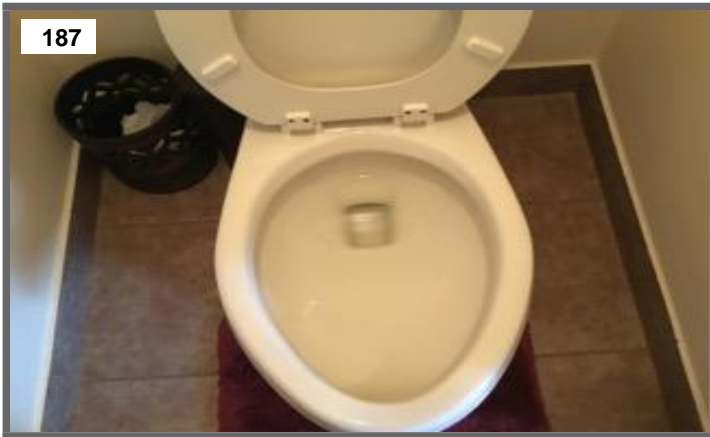
187

Master toilet

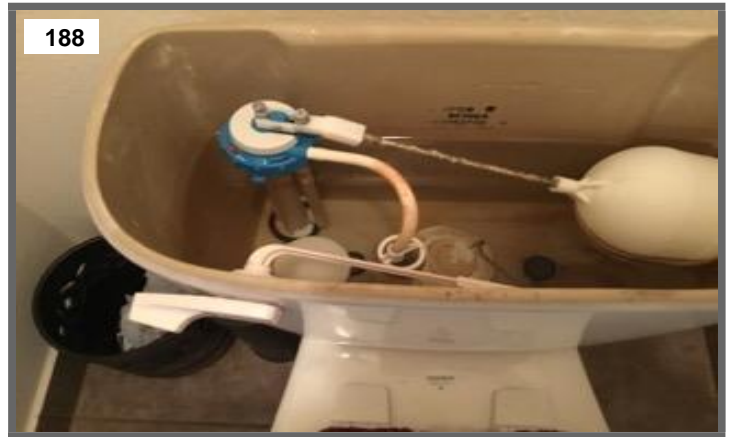
188

Master toilet

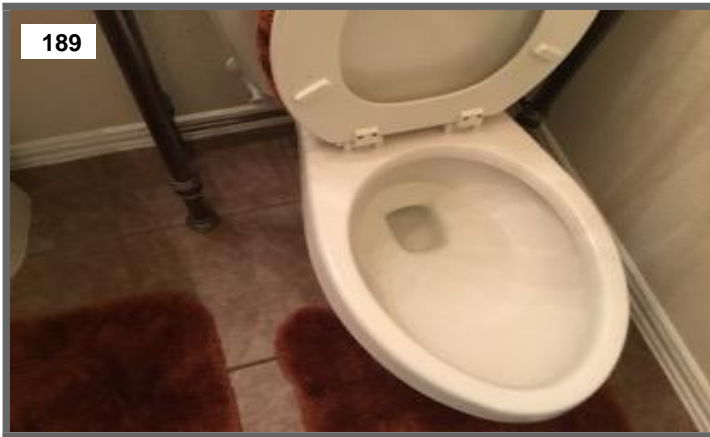
189

powder room toilet

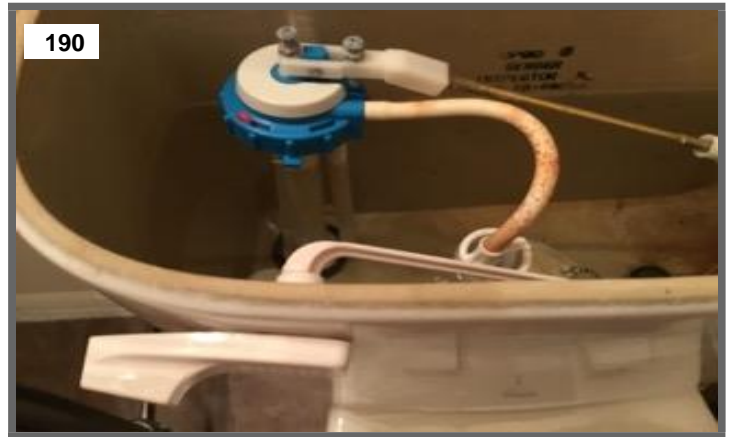
190

powder room toilet

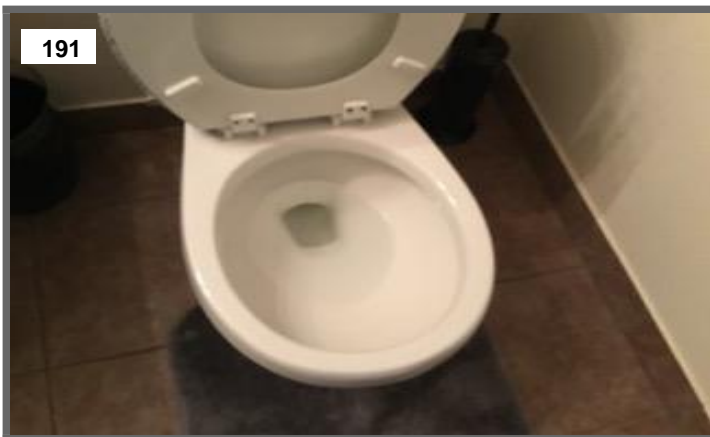
191

upstairs right toilet

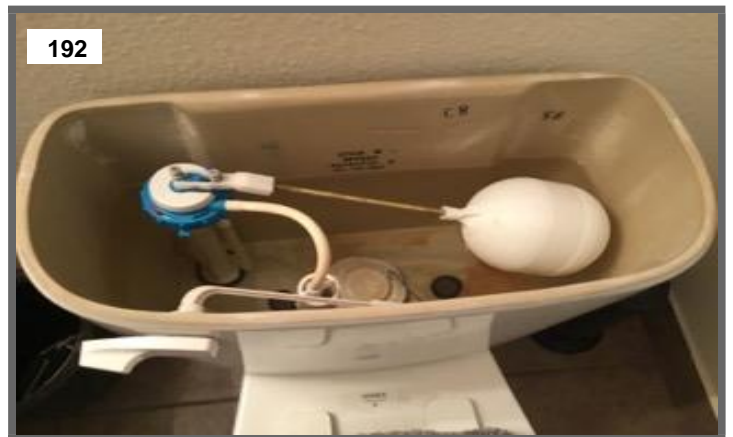
192

upstairs right toilet

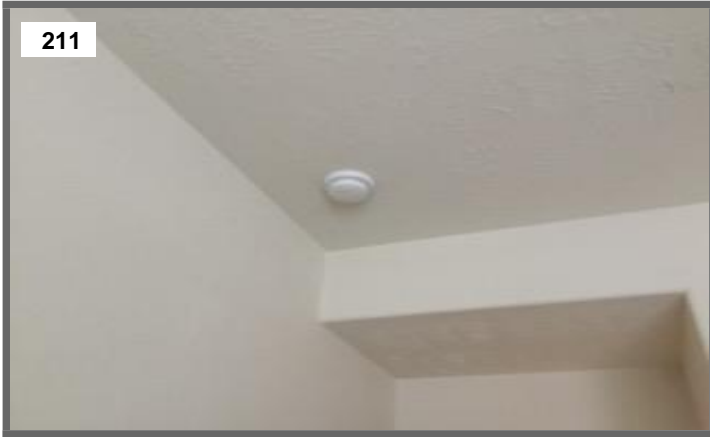
211

upstairs right

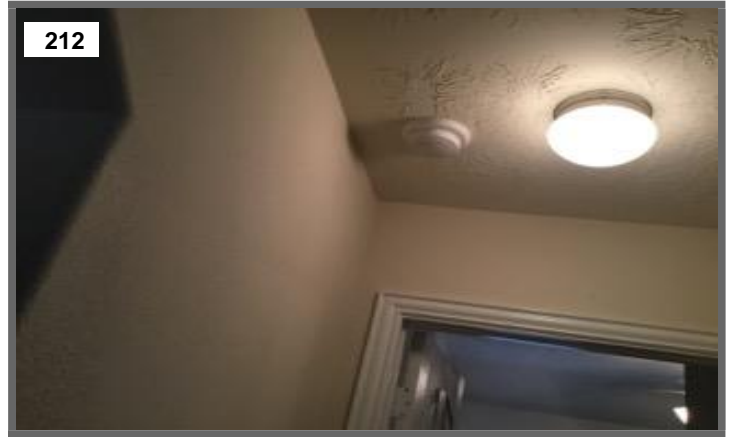
212

upstairs hallway

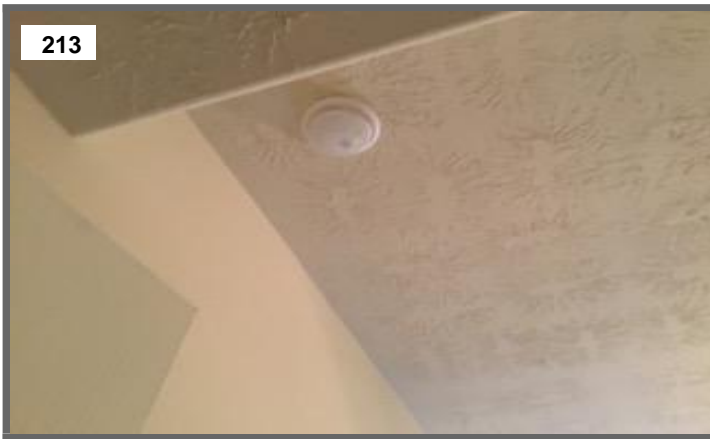
213

upstairs right rear

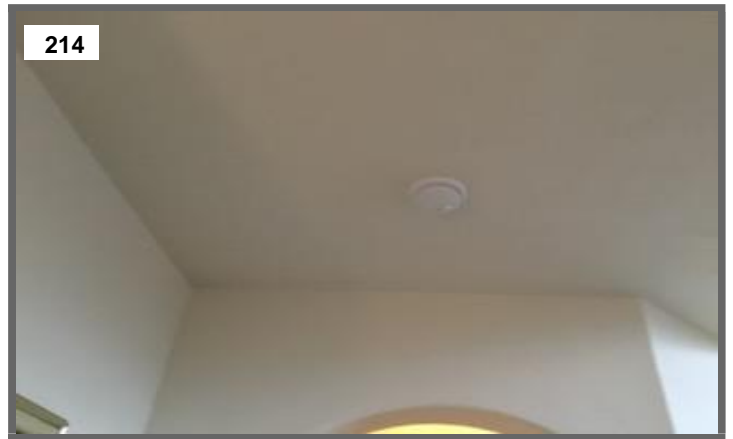
214

master hall

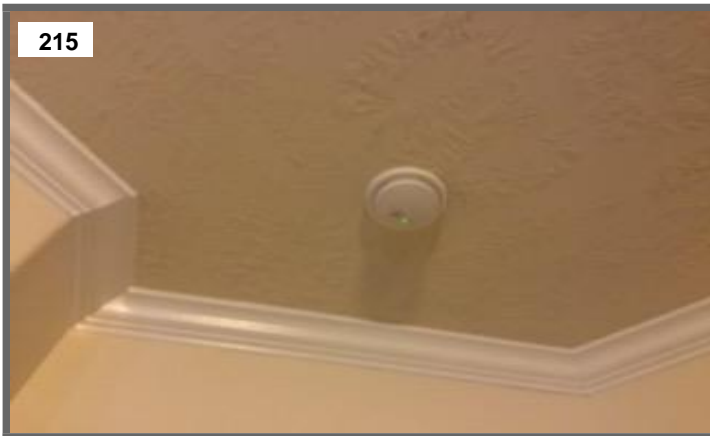
215

master bedroom

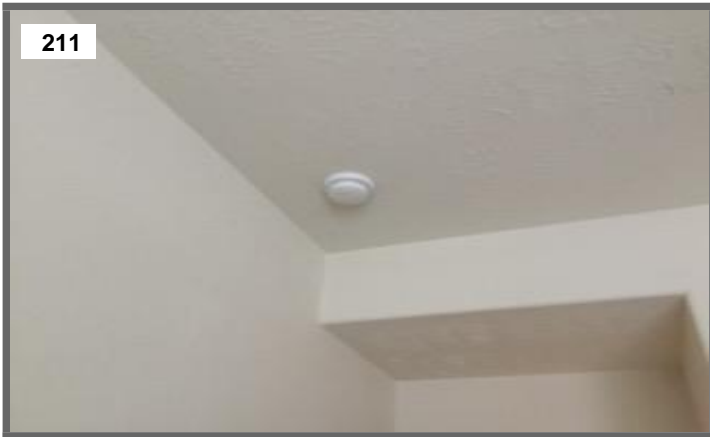
211

upstairs right

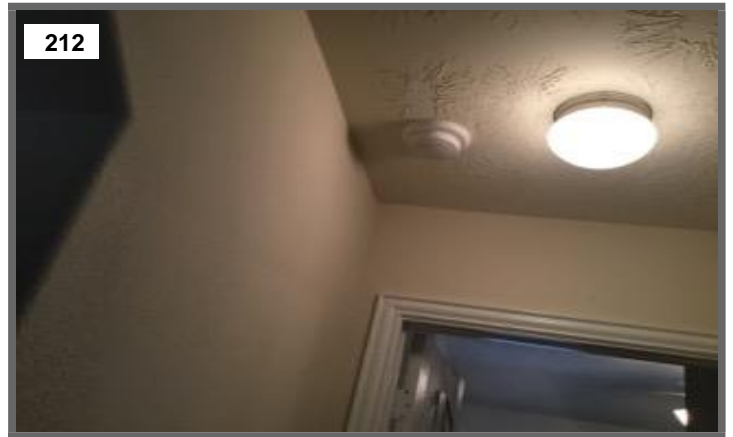
212

upstairs hallway

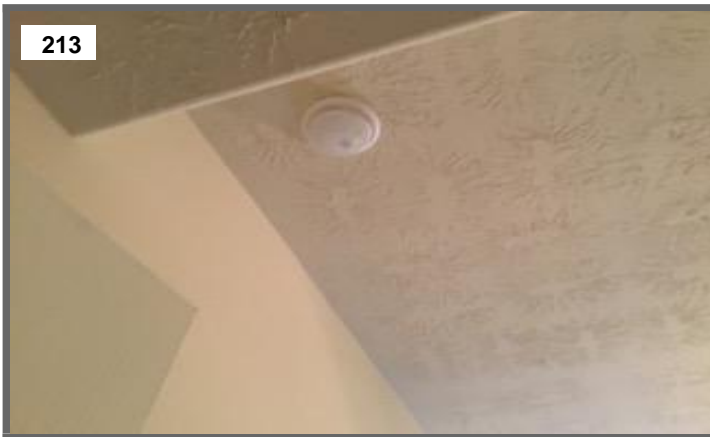
213

upstairs right rear

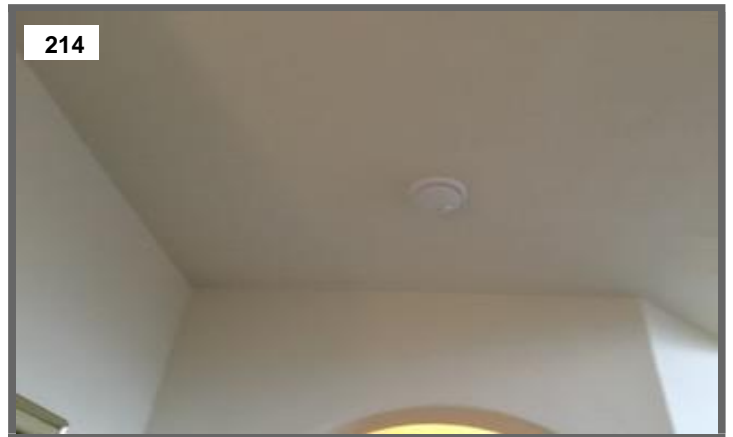
214

master hall

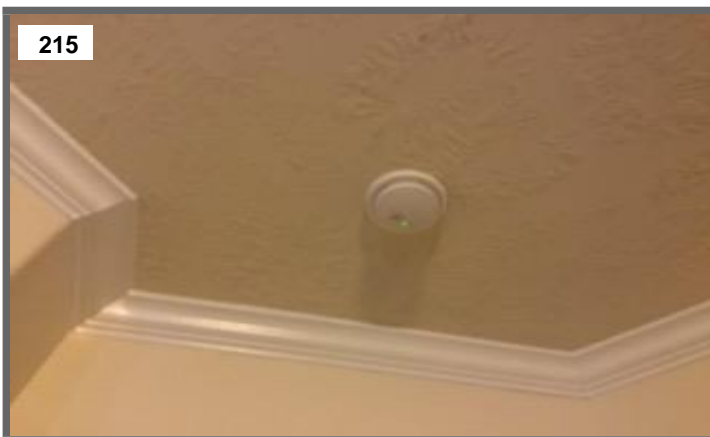
215

master bedroom

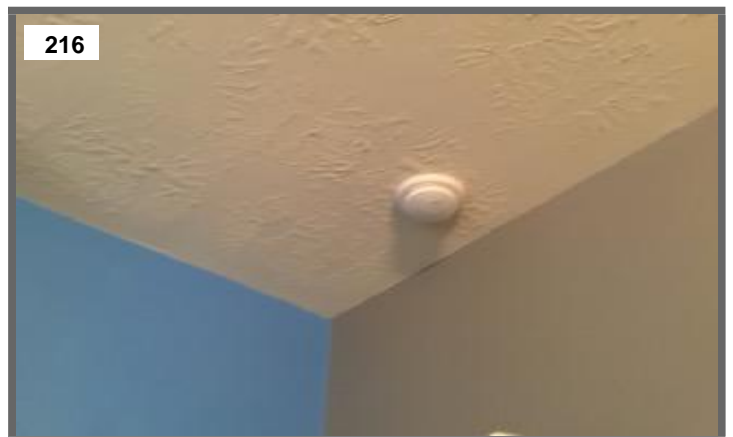
216

upstairs left
