# PROPERTY INSPECTION REPORT

**Concerning:** 7534 Rosepath Ln., Richmond, TX 77407  
(Address or Other Identification of Inspected Property)

**By:** Sam Hestand, Lic #24118 06/11/2021  
(Name and License Number of Inspector) (Date)

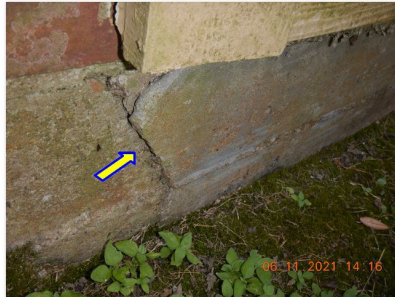
SLAB CRACKS:

A slab crack was noted on the back right addition. Continue to monitor.

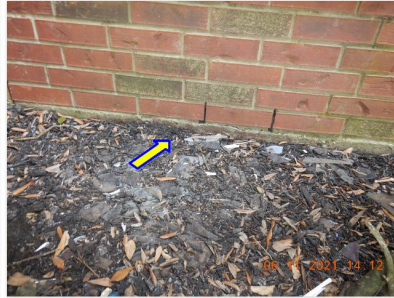
Lower mulch levels at the planting beds

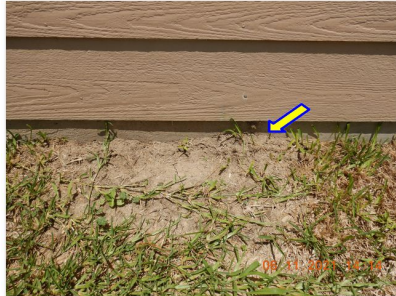
Signs of insect activity were noted at the back of the garage.

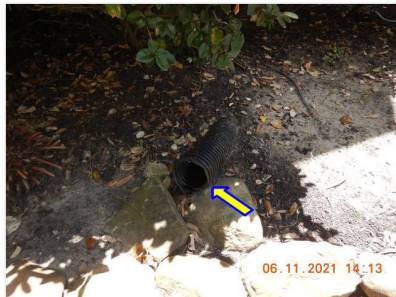
**SUBSURFACE DRAINAGE:**

The front gutter drain line is not negatively sloped so water is not draining out of it.

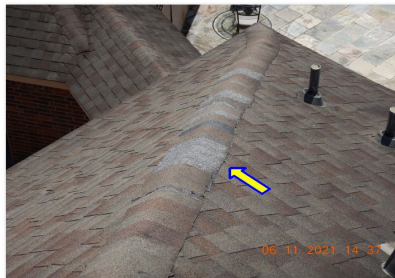
Note: Previous roof repairs were noted at the time of inspection.

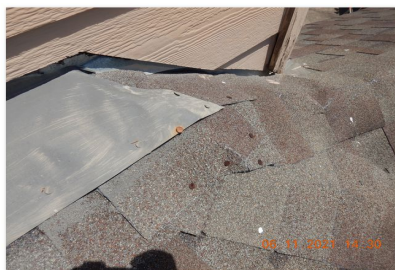
**SHINGLES:**

Nail heads are exposed at the flashing and/or composition shingle.

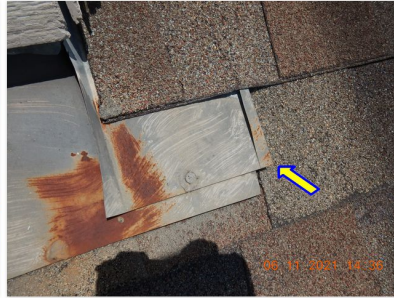
J flashing was used to seal the junctions between the roof's surface and the side walls. Step flashign should have been installed.

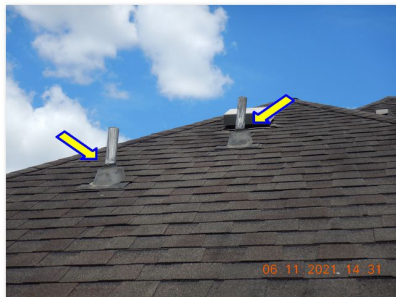
The house is old enough to require the boot jacks to be re caulked due to deterioration at the seal or possibly changed.

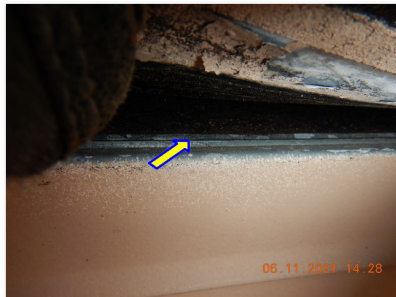
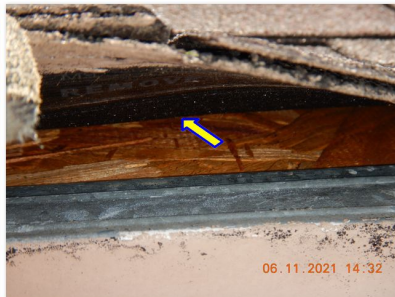
**DRIP EDGE FLASHING**

The roofing felt did not extend to the rakes or bottom of the roof deck in all of the areas that were inspected.

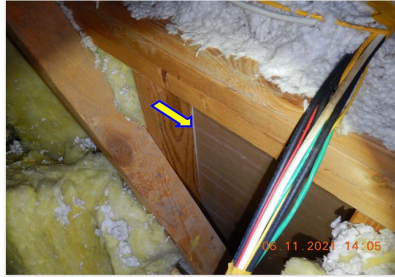
Some of the batt insulation has fallen out of place, is missing, lacking, or does not fit correctly against the vertical wall in the attic. Netting or straps should be used to hold the insulation in place.

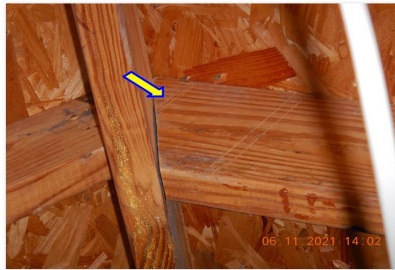
Rafters were secured to the ridge board with 0 nails on one side, versus the appropriate number on one side, the appropriate number on the other.

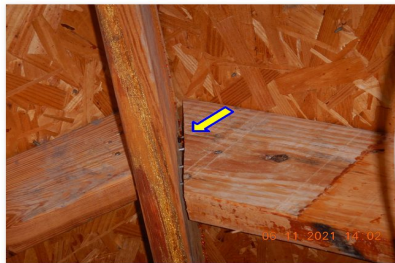
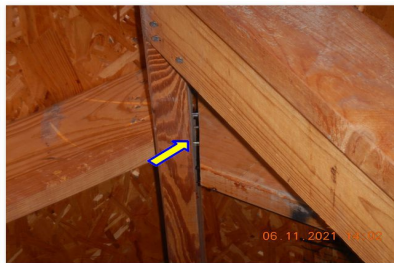
Rafters cuts not flush at the ridge, hip and or valley boards in the attic.

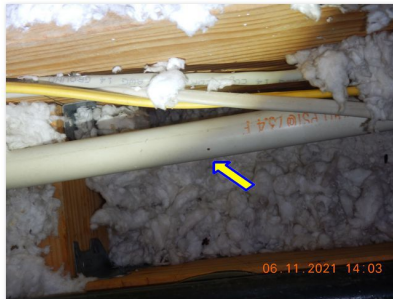
Insulation is missing on the condensate drain line and/or water lines in the attic. The water and drain lines should be completely insulated in the attic.

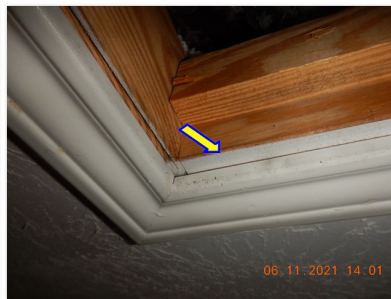
Disappearing attic access ladder is not installed with a weather strip at the ceiling.

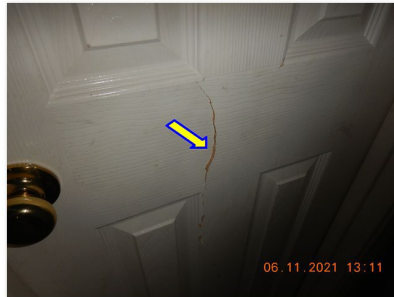
- Door damaged at the following locations: Back right addition closet.

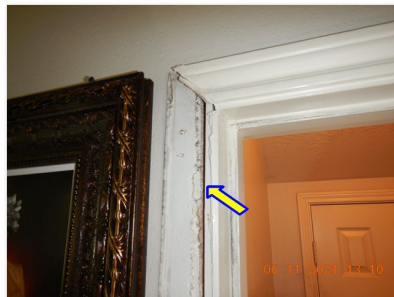
- Door trim is missing at the master bedroom.

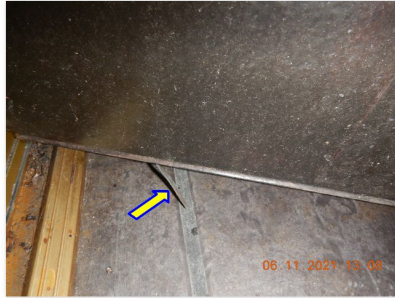
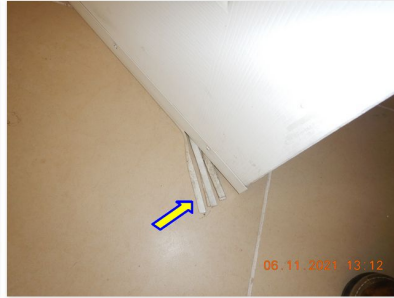
Weather strip damaged was noted. Some Examples: Back addition, Front door.

Weather strip not sealing properly, light visible around the door. Some Examples: Garage entry door.

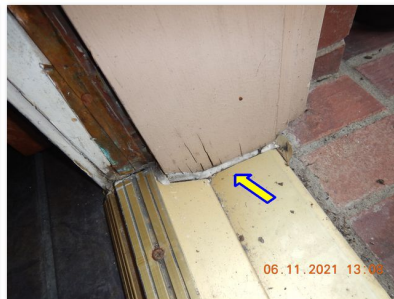
Caulking around the door missing or deteriorated was noted. Some Examples: Garage entry, Back door, Front entry door, Back addition door.

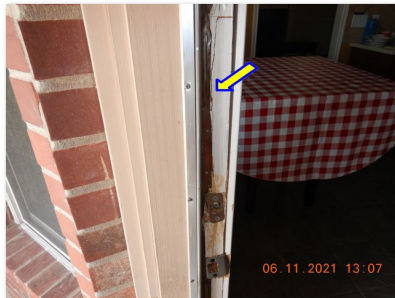
Door and/or door jam casing deteriorated from weathering. Some Examples: Garage entry, Back left addition.

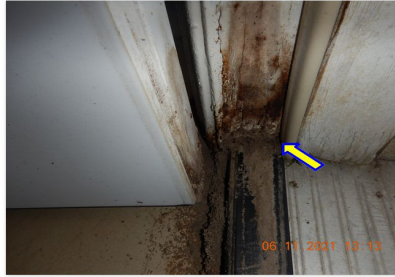
Insect activity was noted at the back left addition door.

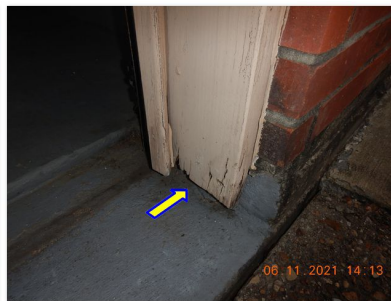
Garage door jambs deteriorated from weathering.

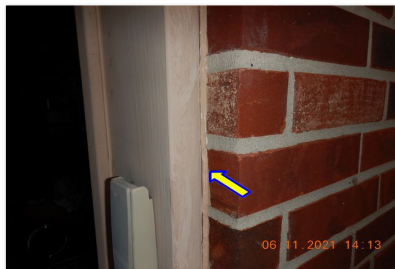
Caulking is deteriorated at the garage door trim.

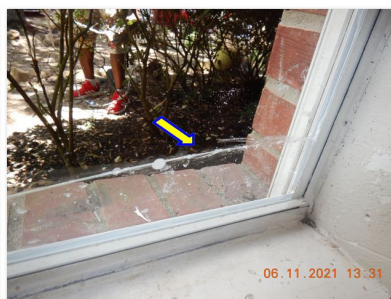
Broken windows observed at the following locations: Master bathroom.

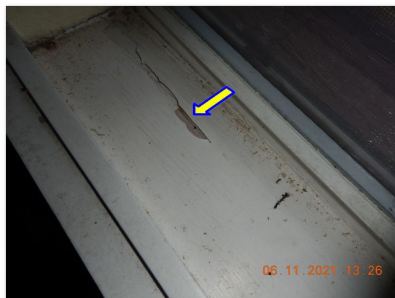
Signs of moisture staining on the window sills were present on the windows at the time of the inspection. Location: 2nd floor back right bedroom.

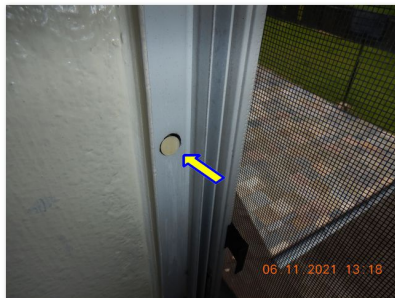
Alarm holes in the sills were present on/in the windows at the time of the inspection. The alarm holes should be re-caulked.

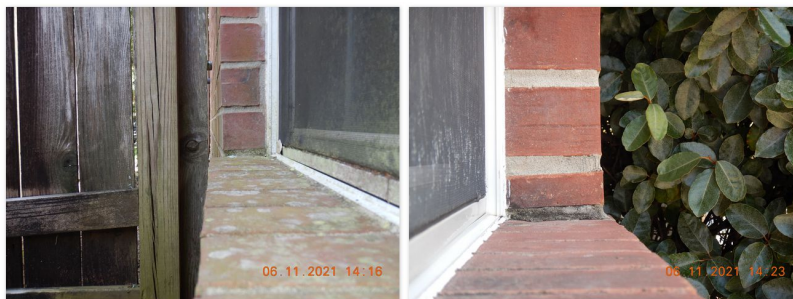
Window brick ledges are not properly sloped to shed water. The brick ledge should be installed with a 3/4" slope or at least a 15 degree angle.

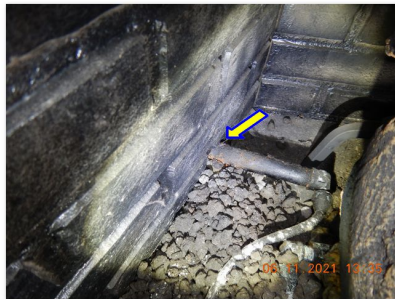
The area where the gas line enters the fireplace should be sealed.

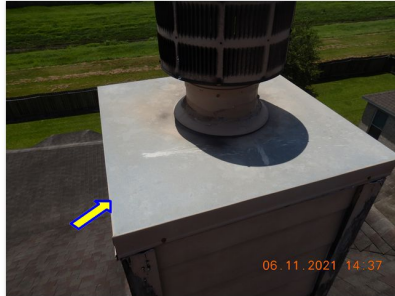
The chimney cap should be painted to prevent further rust/deterioration.

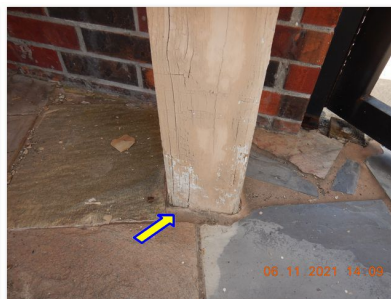
Base of the columns are in direct contact with the flatwork. These can deteriorate over time due to water accumulating around them.

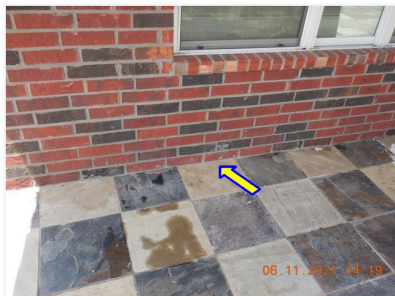
Weep holes are missing at the back patio brick work.

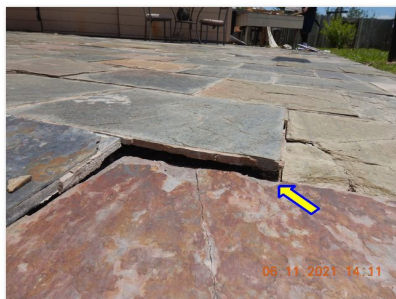
Loose and cracked floor tiles were noted at the back patio.

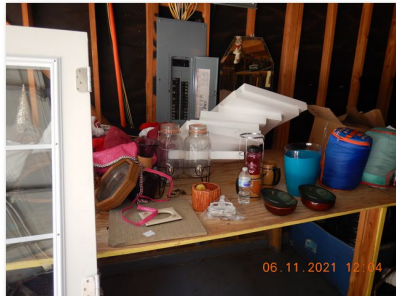
The service equipment disconnecting means panel board enclosure is not installed with proper clearance. A 30" wide and 36" deep area should be free of obstructions at the front of the panel board enclosure. The interior of the panel could not be inspected due to this.

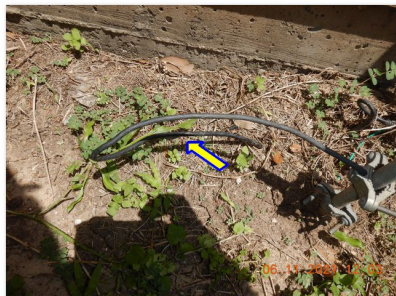
The grounding electrode conductor connected to the grounding electrode is not protected from physical damage.

Two means of grounding are required for the service equipment for residential structures. A second means of grounding should be installed. The presence of a proper grounding electrode system should be verified by a licensed electrician or a proper grounding electrode system should be installed for safety.

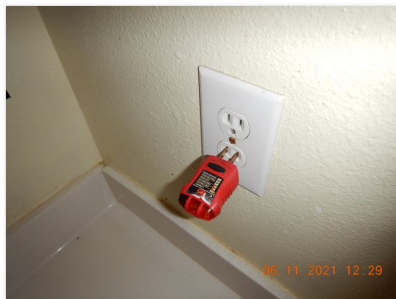
☑ Note: The 2nd floor right front bathroom outlet could not be tested and appears to be clogged with something.

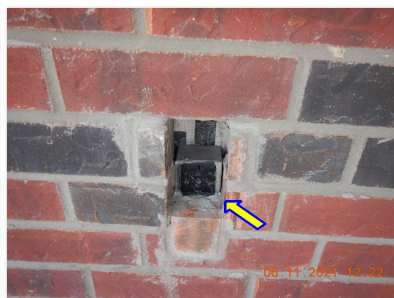
☑ Receptacle cover plates observed missing at the following locations: Back right addition closet, Back patio, Garage.

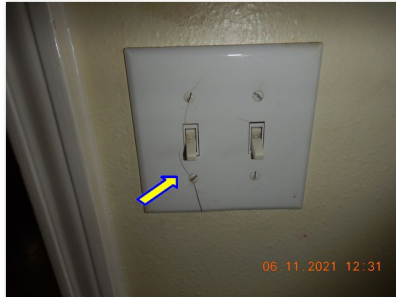
Switch cover plates observed broken at the following locations: 2nd floor back right bedroom, 2nd floor back left bedroom, 2nd floor front left bedroom, 2nd floor left bathroom.

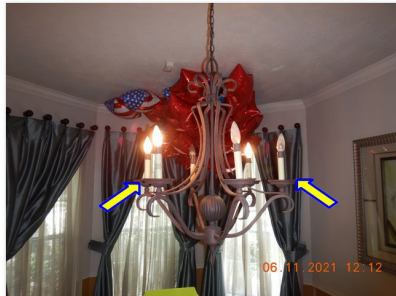
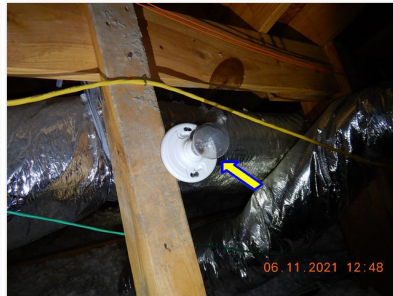
Light fixture globes missing at the following locations: Attic, Formal dining room, Entry way, Garage.

Light inoperable, possible bulb, at the following locations: Attic, Kitchen, Breakfast area, Formal dining room, Master bathroom, Back right addition closet, Back patio, 2nd floor right bathroom, 2nd floor left hallway.

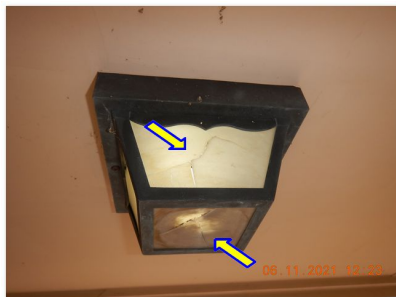
The back patio light cover is damaged.

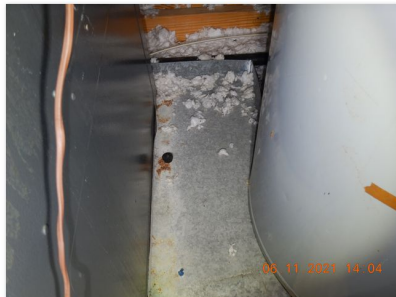
Insulation/debris observed at the A/C auxiliary condensate drain pan.

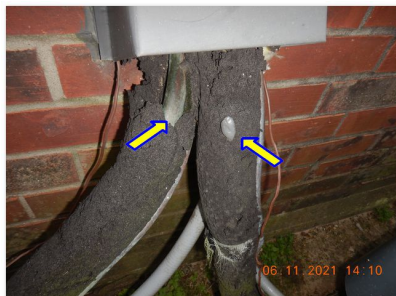
Insulation is missing or deteriorated on the A/C suction line at the condensing unit.

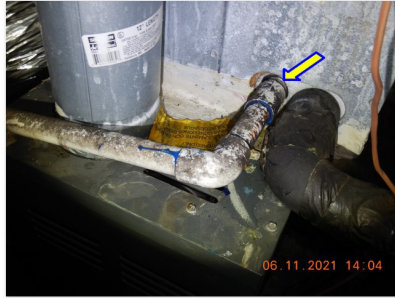
- Organic growth was noted at the drain line of one of the units in the attic.
- Condensate line termination point(s) was not determined in the attic. It's recommended the condensate line (s) be inspected, treated (chlorine tabs put in drain lines) to avoid possible backups in the wall and ceiling.

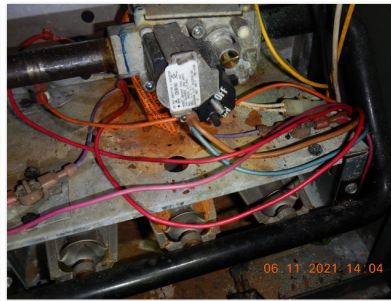
- One of the HVAC covers was removed at the time of inspection. Rust was noted at various locations on the equipment.
- HVAC systems should be inspected and serviced by a licensed technician per manufactures recommendations or on a bi-annual basis. If unable to obtain service records from current owner, buyer should consider having units serviced by a qualified and licensed professional.

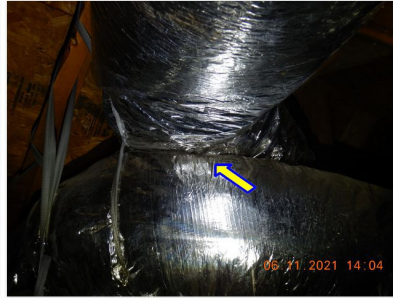
☑ Separate ductwork where touching at attic to prevent thermal bridging. Thermal bridging causes condensation to form between the duct lines and can drip into the attic.

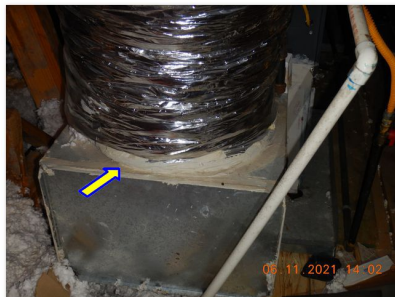
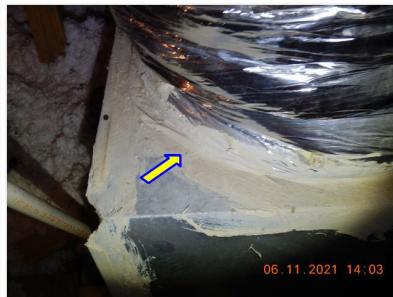
☑ Mastic is applied to the outside of the ductwork. Normally, the inner ductwork liner should be sandwiched between two layers of mastic.

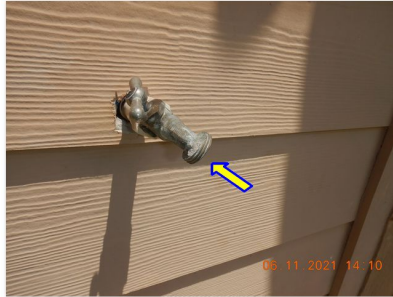
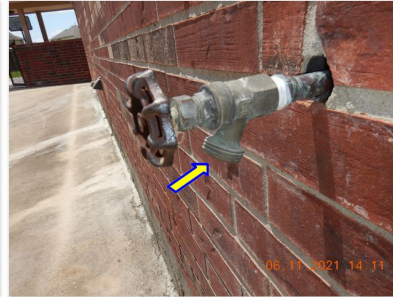
☑ Exterior hose bibs not installed with anti-siphon devices at various locations.

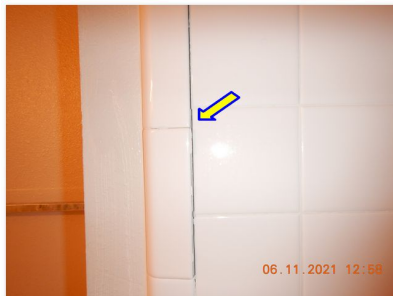
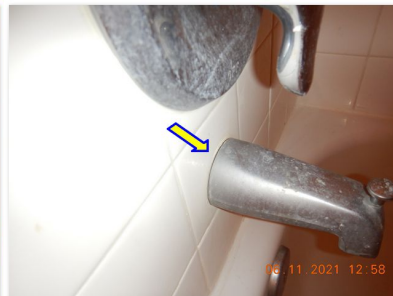
☑ Caulk and/or the bathtub and/or shower enclosures and around fixtures where missing or deteriorated at the following locations: Master bathroom, 2nd floor right bathroom, 2nd floor left bathroom.

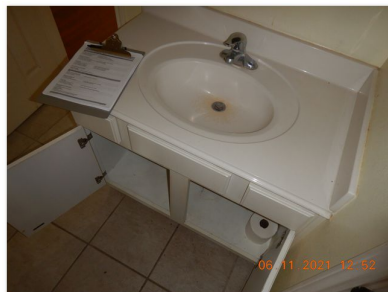
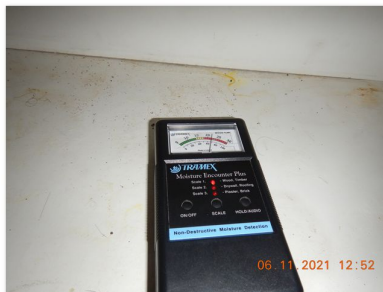
Location: 2nd floor front right bathroom.

☑ Sink cabinet area- High moisture readings were noted with the moisture meter in the tested area.

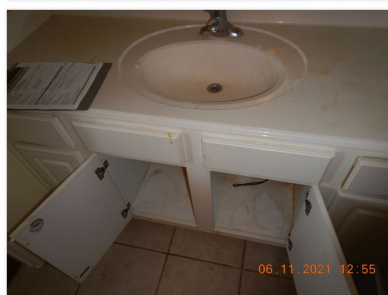
Location: 2nd floor back right bathroom.

☑ Sink cabinet area- Higher than normal (Relative reading of 14 -- 19) moisture readings were noted with the moisture meter in the tested area.

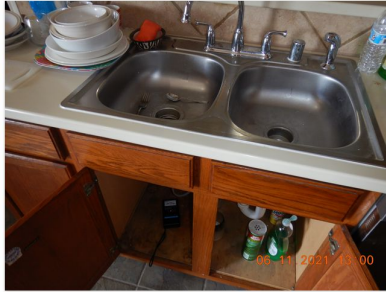
Location: Kitchen.

Sink cabinet area- High moisture readings were noted with the moisture meter in the tested area.

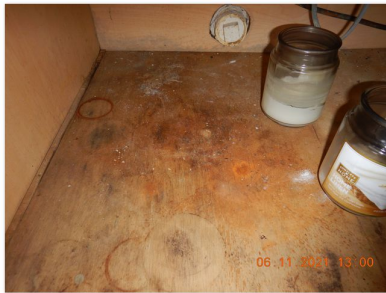
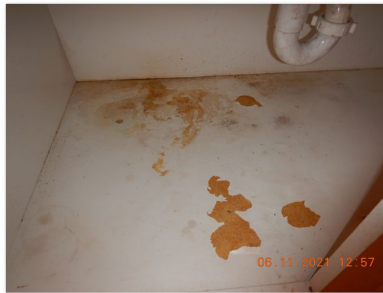
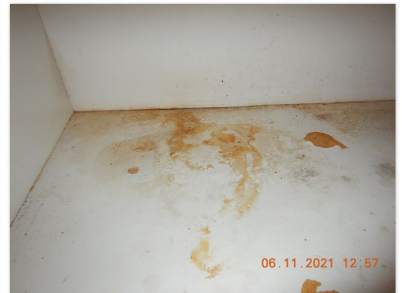
Moisture stains/damage were noted at the sink cabinets at the following locations: 2nd floor back right bathroom, 2nd floor front right bathroom, Kitchen.

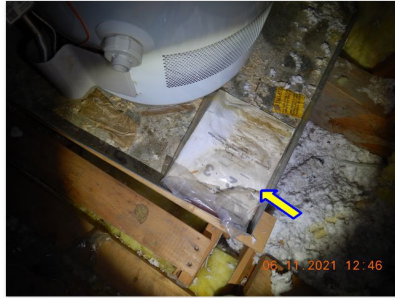
Insulation/debris observed at the water heater auxiliary drain pan.

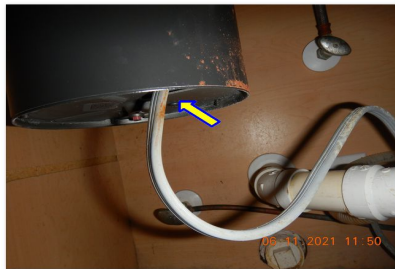
The food waste disposal whip cord is not properly secured at the clamp at the base of the food waste disposal.

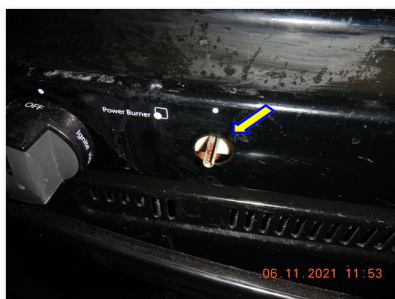
One of the cooktop burner knobs is missing:

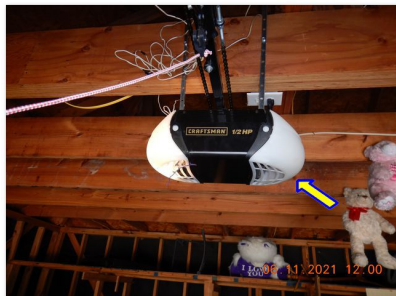
Garage door opener light is inoperable, possible bulb.

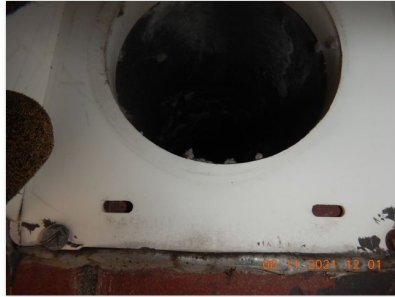
The dryer's vent should be cleaned out completely This includes the termination point of the vent system. This material is very flammable.
