Report Prepared For:
Mary Sharkey

5410 Navarro
Houston, Texas 77056
September 12, 2017

Stucco Inspection Report

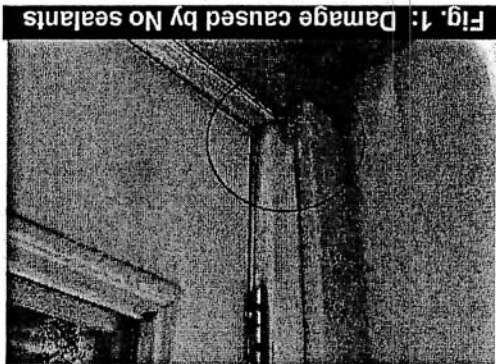
Fig. 1: Damage caused by No sealants

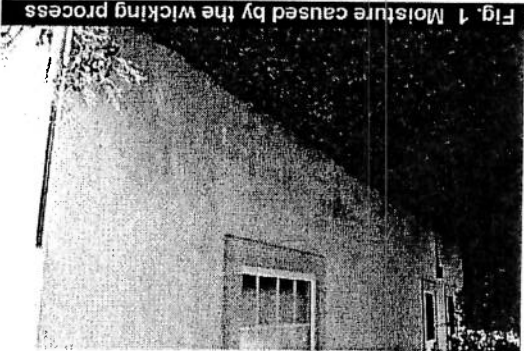
- 1) To prevent wicking, a process in which standing water is absorbed by the EPS foam board, which leads to mold and mildew behind EIFS. Figure 1 shows an example of a home where the stucco system was not backwrapped and extended below grade. Water wicked up behind the stucco, causing mold, mildew and decay of the underlying sheathing. Wicking can also occur when stucco is terminated at grade level as seen in Figure 4.

Fig. 1 Moisture caused by the wicking process

One way this problem can be resolved by cutting the stucco eight inches above grade and adding a PVC accessory trim to "lock" the EPS board in place (Figure 2). The PVC accessory trim is an optional item that looks nice and eliminates the need for backwrapping the EIFS. The trim is then sealed with a high-quality sealant. Finally, a textured coat is applied to the bare foundation wall and colored to match the existing EIFS. The pictures below show a cutback with accessory trim. Once landscaping is in place, the modification is hardly noticeable (Figure 3).

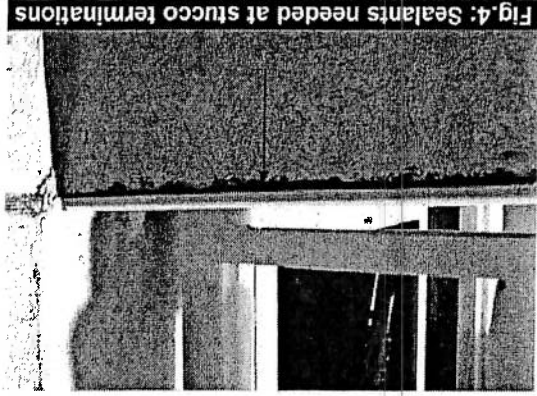
Fig. 4: Sealants needed at stucco terminations

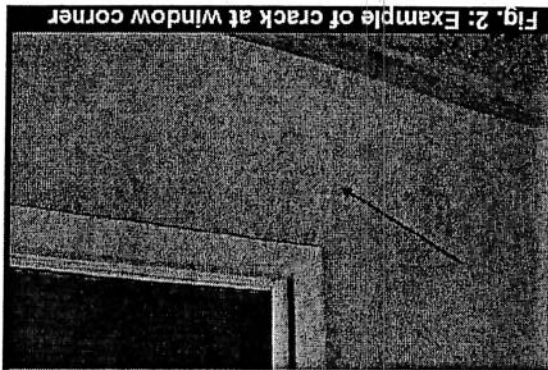
Fig. 2: Example of crack at window corner

The most common areas that experience cracking in EIFS are at the corners of windows or roof terminations as seen in Figures 2 and 3. To prevent cracking in this area, most manufacturer and EIMA details specify that an additional layer of reinforcement mesh be applied diagonally at the corners of all windows, doors and other openings. This is called "butterfly" mesh.

It does not take a very big crack to allow water intrusion. In fact, a crack as small as 1/16" of an inch wide can permit water to enter behind the stucco, especially with a stucco system that has no moisture barrier. All cracks 1/16" wide or larger and all damaged areas of stucco should be properly repaired as per manufacturers guidelines. Many times the patched areas will still be slightly noticeable even with a good repair application. Extreme cracking will sometimes require the reapplication of EIFS base, mesh, and finish to prevent more cracking and provide a consistent appearance. Cracking is common in hard coat stucco systems, therefore expansion joints are called for every 144 sq. ft. as well as between floorlines and extending vertically from window and door corners to help control cracking.

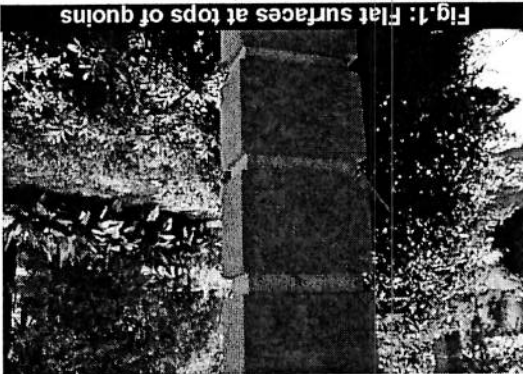
Flat stucco surfaces, whether conventional hard coat stucco or EIFS, collect and hold water in its rough texture, softening the finish coat, damaging the system and promoting leaks, mildew and discoloration. A good EIFS design will call for bands, quoins, and other accents to have a slope to prevent water accumulation.

Fig. 1: Flat surfaces at tops of quoins

The easiest corrective measure would be to coat all flat surfaces with an elastomeric waterproofing coating tinted to match the existing stucco color as closely as possible. Large flat areas, such as a parapet wall, can be capped with metal and sealed.

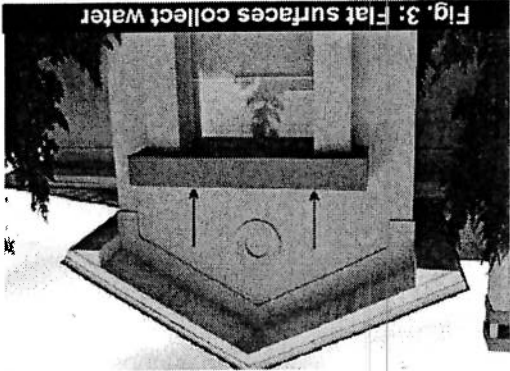
Fig. 3: Flat surfaces collect water

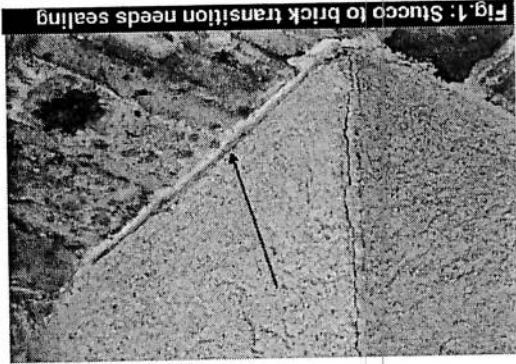
Different materials expand and contract at different rates. This expansion and contraction causes a crack or gap to form where the two materials join.

If left unsealed, or if sealed improperly, this area will allow water to enter the wall cavity. Examples of this would include stucco to wood trim, stucco to brick (Figure 1), stucco to stone (see Figure 2), stucco to concrete, etc. All areas such as these should be sealed with quality sealants and appropriate bond breakers.
