## **Property Inspection Report**

**27815 Dewy Meadow Run Ct., Spring, TX, 77386**

INSPECTION PREPARED FOR: James Andrew Marr  
AGENT: Woody Marr - Team Marr Coldwell Banker  
Date of Inspection: 7/17/2020

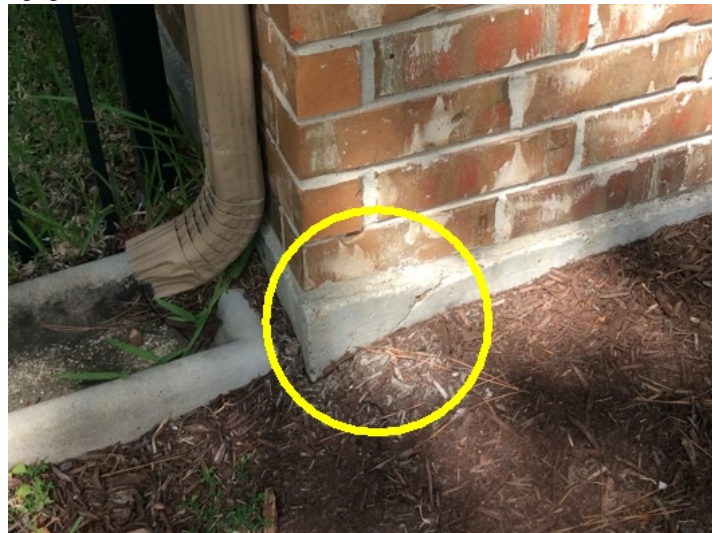
- All components were found to be performing and in satisfactory condition at the time of the inspection
- **Perimeter foundation corner spalling, or "corner pops" are typically caused by uneven curing and even carelessness during the construction phase. Usually these corners have no negative effect on the integrity of the foundation, and only has an aesthetic effect.**

*Corner pop*

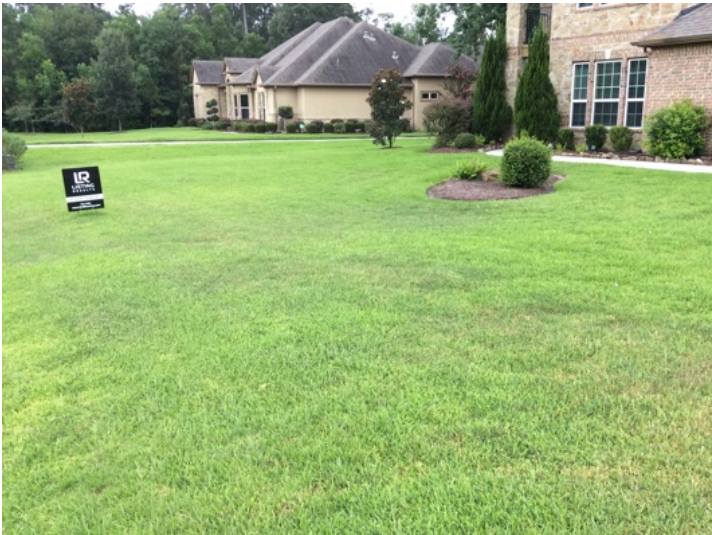
The home site appears level

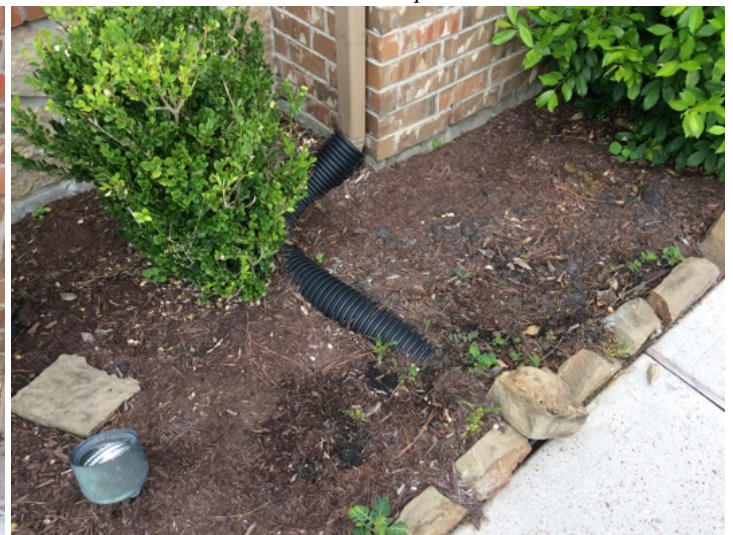
The gutter drainage system is tied into an underground drain system

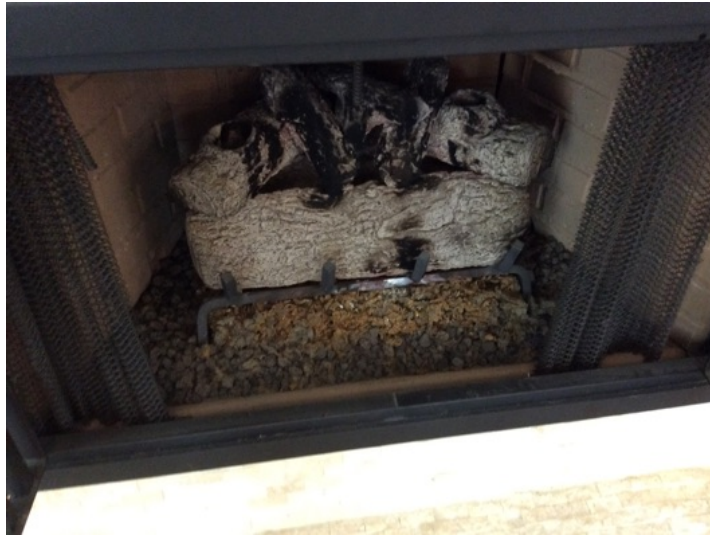
- This fireplace unit appears to be a remote operated fireplace, and the remote device could not be found.

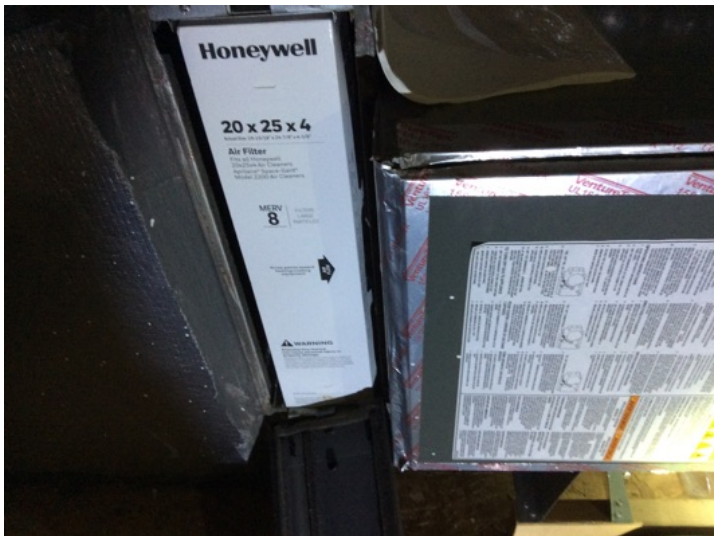
- The filter in both units in the attic are high efficiency filters. 20" x 25" x 4" Honeywell
- The AC ductwork appears to be professionally installed with the proper support as prescribed by current practices.

*High efficiency filter*

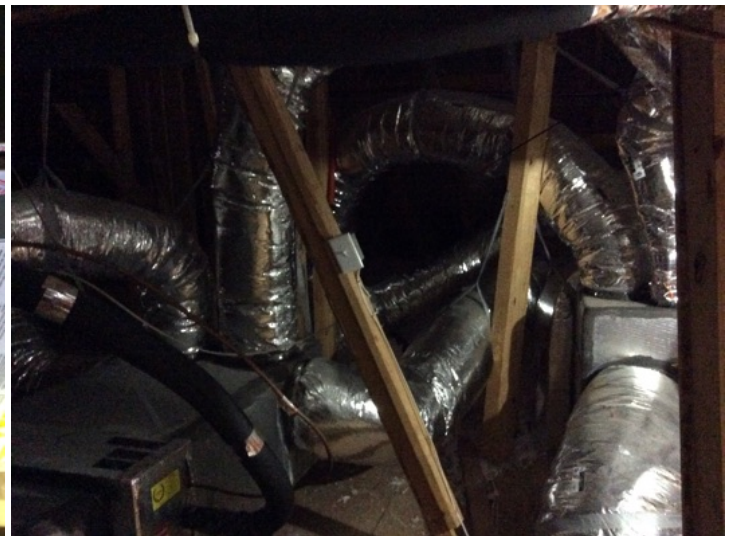
*Ductwork*

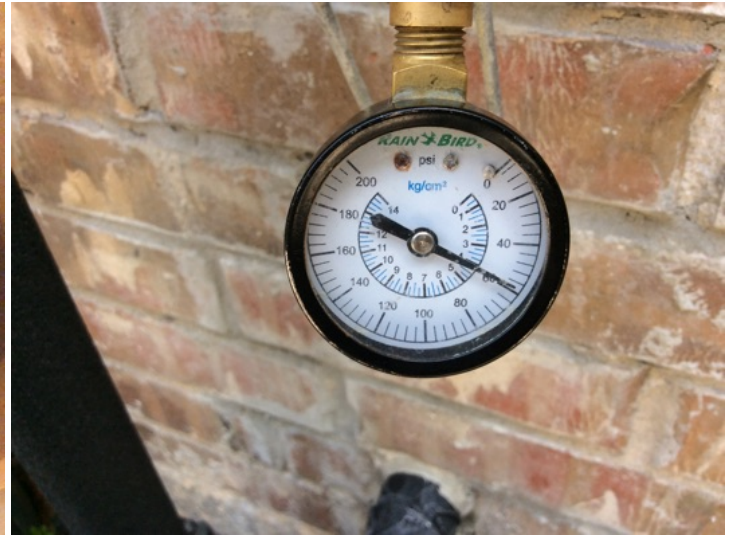
*Static water pressure from a public water source is 60 pounds PSI*

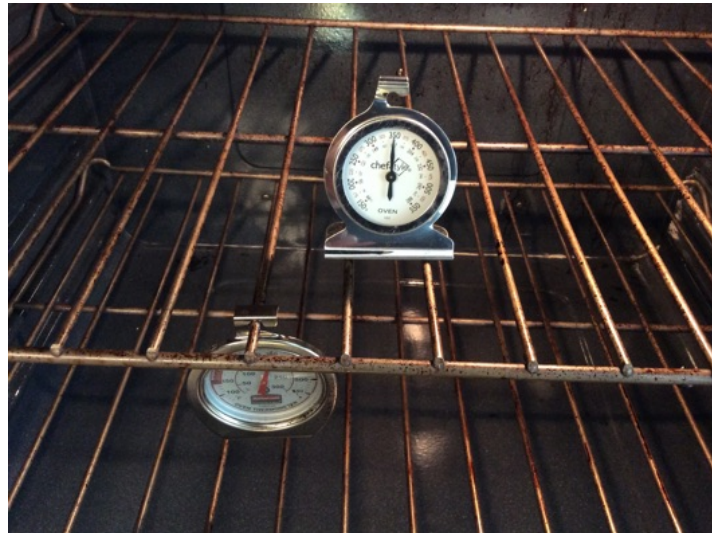
Oven heated to 350° when set at 350°

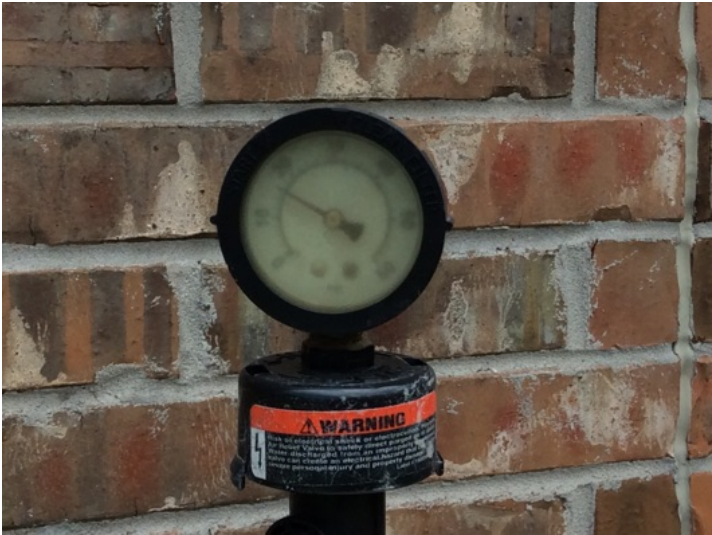
*Operating pressure of the cartridge filter for the pool equipment is approximately 15 pounds PSI*

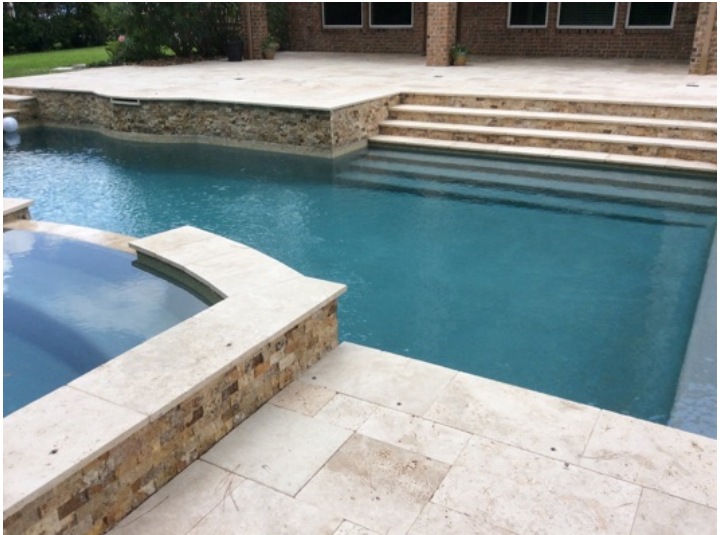
*Pool, deck, and coping all appears in good condition*
