PROPERTY INSPECTION REPORT

Concerning: 6646 Miller Shadow Ln, Missouri City, TX 77459
(Address or Other Identification of Inspected Property)

By: Michael Holguin, Lic #3752 ICC #5116880 09/04/2019
(Name and License Number of Inspector) (Date)

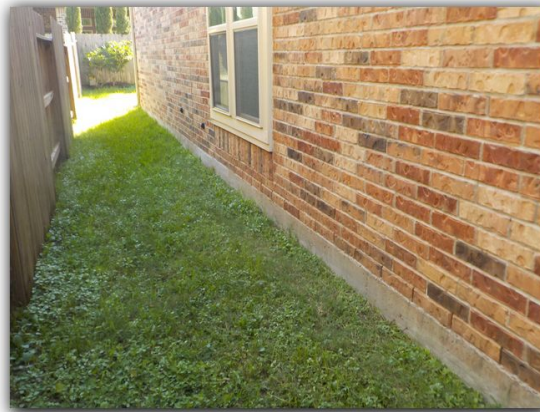
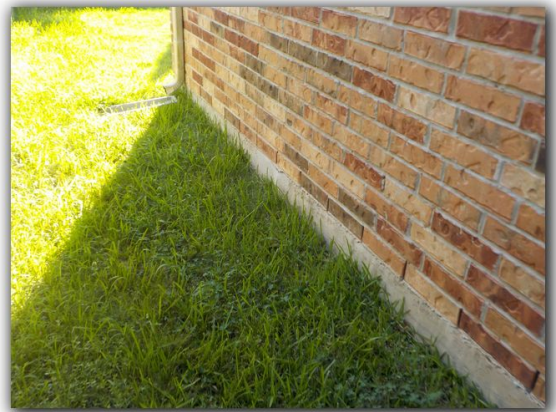
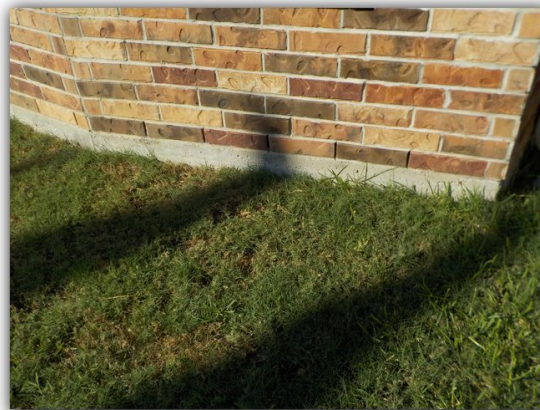
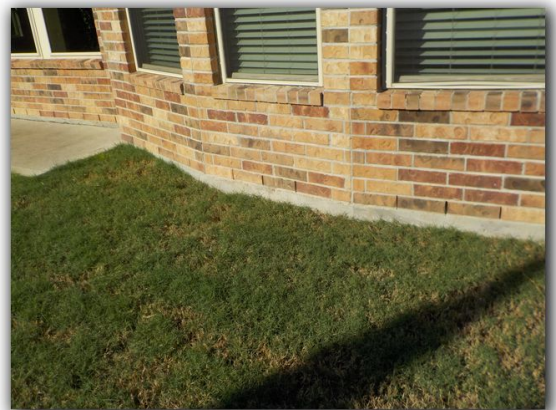
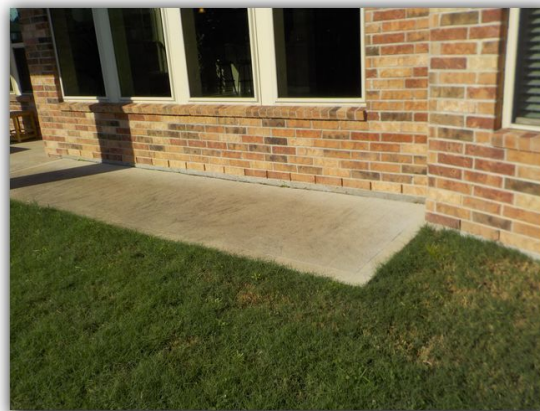
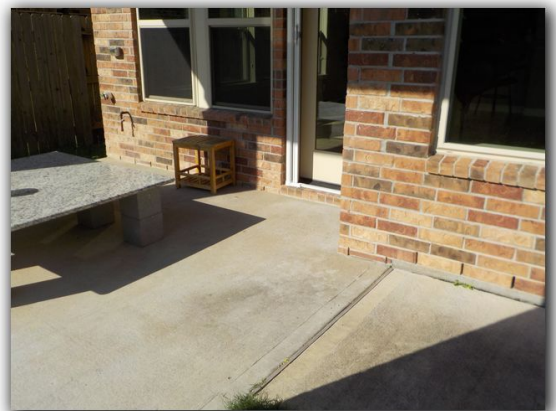
A. Foundations

Comments: Performing as intended.

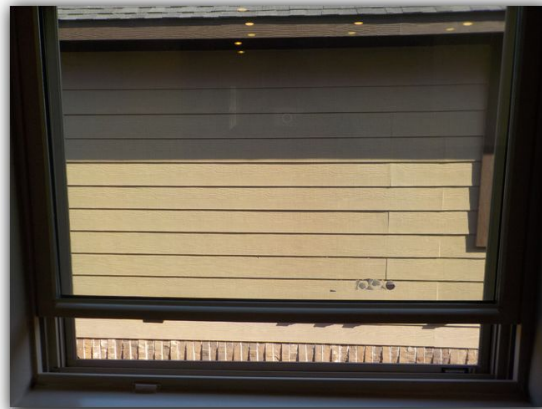
Comments: The left game room window is jamming.

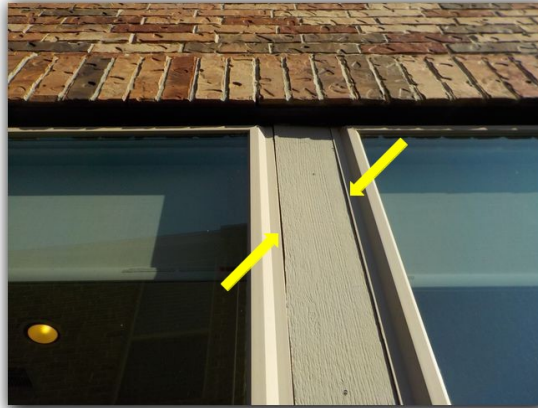
The exterior window frames caulk needs maintenance.

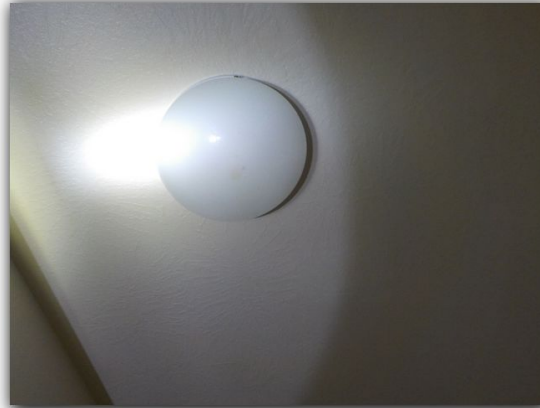
Comments: The upstairs right middle room closet light is inoperative. The master bath has burned out bulbs.

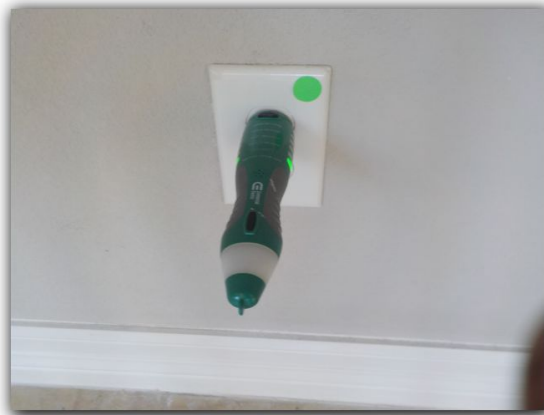
The right kitchen side receptacle serving the counter top should have GFCI protection.

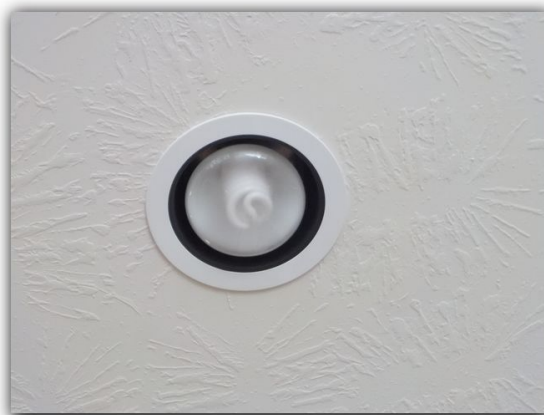
The kitchen has a light out.

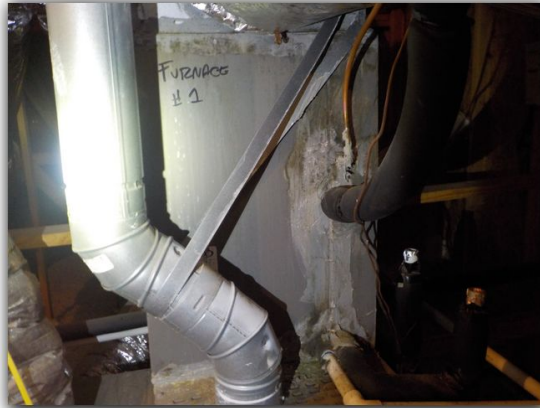
Comments: The right evaporator suction line insulation should be butted up to the cabinet to prevent condensation from dripping and causing a rusting condition.

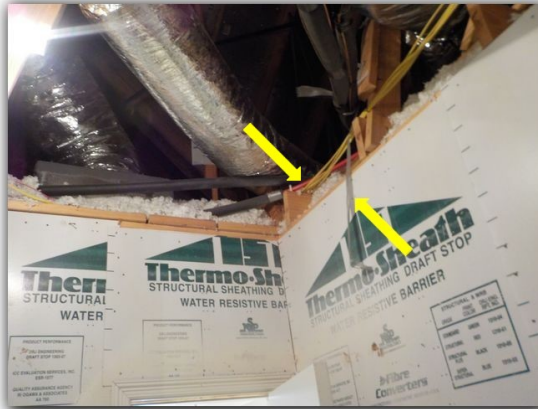
One evaporator suction line support strap is broken at the HVAC side attic.

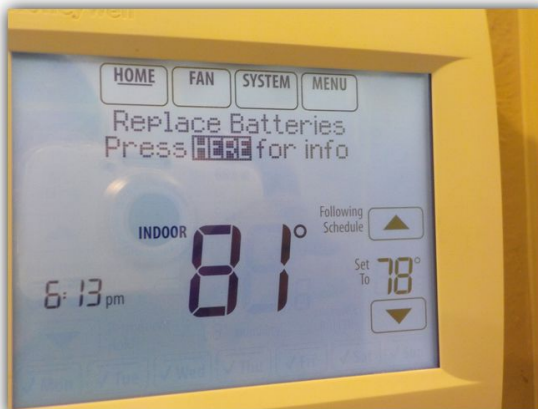
The upstairs thermostat has a low battery charge.

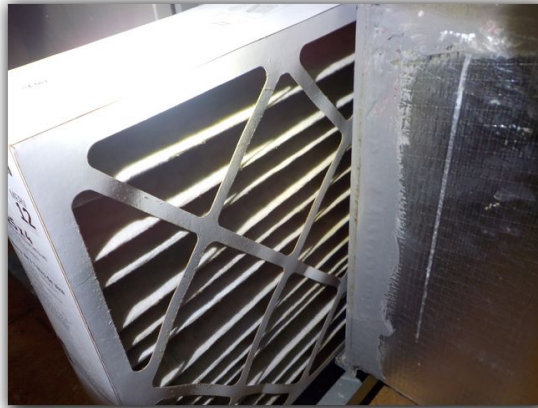
Comments: The dirty media filters should be replaced which should improve the cooling temperature differential.

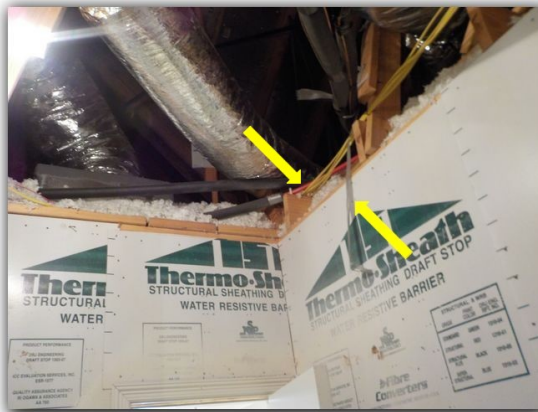
Comments: The exposed water line at the HVAC side attic should be insulated. There is a water pressure drop when all the fixtures are operating even though the water pressure drop is not visible to the eye from 64# to 35#. Consult a licensed plumber.

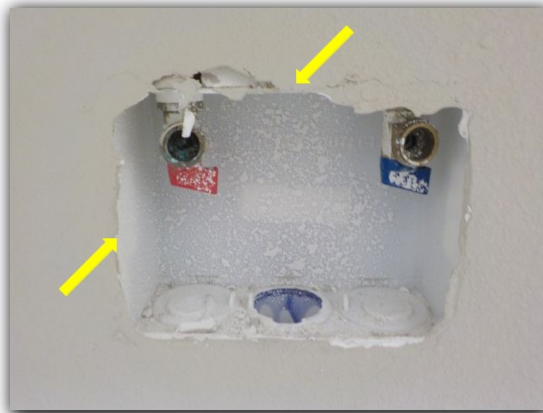
The laundry bibs should have a plastic trim.

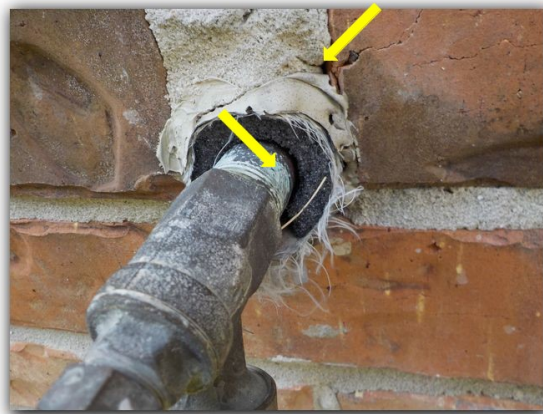
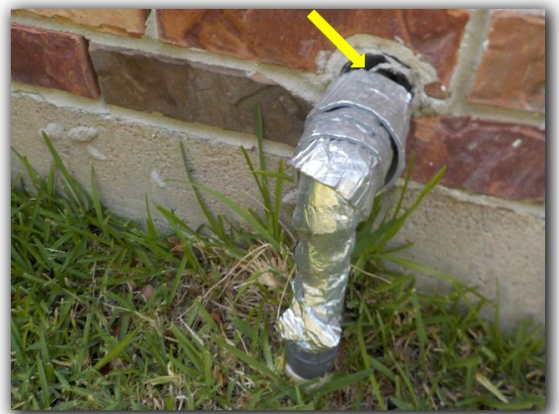
Wall piping penetrations should be sealed off.

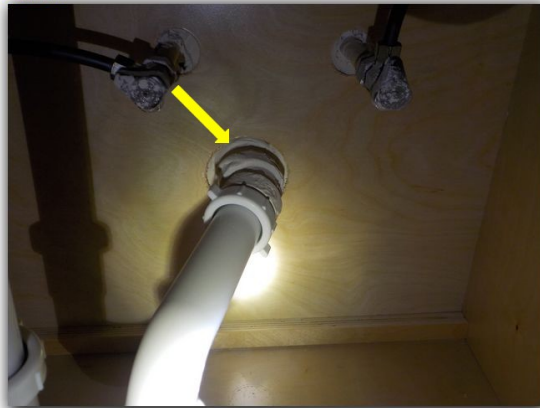
sealed off

Comments: The annual drain line space under the left master bath lavatory should be sealed off.

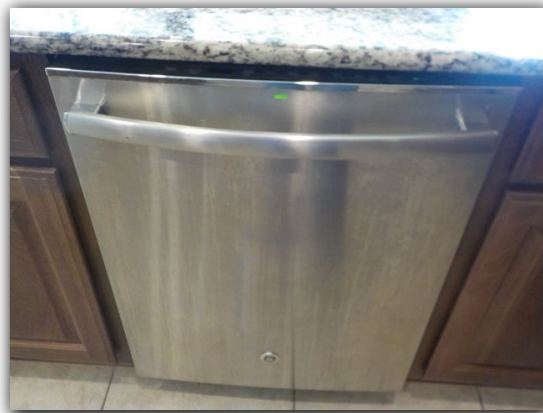
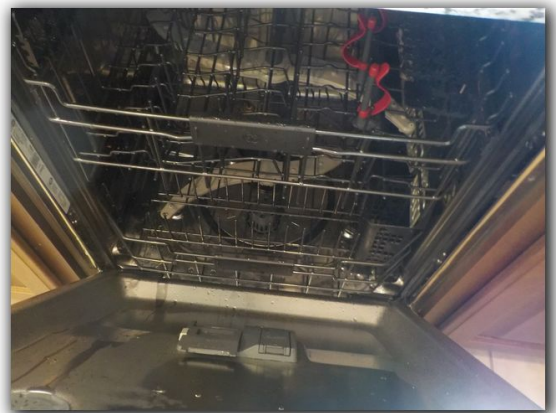
A. Dishwashers

Comments: Performing as intended.

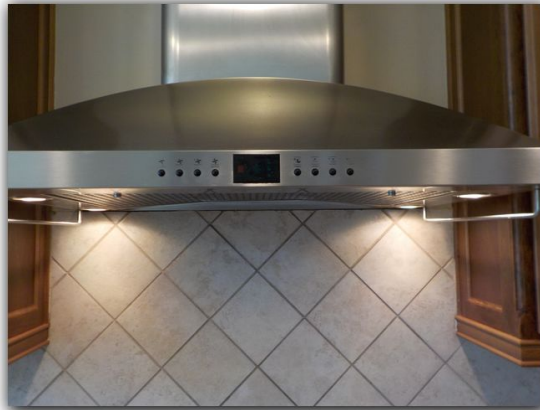
C. Range Hood and Exhaust Systems

Comments: Performing as intended.

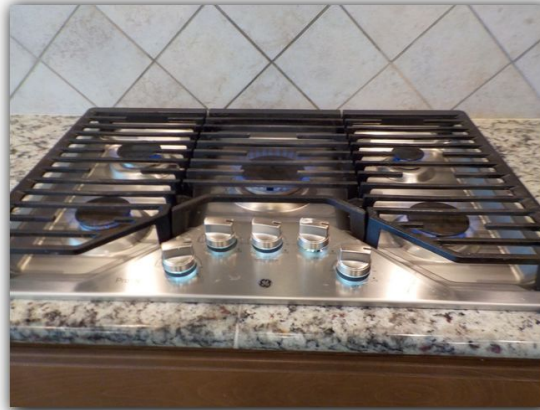
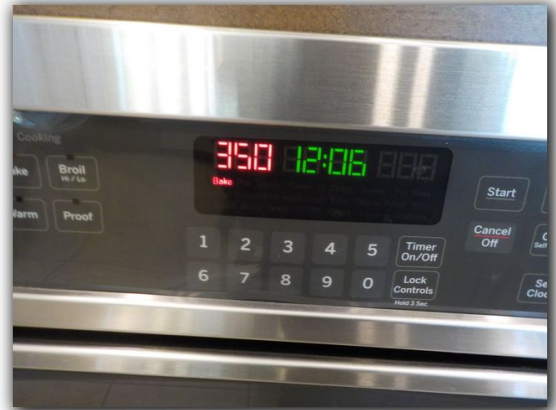
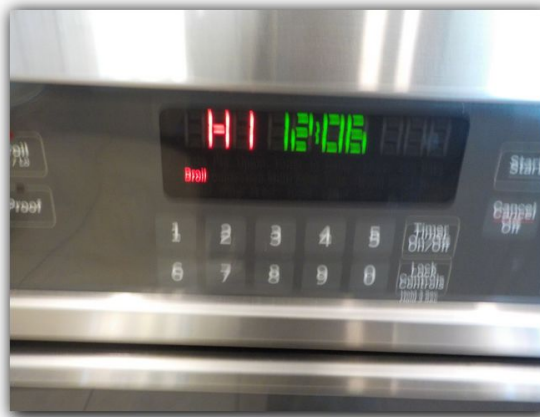
D. Ranges, Cooktops, and Ovens

Comments: Performing as intended.

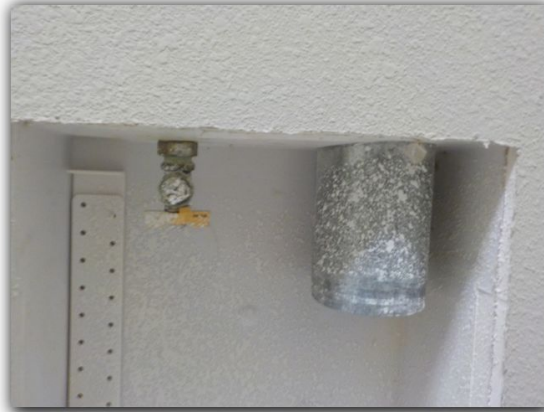
H. Dryer Exhaust Systems

Comments: Performing as intended.
