Property Inspection Report

PROPERTY INSPECTION REPORT

Concerning: 7911 Deaton Dr., Humble, TX 77346
(Address or Other Identification of Inspected Property)

By: Larry Fleming, Lic #4860 08/09/2019
(Name and License Number of Inspector) (Date)

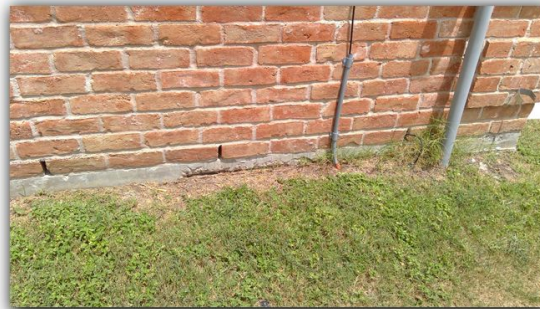
- Exposed rebar observed at the slab foundation. Parging is recommended to keep the exposed rebar from rusting.

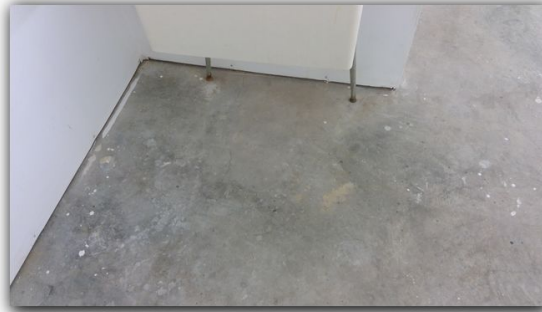
Cracks observed in exposed garage concrete floors at one or more locations.

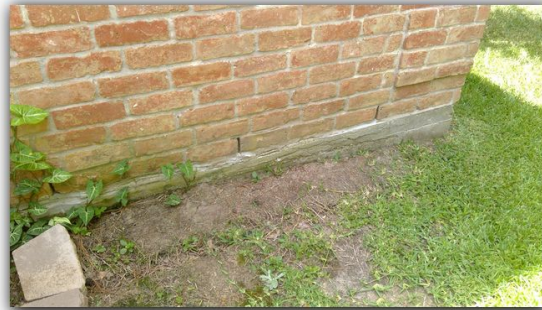
Horizontal cracks observed in the side of the slab concrete surfaces at the rear corners of the slab foundation.

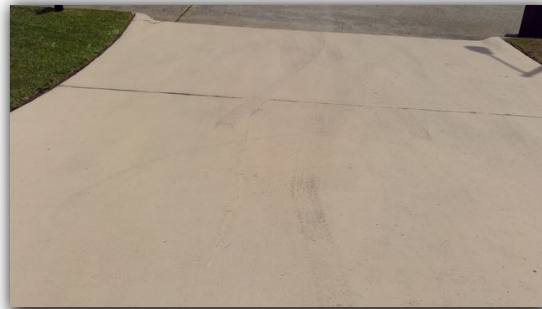
Cracks observed in flatwork (Driveways, sidewalks, etc. Not related to foundation of structure but noted on report for potential buyer to be fully informed

Would recommend that a licensed and / or qualified contractor be consulted to make any further recommendations and / or repairs

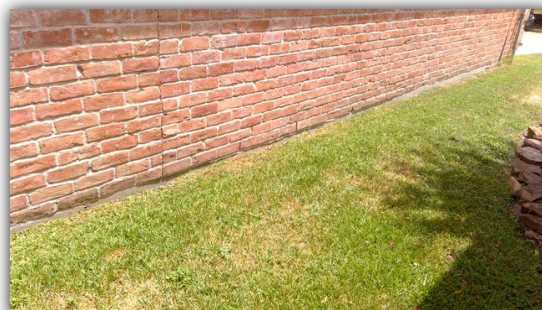
Soil level too high around the perimeter of the slab: Grade does not conform to current code requiring a 4" slab exposure between the finished grade and exterior brick

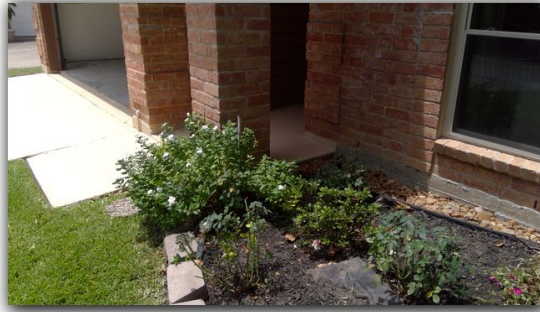
Soil level too high around the front porch post (s) areas at one or more locations. Grade does not conform to current code requiring a 4" slab exposure between the finished grade and exterior brick

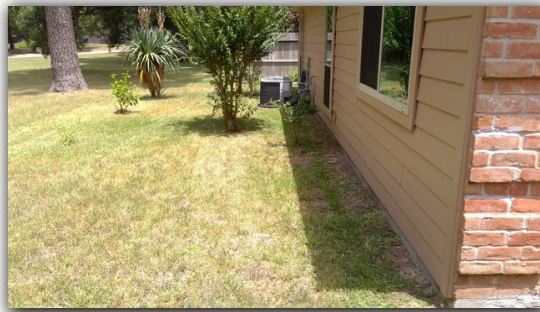
Grade does not conform to current code requiring a 6" fall 10' from the structure

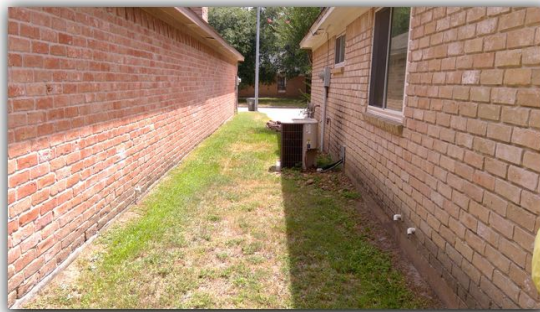
Drainage on the left side of the house does not appear to be properly draining water away from the foundation

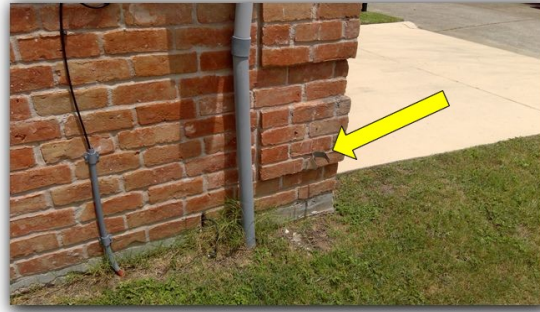
Evidence observed of previous gutters present on house. It appears the gutters and downspouts have been removed, but downspout straps are still present in some locations.

Would recommend that a licensed and / or qualified contractor be consulted to make any further recommendations and / or repairs

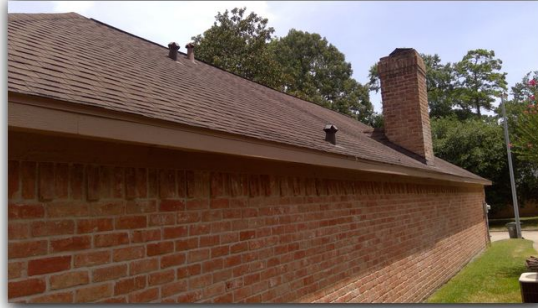
- Higher and lower areas observed in roof covering noticeable at one or more locations.

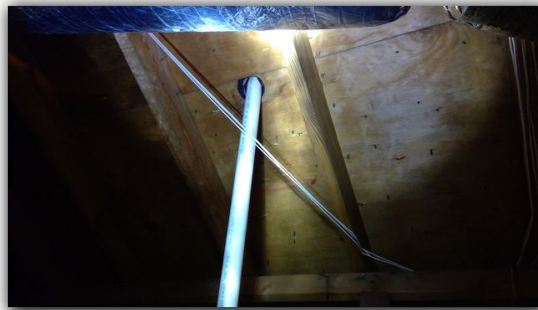
Evidence of previous moisture penetration observed in roof decking from attic side

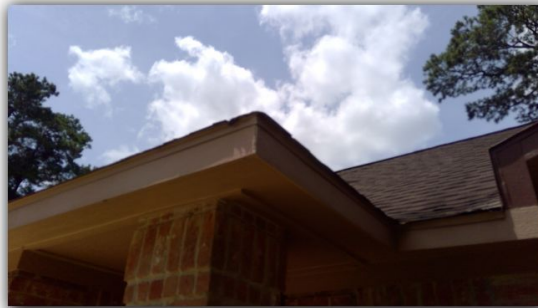
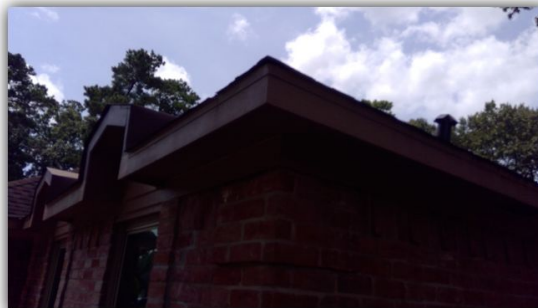
Edges of shingles around the perimeter are damaged at one or more locations.

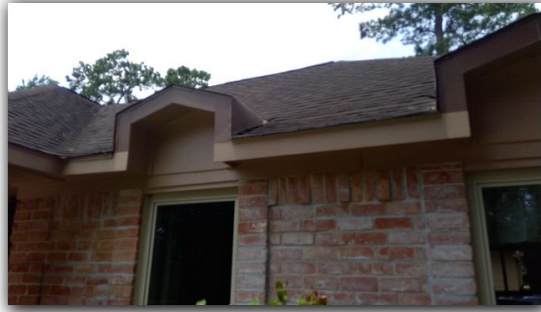
Roof covering shows evidence of deterioration / fiberglass threading showing in some locations.

Early signs of roof deterioration were observed. Gravel coming loose, pitted surfaces, fiberglass threading showing at edge of shingles

Would recommend that a licensed and / or qualified contractor be consulted to make any further recommendations and / or repairs

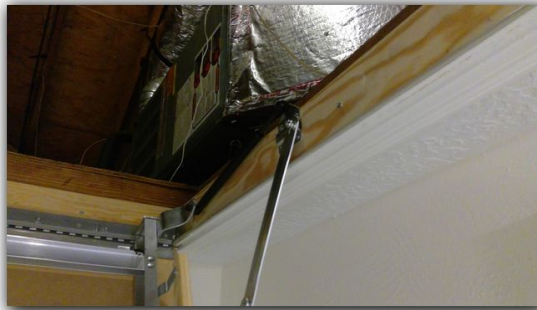
- Attic access fold down ladder not installed per manufacturer's specifications / proper fasteners

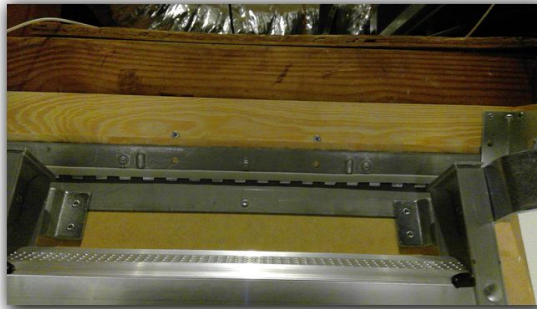
- Framing at the attic access does not conform to current standards requiring double framing for the access door.

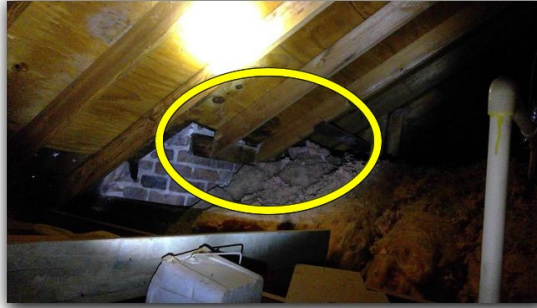
Framing at attic access was cut and not properly supported at the hallway attic access..

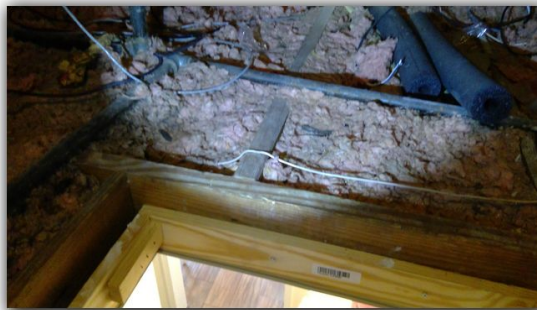
Proper 30" working clearance and level platforms needed in front of equipment located in attic space at one or more locations.

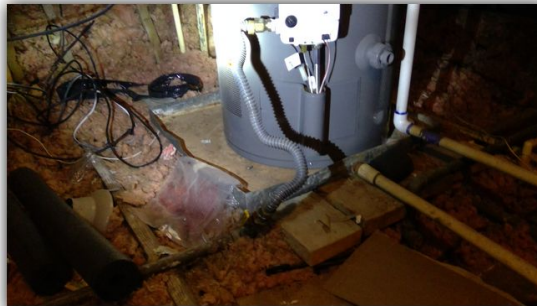
Attic does not conform to current code requiring a continuous / solid and unobstructed 24" wide catwalk

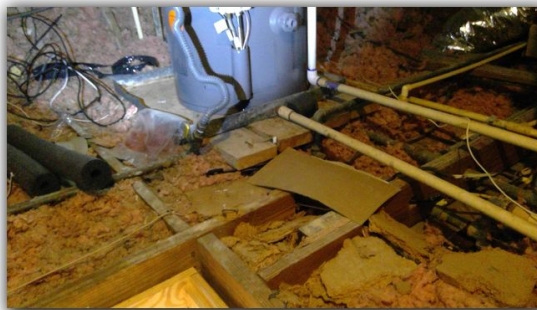
Voids observed in insulation in attic space at one or more locations.

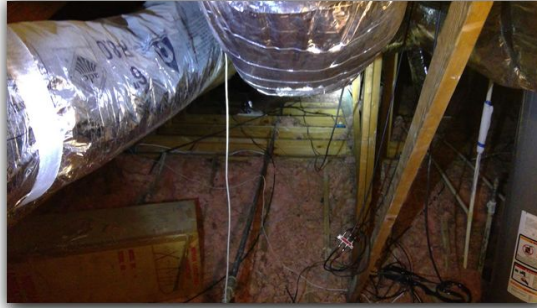
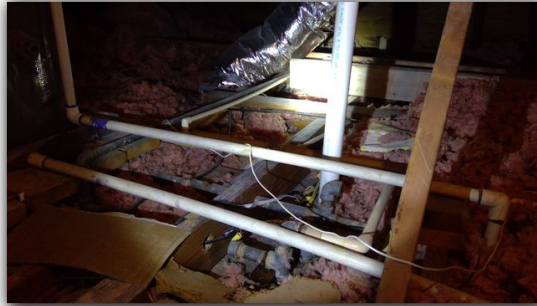
Insulation piled up in some areas of the attic space that appear to need to be redistributed.

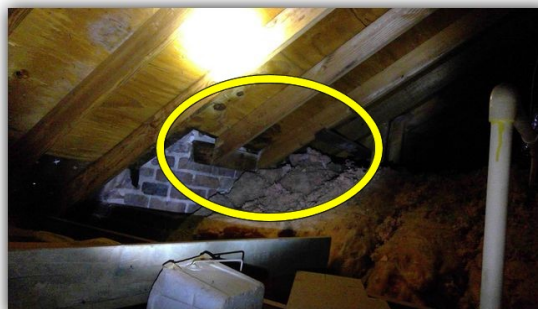
House was not constructed per current standards requiring the purlin brace to be the same size or larger than the rafter being supported. 2 x 4 purlins supporting 2 x 6 rafters observed.

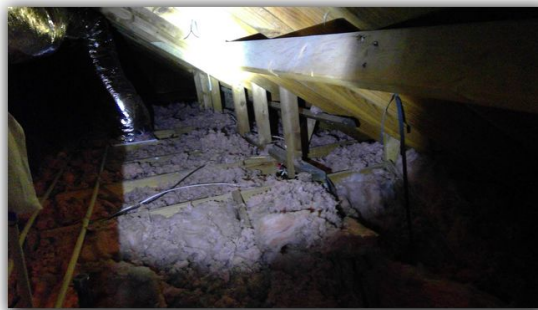
Purlin braces needed every 4' per current code to properly support purlins in attic space. It

appears that some purlin braces are missing at some locations.

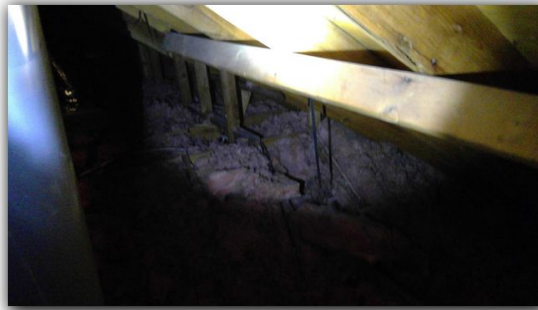
Ridge board is not properly sized larger than the rafters attached per current standards and shows signs of movement.

Would recommend that a licensed and / or qualified contractor be consulted to make any further recommendations and / or repairs

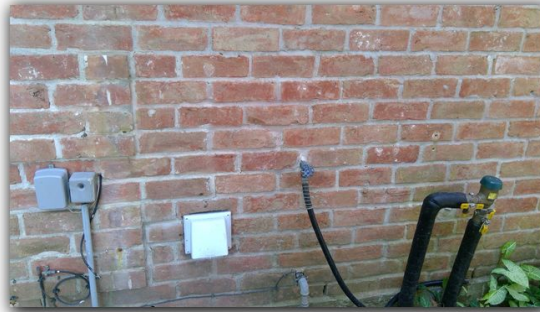
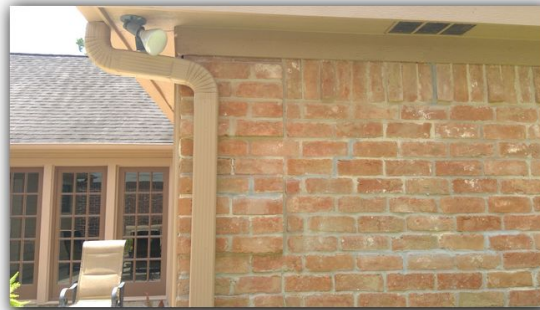
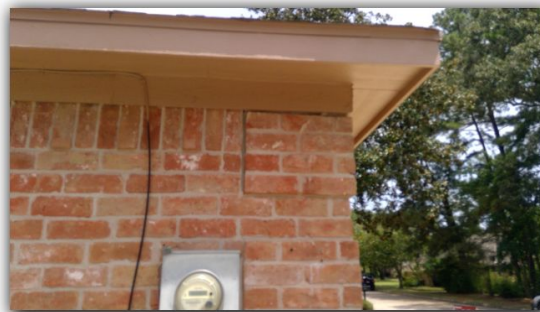
Mortar is separated, cracked or missing in some areas

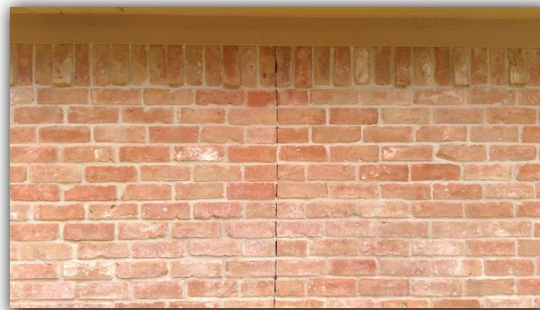
Caulking / sealant is separated or missing in some areas

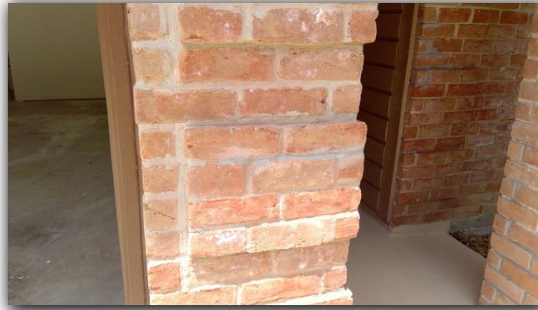
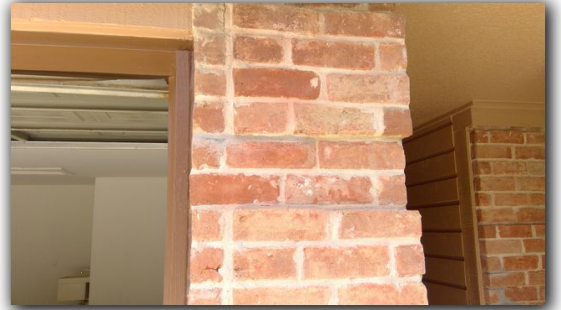
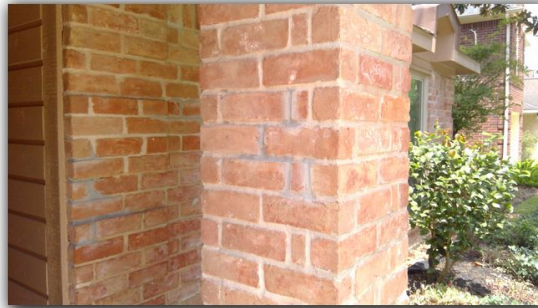
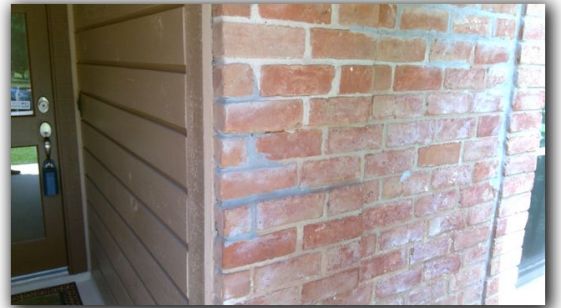
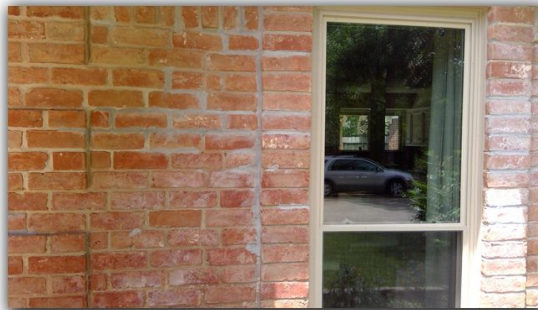
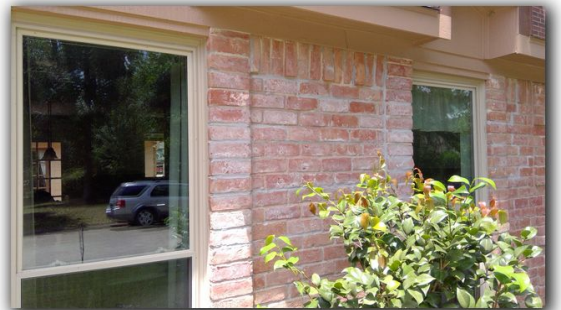
Evidence of previous exterior siding repairs observed

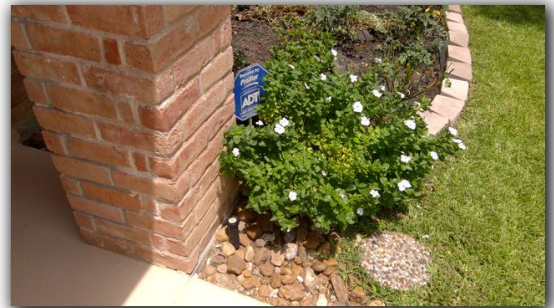
Heavy vegetation needs to be trimmed from touching exterior walls

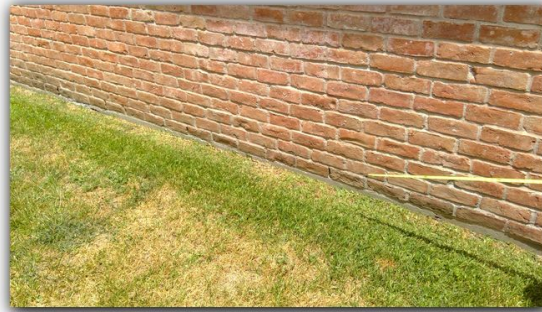
Weep holes not properly spaced per current code standards at multiple locations. Current code requires a weep hole within every 33".

Would recommend that a licensed and / or qualified contractor be consulted to make any further recommendations and / or repairs.

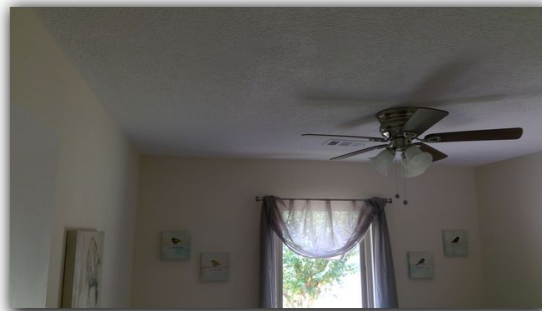
Ceiling cracks observed in one or more areas. See right rear bedroom ceiling.

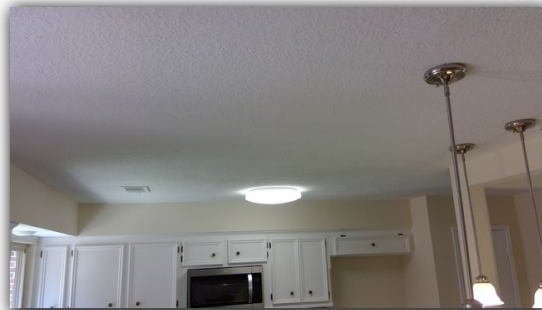
Evidence of previous repair observed in multiple sheetrock ceiling locations

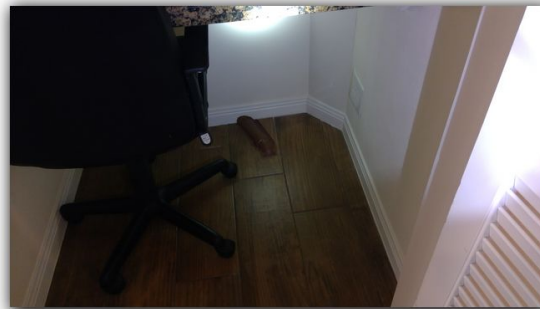
Tile flooring was not installed in a usual and customary building practice manner. PVC drain line observable at the tile flooring in what appears to be an old "wet bar" location.

Would recommend that a licensed and / or qualified contractor be consulted to make any further recommendations and / or repairs

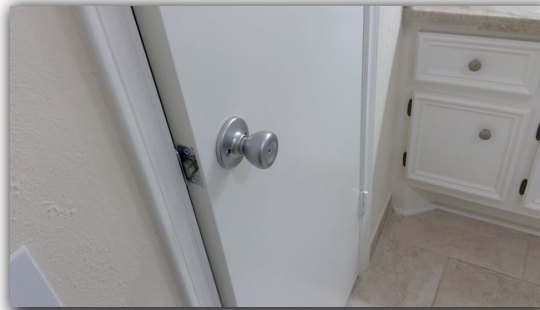
Interior doors do not latch properly at one or more locations.

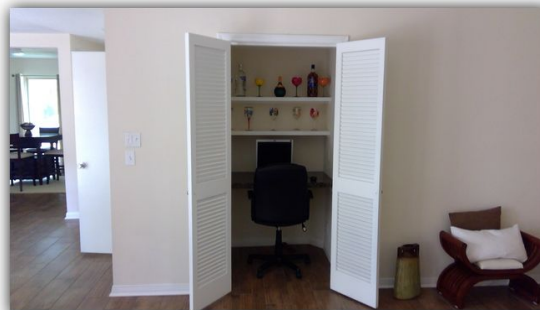
Ball latches appear to be damaged / missing at one or more door locations which keeps the door from latching properly. See study closet area. Doors do not appear to be supplied with appropriate ball latches.

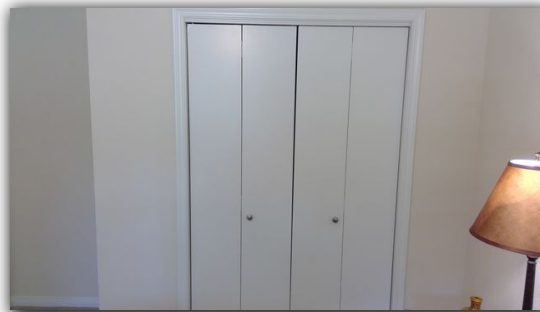
- Double door units do not fit square to each other at one or more bedroom closet locations

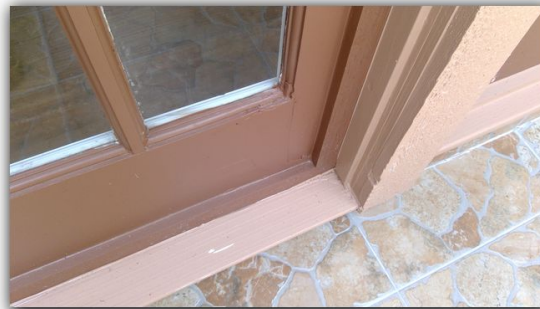
- Wood rot observed in the lower door area of one or more exterior doors where it appears that the middle window present was once a door that has been permanently fixed into a window.

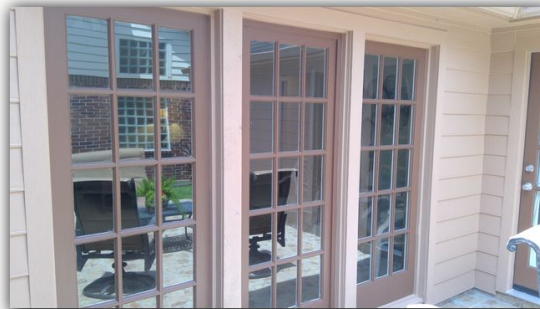
- Exterior door has been altered and turned into a window location at the middle patio area.

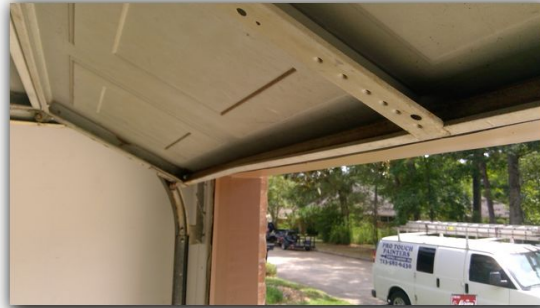
Bottom panel of garage door is bowed / bent / damaged on the interior side of the door.

Would recommend that a licensed and / or qualified contractor be consulted to make any further recommendations and / or repairs

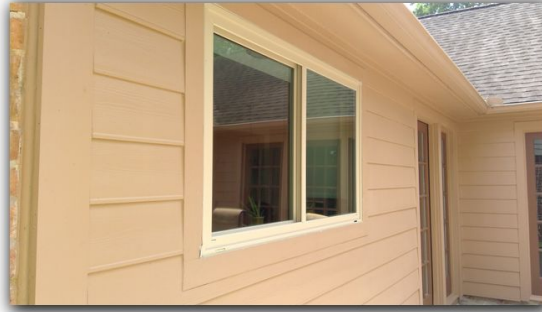
Some window / door screens are damaged or missing

Would recommend that a licensed and / or qualified contractor be consulted to make any further recommendations and / or repairs

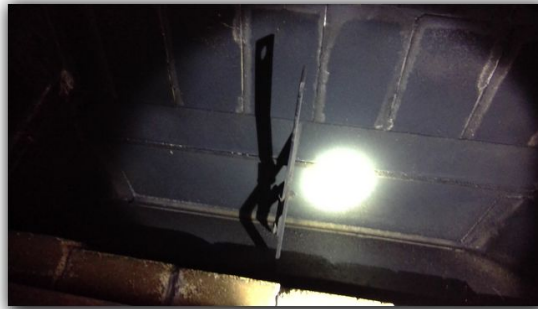
No damper anti closing device installed to prevent damper from closing with gas fired appliance present

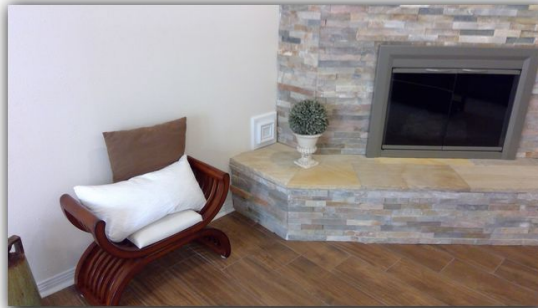
Gas valve does not require the use of a separate key. This can present a potential safety hazard if valve is turned without the use of the key and gas is inadvertently turned on.

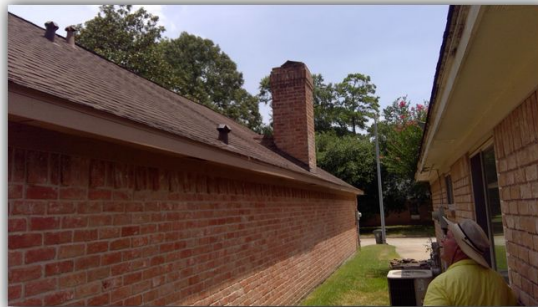
Inspector did not have access to the chimney cap location. Due to the age of the structure and the type of construction, this inspector would recommend that a qualified fireplace specialist make any further recommendations and potential repairs to the mortar chimney cap as needed.

Would recommend that a licensed and / or qualified contractor be consulted to make any further recommendations and / or repair

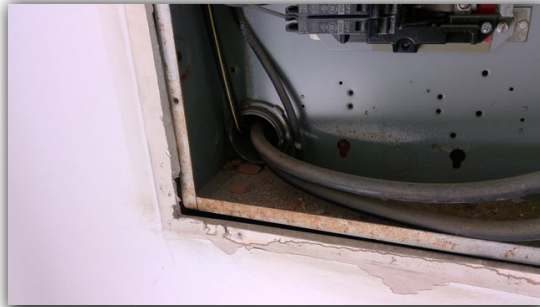
Bonding / grounding / wiring / ground clamp not present at the electrical service entrance panel box per current standards.

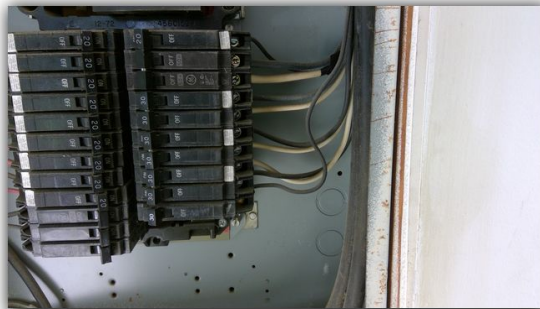
White "neutral" type wiring used as "hot" needs to be properly identified as "hot" in panel box at one or more locations. White wiring should be wrapped with black tape or marked with a black (or other appropriate color that is not white, grey or green) marker.

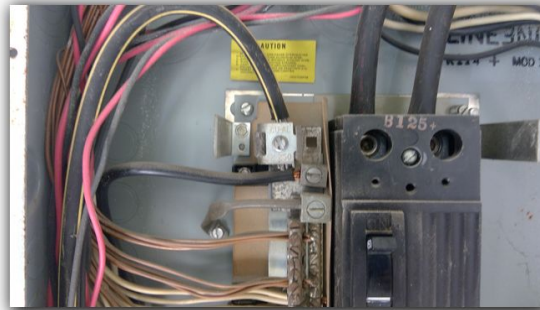
Lack of anti-oxidants on aluminum conductor terminals in panel box at one or more locations.

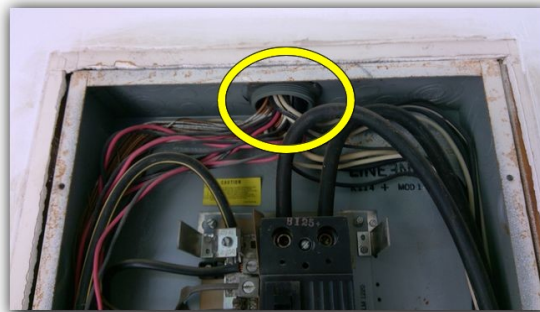
Wiring entering the panel box without appropriate clamps / bushings at knock out holes

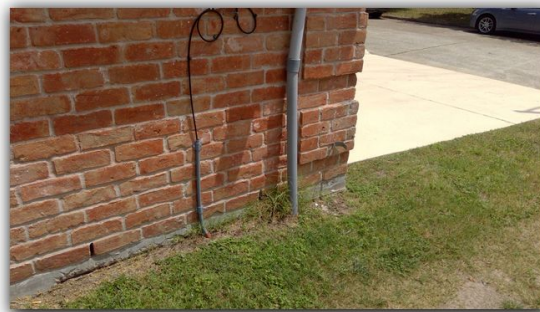
Conduit appears damaged (not installed in a usual and customary building practice manner) at the electrical meter can.

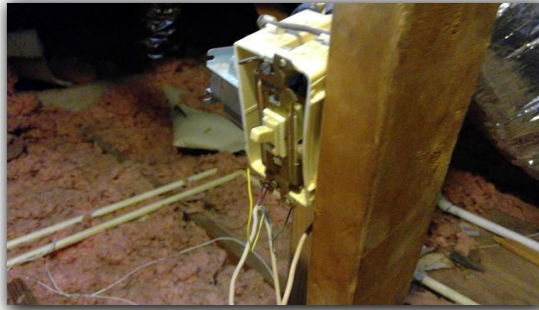
Loose, damaged, missing outlets / switches /covers at one or more locations.

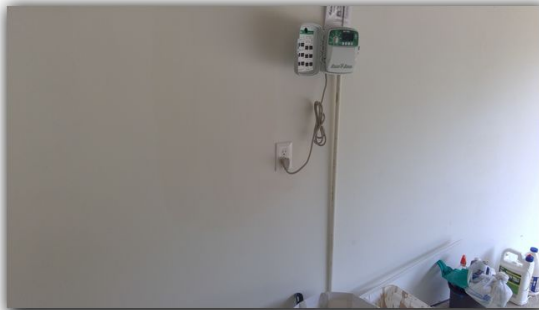
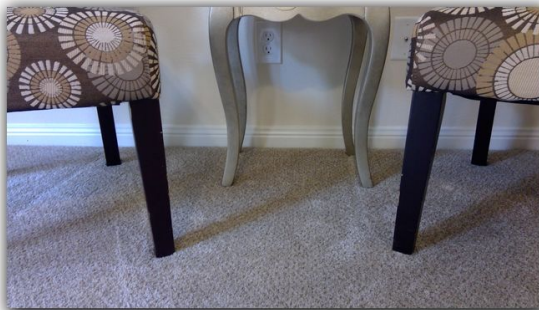
Outlet/Switches loose at multiple locations.

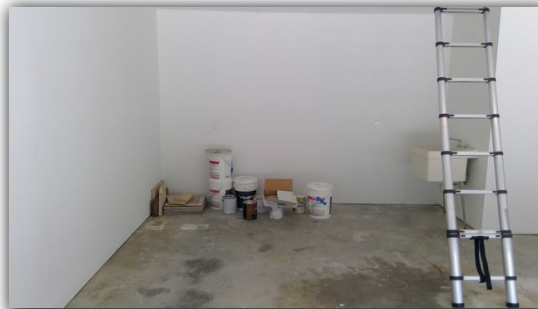
No GFCI protection at one or more location. This is considered a recognized safety hazard: All kitchen, bathroom, garage, exterior, washing machine, dishwasher, disposer and wet bar locations are required by current code to be GFCI protected.

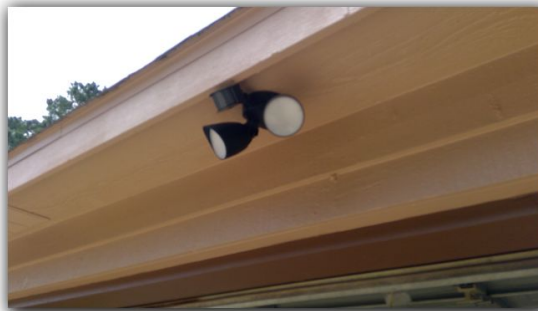
Light fixtures not operating in one / more locations: May be due to dusk / dawn sensors or timers present

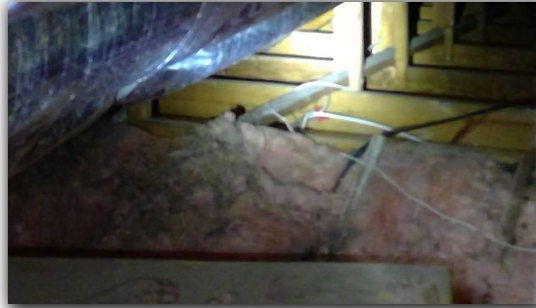
- Electrical wiring observed that was not properly terminated in a junction box.

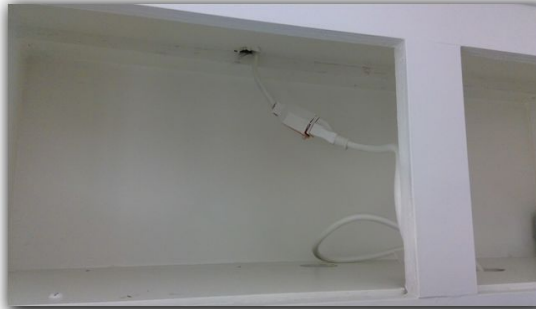
- Improper use of extension cords as permanent wiring observed in one or more locations. Permanent use of extension cords for permanent wiring is considered a safety hazard by current standards. See above microwave area.

- Would recommend that a licensed and / or qualified contractor (Electrician) be consulted to make any further recommendations and / or repair

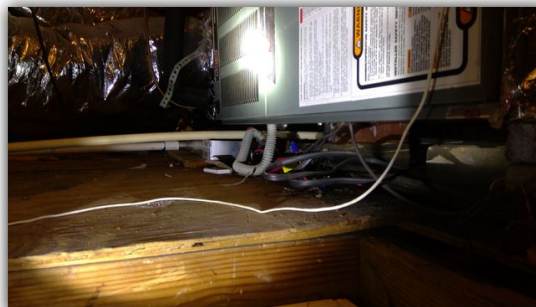
- No sediment trap observed in gas line of HVAC system
- 30" unobstructed working clearance and level platform needed in front of the HVAC furnace unit.
- Gas line entering the casing of the HVAC furnace should be "hard piped". Flexible gas line should not enter the casing of the furnace.

Would recommend that a licensed and / or qualified contractor be consulted to make any further recommendations and / or repair

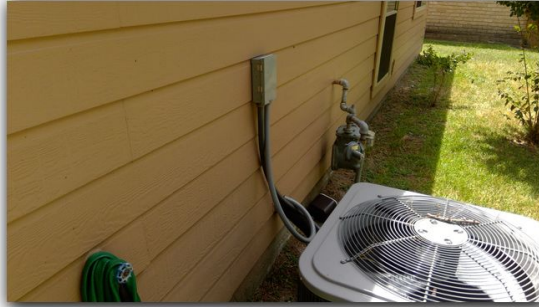
- Lack of GFCI exterior receptacle near unit for technician per current code.

Would recommend that a licensed and / or qualified contractor be consulted to make any further recommendations and / or repair

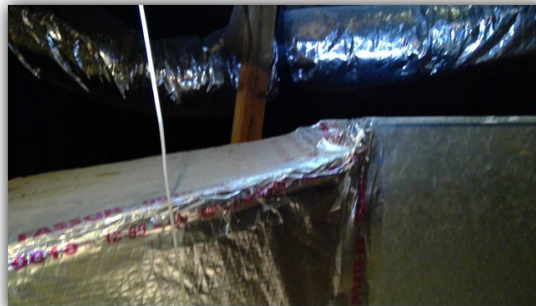
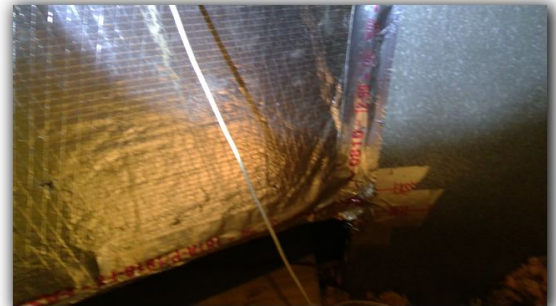
HVAC duct system does not conform to current code regarding proper sealing / mastic

Would recommend that a licensed and / or qualified contractor be consulted to make any further recommendations and / or repair

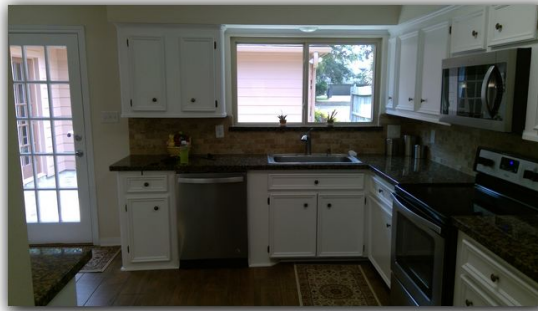
- Minimal water pressure observed at the kitchen sink faucet.

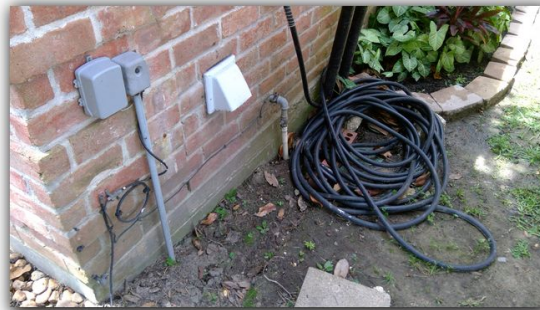
Proper insulation needed on exterior exposed water lines / plumbing

Would recommend that a licensed and / or qualified contractor be consulted to make any further recommendations and / or repair

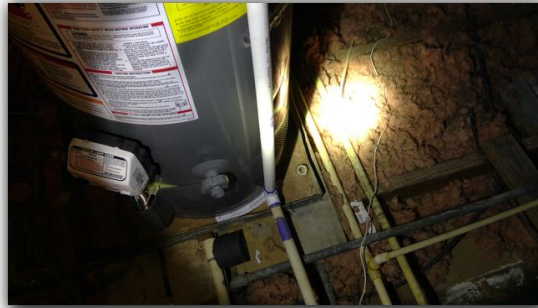
- Sediment trap not present in gas line at water heating equipment

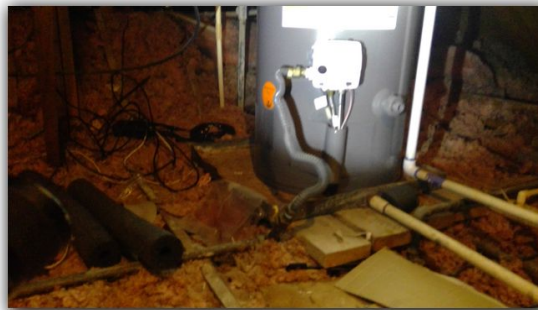
- 30" working clearance and platform needed in front of water heating equipment

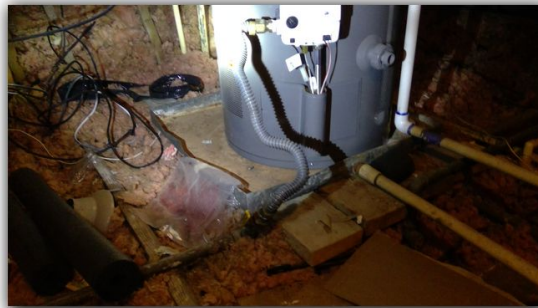
- Drain pan is damaged / dented at water heating equipment.
- No cold water shut off valve present at the water heating equipment per standards.

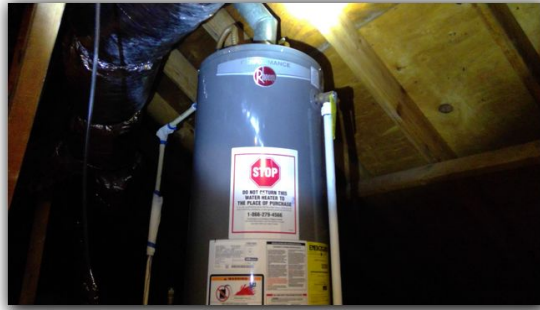
Water heater Temperature and Pressure Relief Valve

Water heater T & P valve piping does not have proper termination. Piping needs a 90 degree elbow at the termination point and the termination needs to be made within 6" of grade or appropriate drain location per current code.

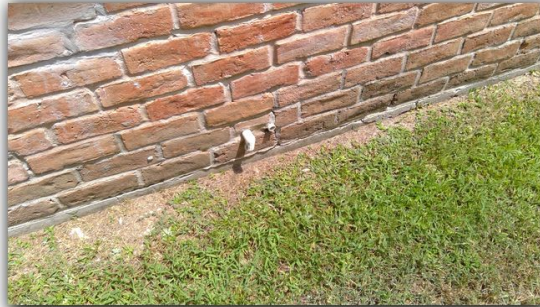
Water heater T & P valve piping is plumbed with wrong material. Piping present is not rated for hot water use.

Would recommend that a licensed and / or qualified contractor be consulted to make any further recommendations and / or repair

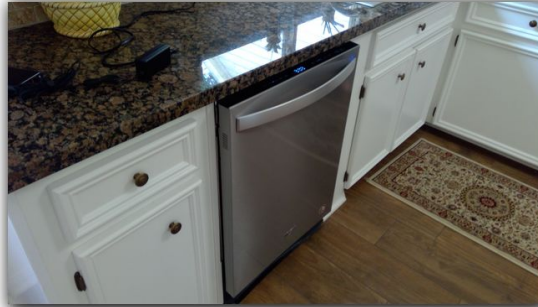
Dishwasher unit appears to be hardwired. No means of electrical disconnect observed per current code.

Would recommend that a licensed and / or qualified contractor be consulted to make any further recommendations and / or repair

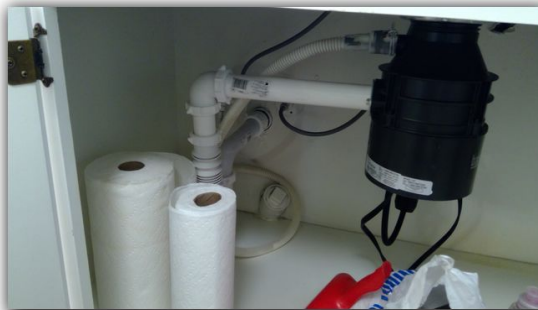
No anti-siphon loop observed at the drain line of the dishwashing equipment per current code standards.

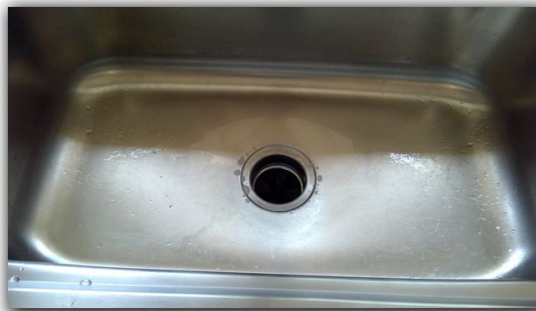
Excessive vibration / noise observed in food waste disposer unit. Appears to have something loose inside the disposer

Would recommend that a licensed and / or qualified contractor be consulted to make any further recommendations and / or repair

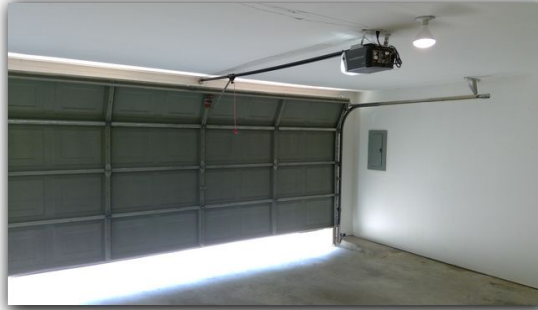
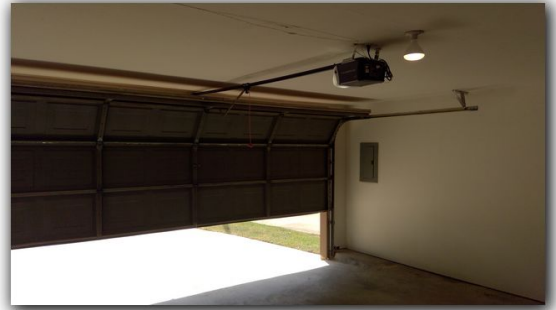
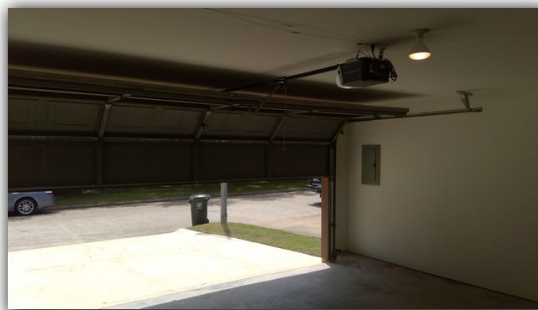
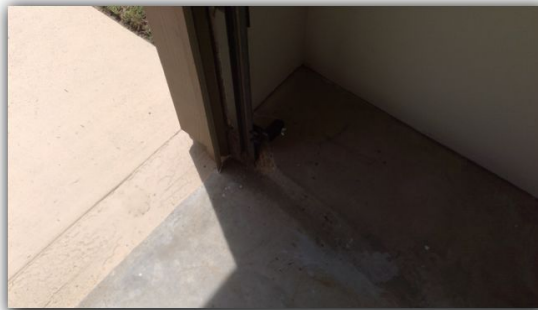
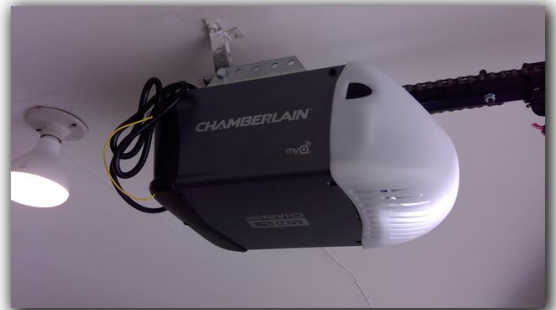
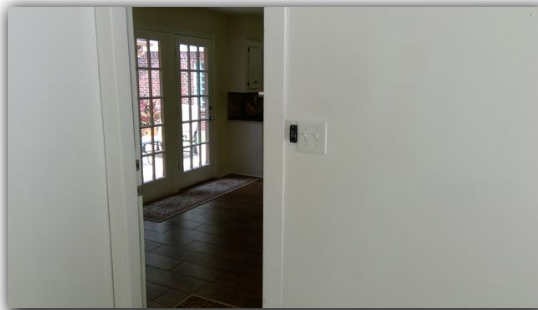
G. Garage Door Operators

- Wiring for the garage door operator controller is not installed in a usual and customary building practice. Wiring was installed on the outside of the sheetrock at wall and ceiling and is visible

from the controller to the garage door operator unit.

Would recommend that a licensed and / or qualified contractor be consulted to make any further recommendations and / or repair

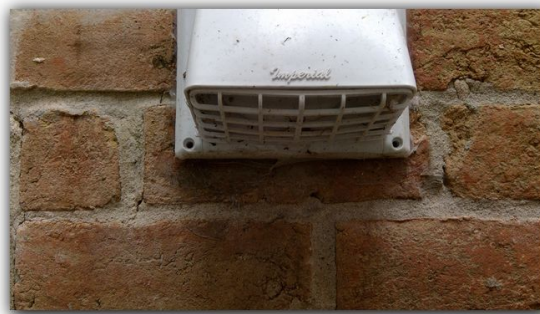
H. Dryer Exhaust Systems

Dryer vent cover does not conform to current code and TREC standards. The cover should not have a screen at the termination point.

Would recommend that a licensed and / or qualified contractor be consulted to make any further recommendations and / or repair

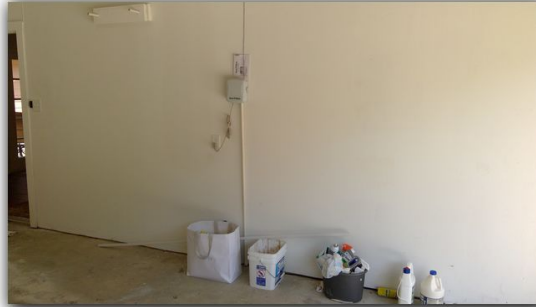
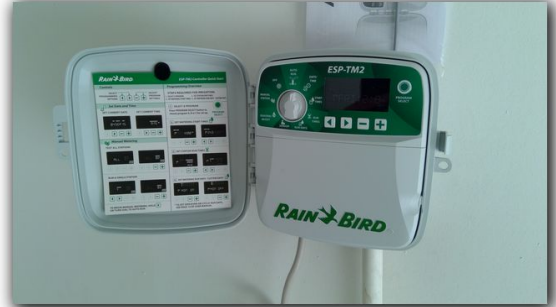
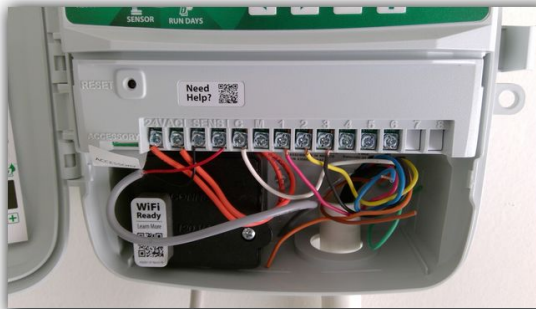
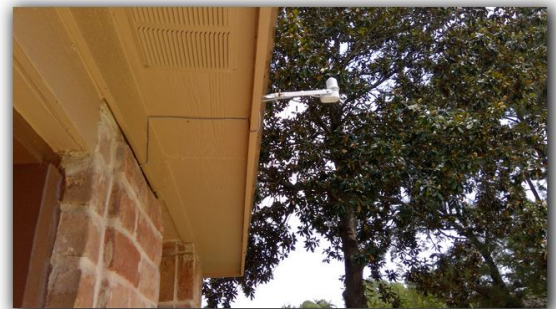
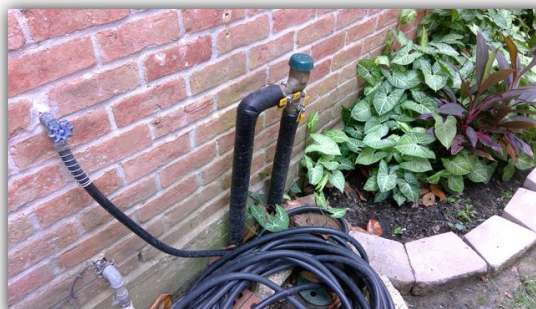
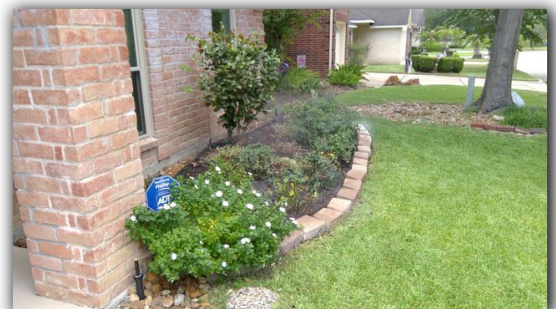
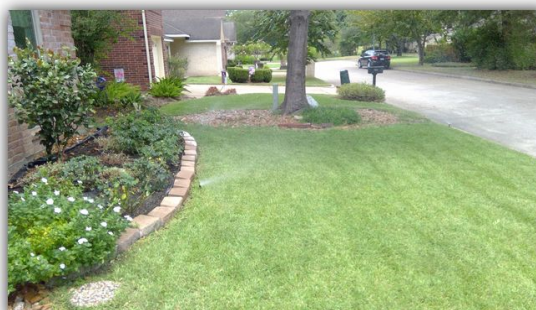
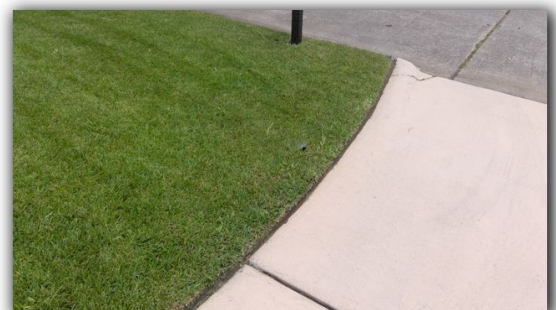
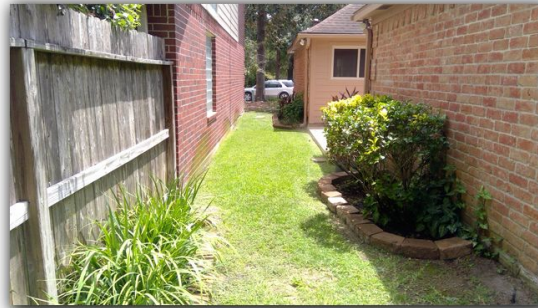
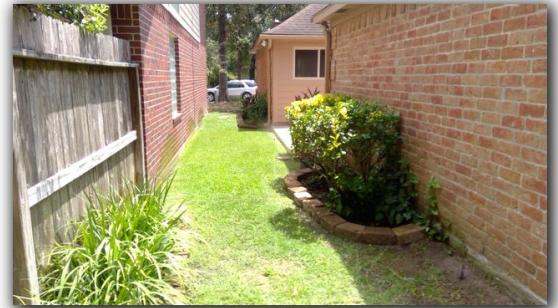
A. Landscape Irrigation (Sprinkler) Systems

Comments: It is the opinion of this inspector that the landscape irrigation system appeared to be performing its intended function at the time of the inspection with the exception of observed / noted / checked (deficient) items below.

Would recommend that a licensed and / or qualified contractor be consulted to make any further recommendations and / or repair
