HEDDERMAN SERVICES

STRUCTURAL INSPECTION

11010 Wickersham Ln
Houston TX 77042

MARCH 4, 2021

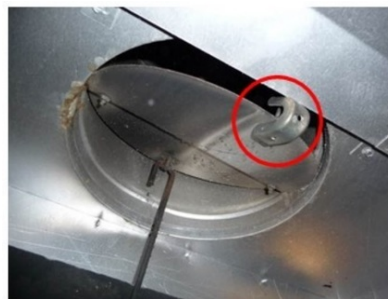
HEI file photo showing c-clamp in masonry fireplace

HEI file photo showing c-clamp in metal fireplace

The fireplace was equipped with a ceramic gas log. The smoke chamber and flue pipe were free from built-up soot, the damper was operational, and the firebox was properly sealed. While the draw of the chimney was not able to be checked, no evidences of poor draw were visible, and no repairs were needed to the fireplace. It is pointed out that the damper was not equipped with a spacer device to prevent the damper from closing completely. This device keeps the damper open slightly, even when it is in the closed position, to prevent combustion gases from building up in the living space should the gas log be operated when the damper is closed. It is recommended that the clamp be installed for safety purposes.

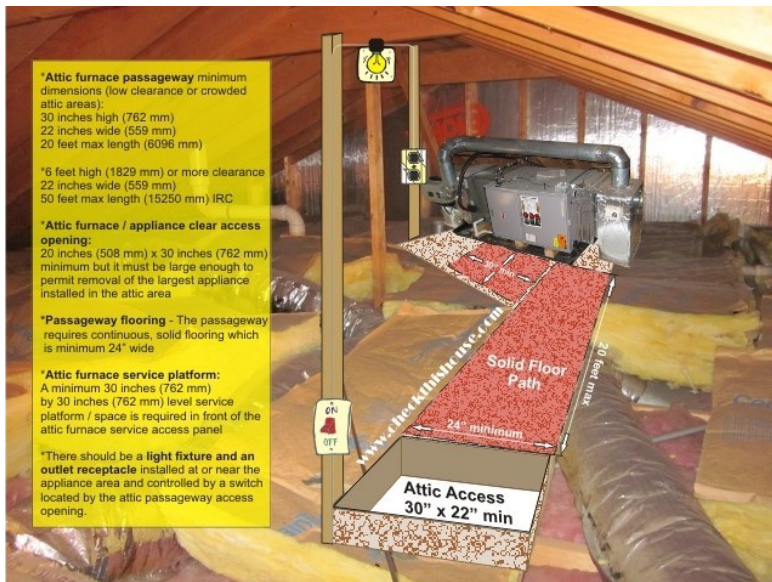
9.4.1 Insulation

THIN 3-5 INCHES

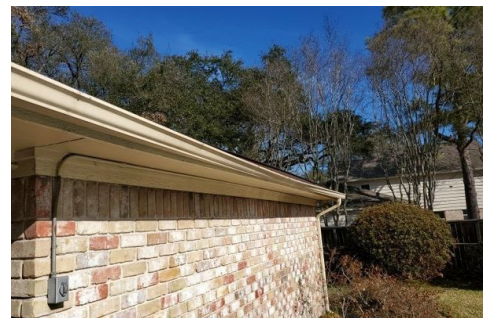
11.2.2 Gutters and Downspouts

DOWNSPOUTS

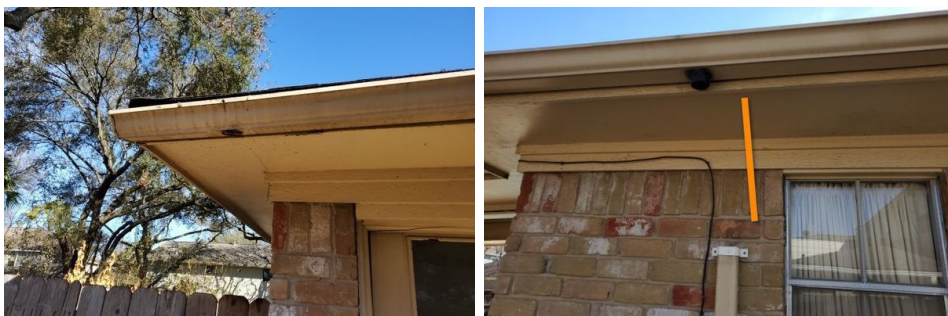
11.2.3 Gutters and Downspouts

GUTTER MISSING

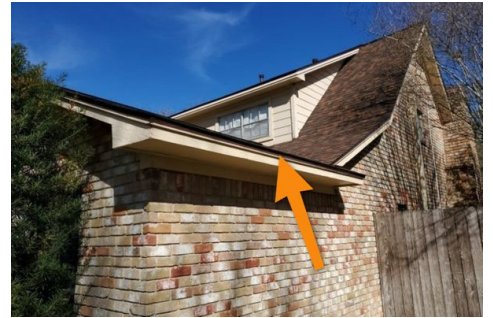
11.2.4 Gutters and Downspouts

SCREENS LOOSE/MISSING

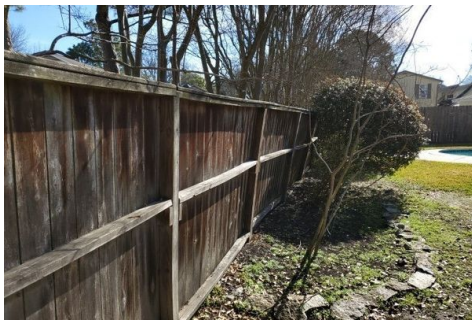
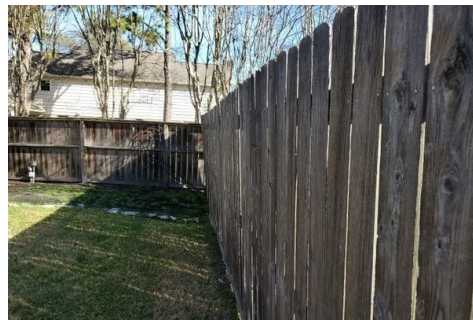
11.4.1 Wood Rot

WOOD ROT

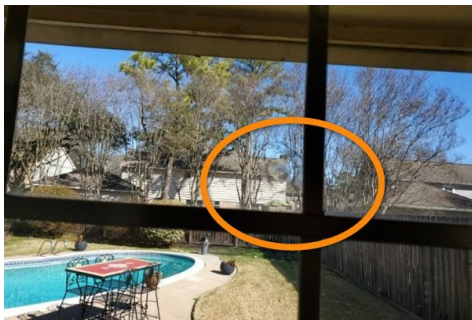
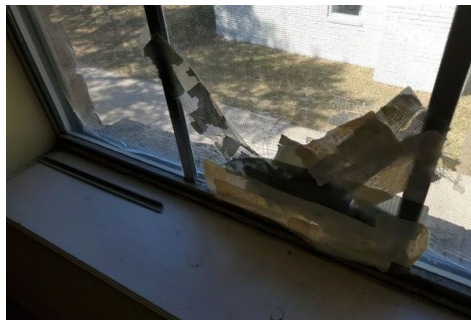
12.2.2 Windows

DAMAGED LOCK

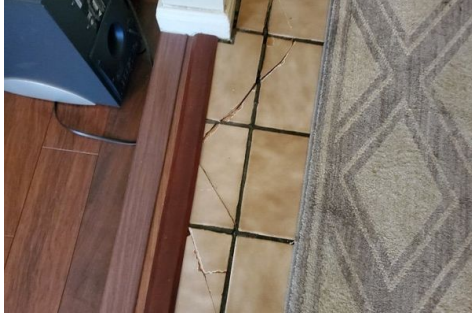
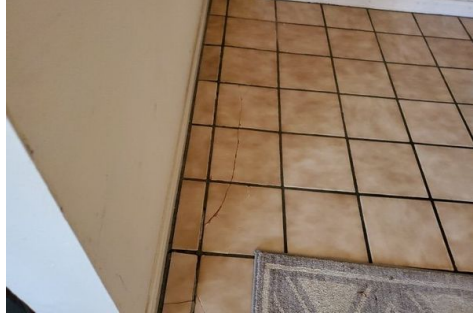
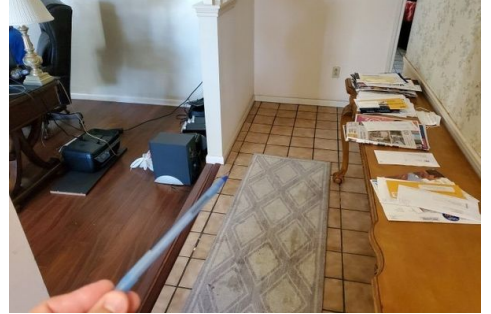
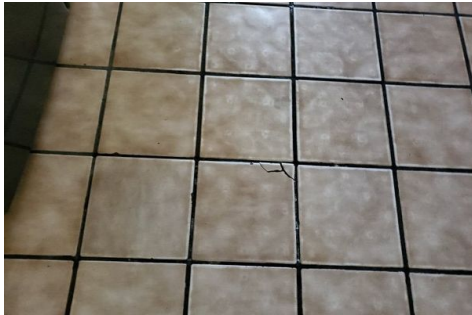
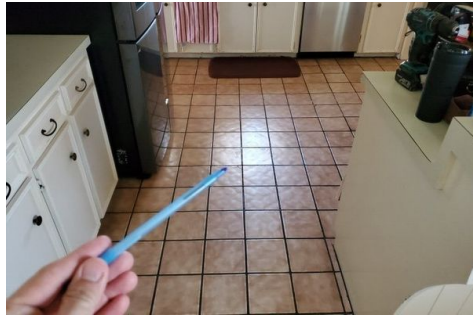
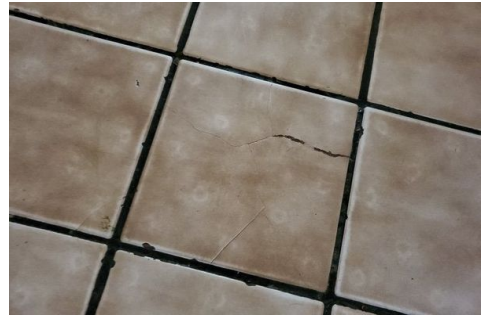
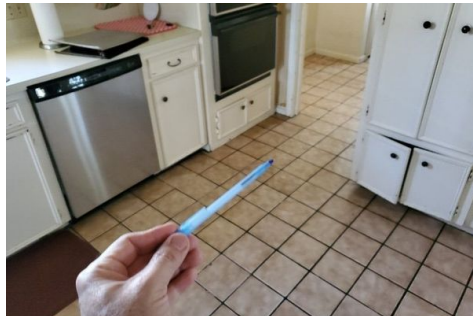
FLOOR TILES CRACKED

Floor tiles were cracked and it is recommended they be replaced.

Contact a qualified professional.

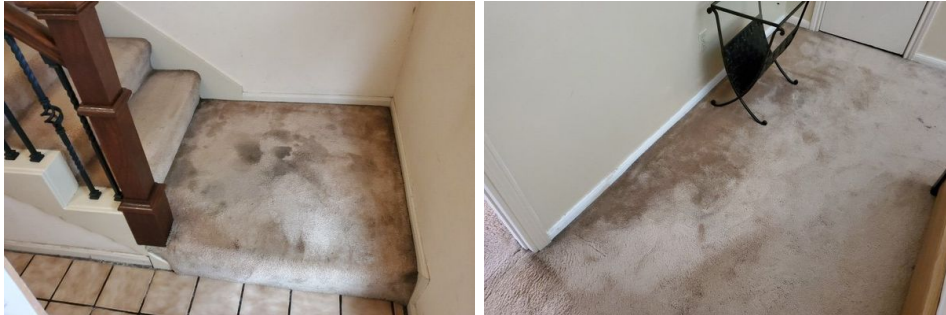
CARPET STAINED

The carpet was observed to be stained, and it is recommended that it be cleaned or replaced.

Contact a qualified professional.

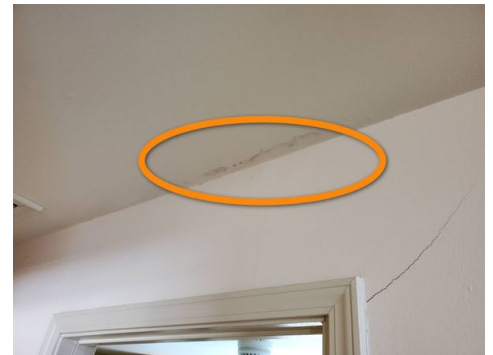
WATER STAINS UNDER ATTIC HVAC EQUIPMENT

Water stains were observed on the ceiling. This is located under the air conditioning system in the attic above, and the stains appear to be related to the air conditioning primary drain rather than to roof leaks. Further investigation with a service company is recommended to determine the source of the stains and to make any needed repairs.

Contact a qualified professional.

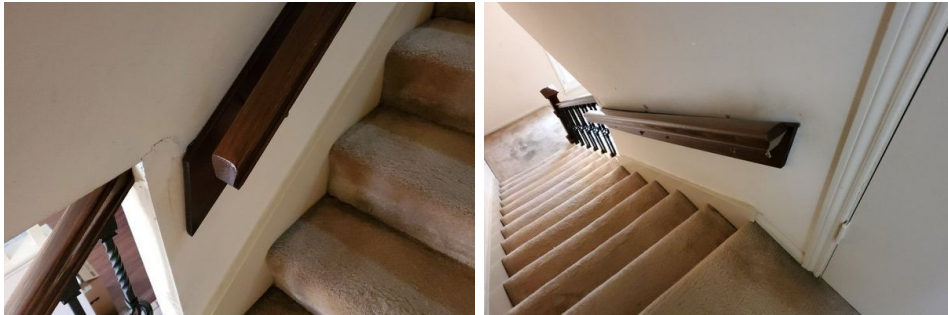
HANDRAIL BALUSTERS > 4"

The handrail was not constructed according to the current building code standards (obviously, given the age of the house). Therefore, the width between the balusters is greater than four inches. If this condition is of a concern to you, then further investigation with a contractor is recommended.

Contact a qualified professional.
