Professional Inspection Report

PROPERTY INSPECTION REPORT

Concerning: 7107 Brownbark, Magnolia, TX 77354
(Address or Other Identification of Inspected Property)

By: Michael Dorman, Lic #24633 07/28/2021
(Name and License Number of Inspector) (Date)

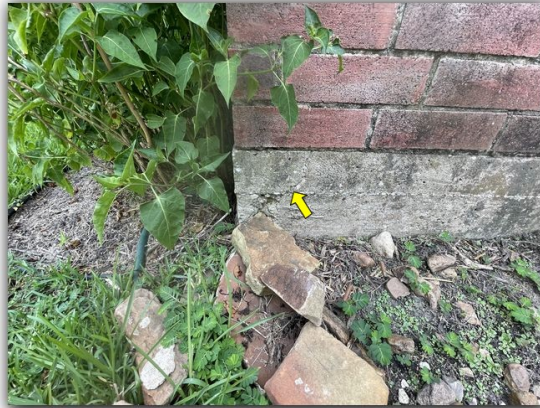
Information: Cracks in concrete do not, in and of themselves, indicate a structure deficiency in the construction or performance of a foundation. The interior surfaces of the foundation of the house were concealed by floor covering materials and could not be inspected.

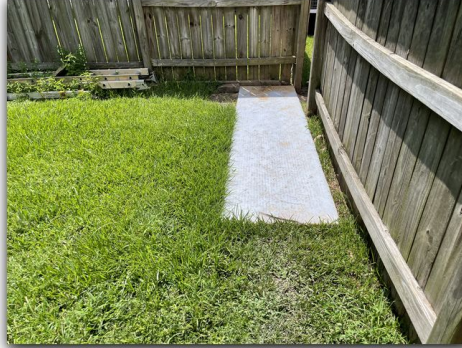
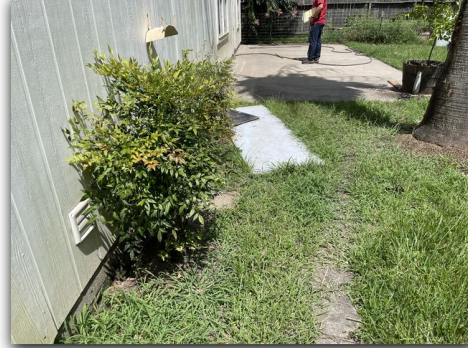
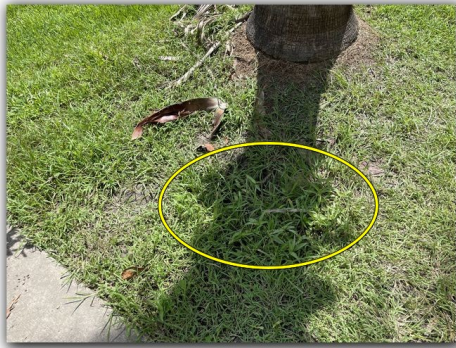
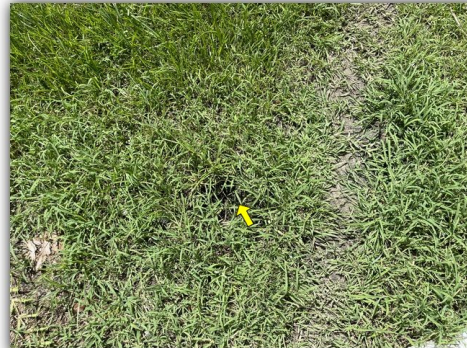
- Multiple sink holes / dog dug holes were observed on the property. Recommend filling to prevent trip hazard.

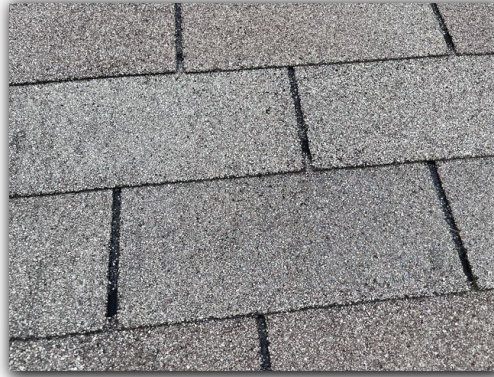
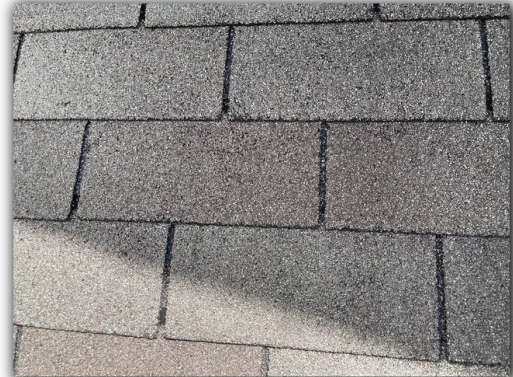
- One or more roof vents was observed to have exposed nail heads / deteriorating caulk. Recommend sealing to prevent water penetration.

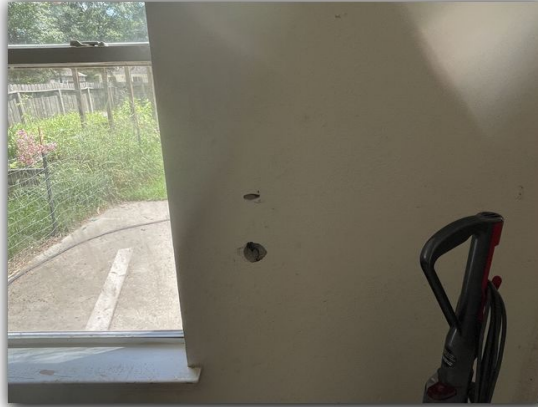
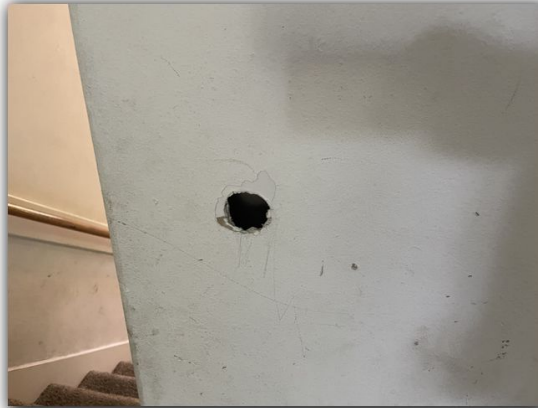
- Multiple holes were observed in the interior walls.

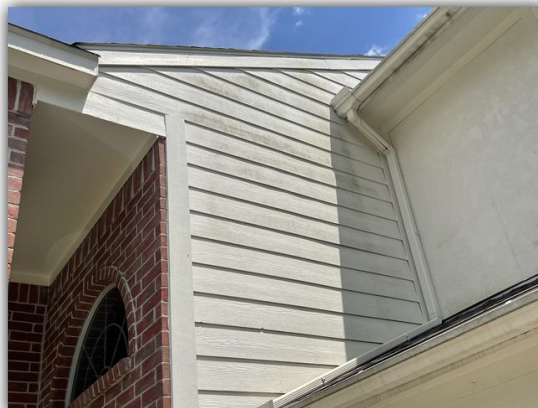
- Multiple areas on the exterior siding were observed to have algae growth.

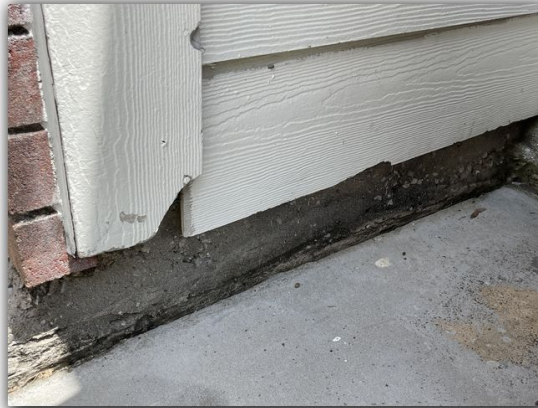
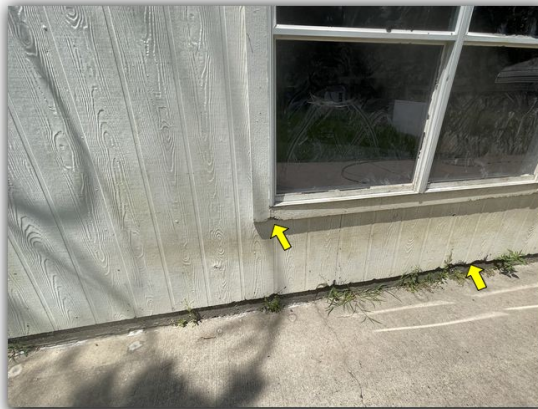
- Multiple areas of the siding were observed to have deterioration / damage.

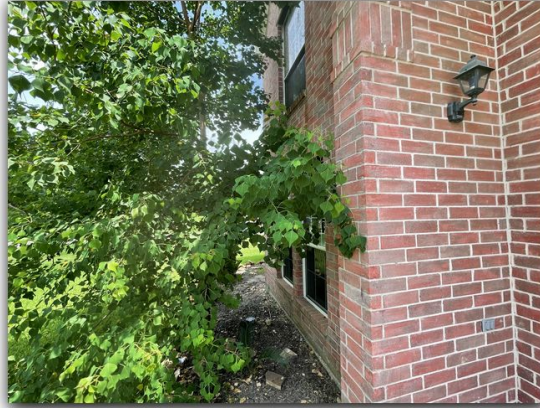
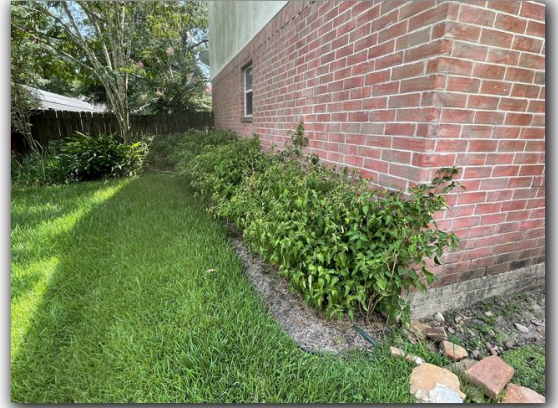
- **Note:** The heavy foliage growing on, over or around the exterior walls of the structure should be trimmed back at least 18-inches. The heavy foliage will limit the Inspectors visual observation of the exterior surfaces.

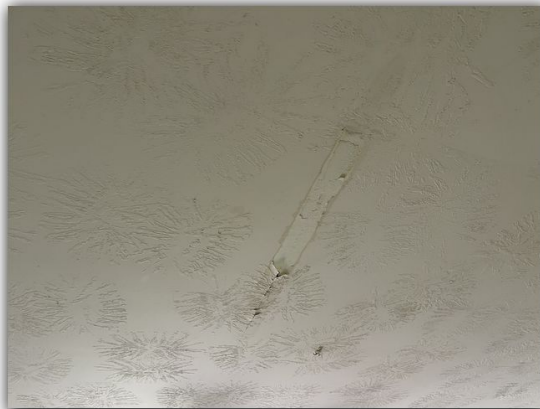
- Two or more areas in the living room ceiling were observed to be damaged.

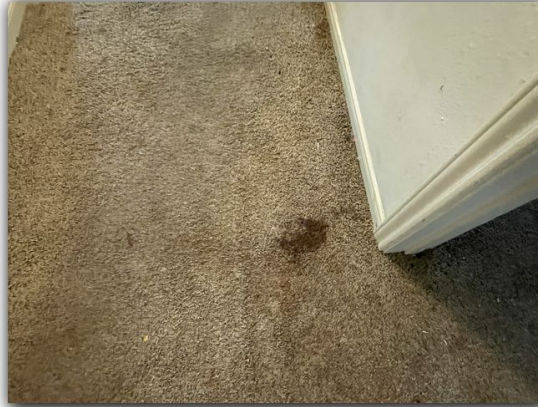
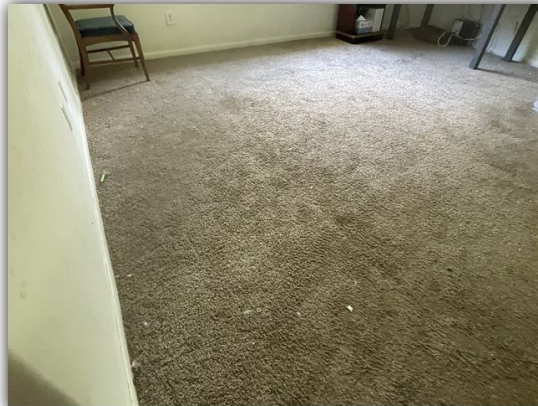
- The flooring in multiple areas upstairs needed to be cleaned.

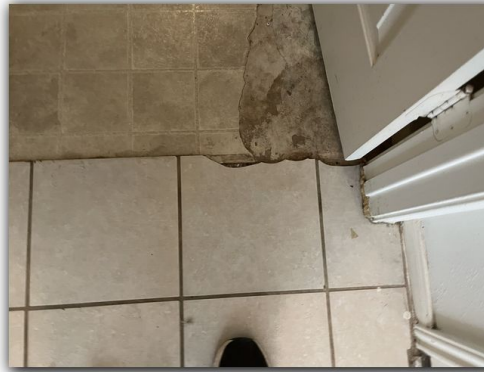
- There was a broken tile observed going into the laundry room.

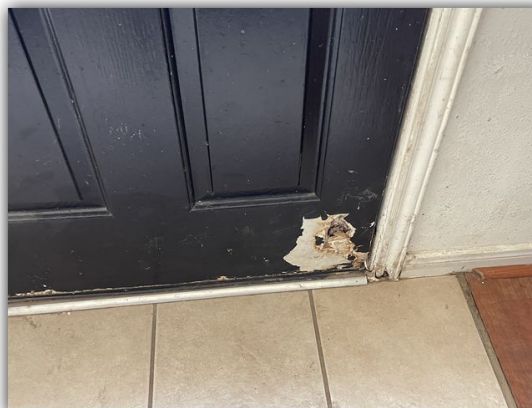
- One or more doors were observed to have damage.

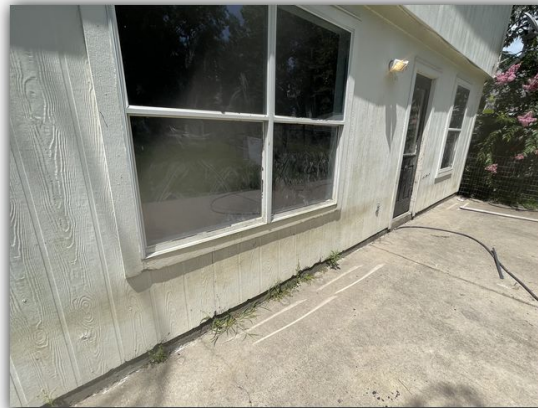
- Multiple windows were observed to be missing window screens.

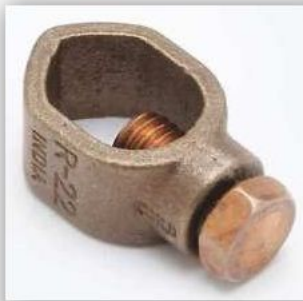
- The clamp for the ground rod is an improper style of grounding clamp. Recommend an acorn style clamp to be installed.

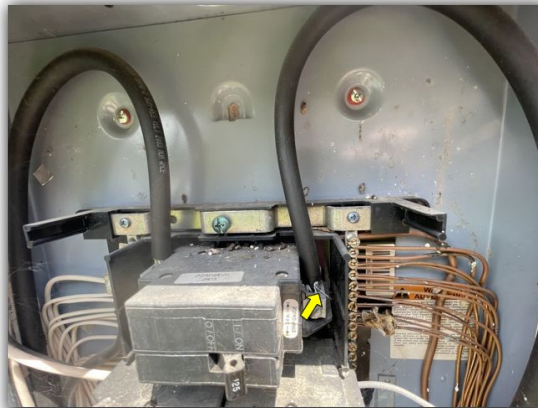
- There was no anti-oxidant gel observed on the exposed aluminum conductor terminations. The NEC and most panel manufacturers do not require the application of anti-oxidant gel on the aluminum service entrance cables, however, the TREC Standards of Practice require notification if anti-oxidant gel is not present. If the buyer has any questions about this issue, it is recommended to consult with a licensed electrician.

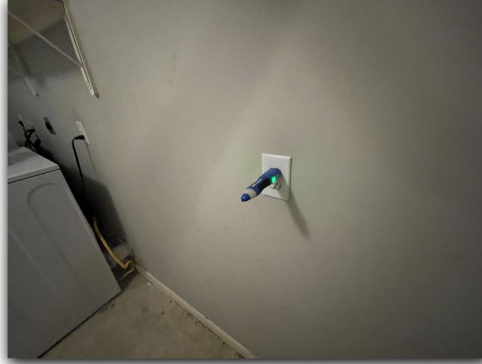
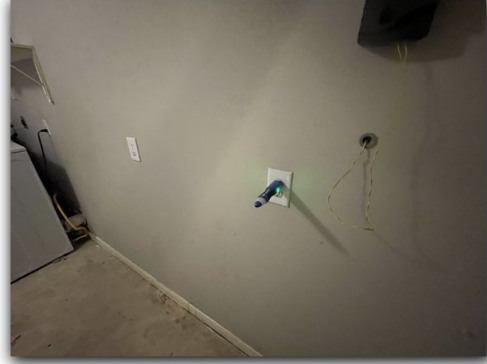
- Not all of the laundry room receptacles appear to be connected to a ground fault circuit interrupter (GFCI) device. Under current electrical standards, all of the receptacles in the laundry room should have GFCI protection.

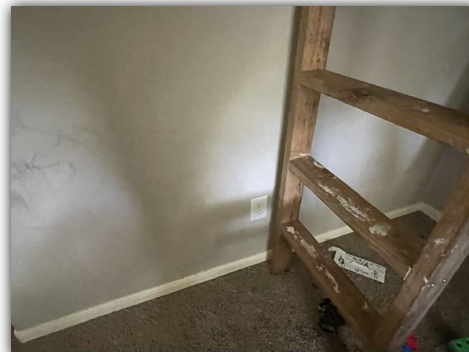
- Multiple receptacles were observed to be too loose at the wall mount in the electrical box. A loose receptacle is a conducive condition for a loose wire, electrical shorts, overheating, and a fire hazard. The pictures provided are not exhaustive of every location, but representative of the condition noted. Recommend evaluating all receptacles and securing loose receptacles satisfactorily in the box as needed.

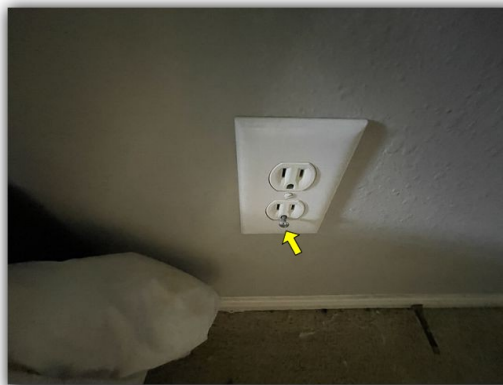
- One or more of the receptacles were observed to be damaged in the front left upstairs bedroom.

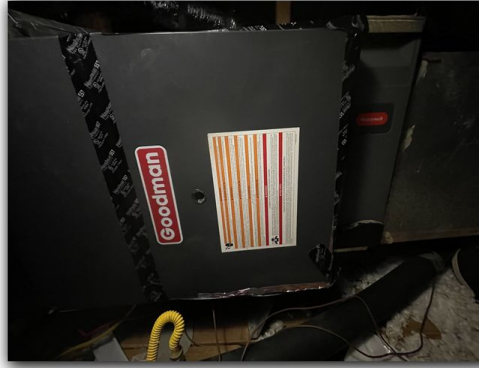
- The burner compartment was unable to be opened due to tape being around it at the time of inspection.

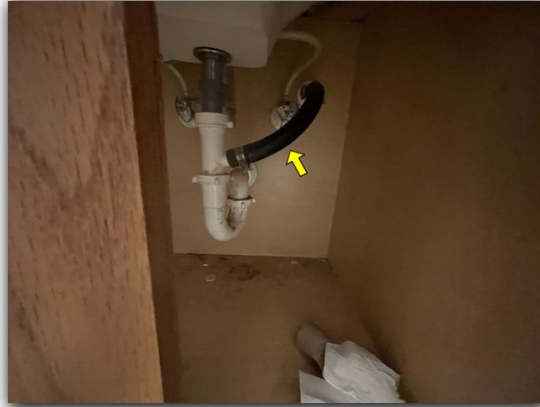
Primary Condensate Drain Line Location(s)

- The location of the primary condensate drain line that is connected to the evaporator core was under the Upstairs Front Left Bathroom Sink. Recommend cleaning the condensation drain line(s) at least annually and ensuring the associated sink trap is free-flowing for proper drainage.

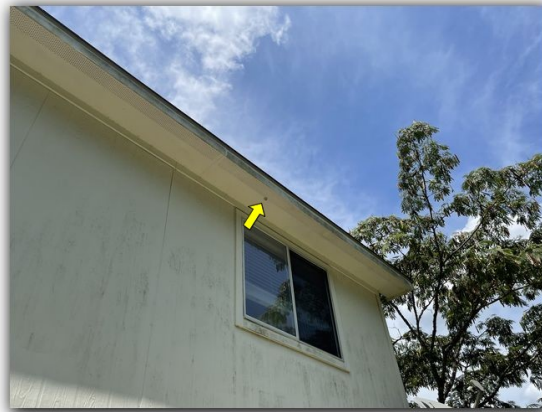
Secondary Overflow Condensate Drain Line Location(s)

- The location of the secondary condensate drain line that is connected to the overflow pan was located at the Rear Soffit. If water is ever seen dripping from this outlet, recommend contacting a qualified HVAC technician for an evaluation of the system.

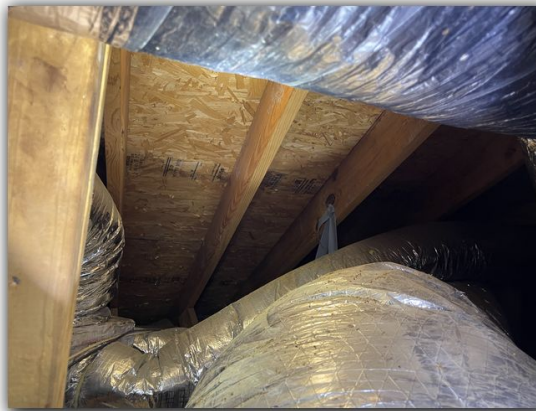
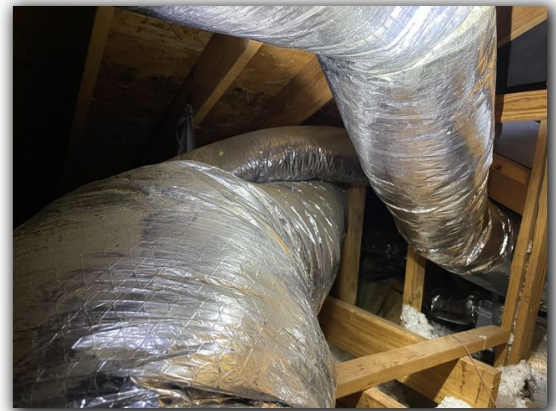
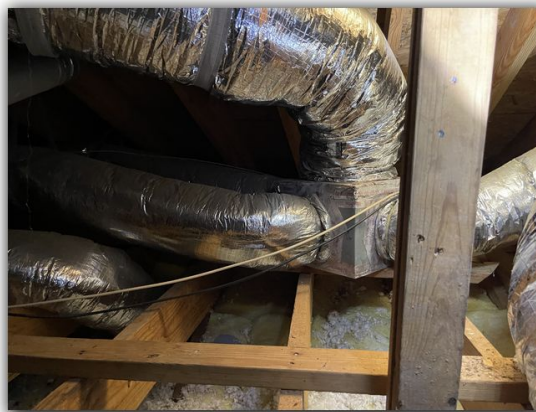
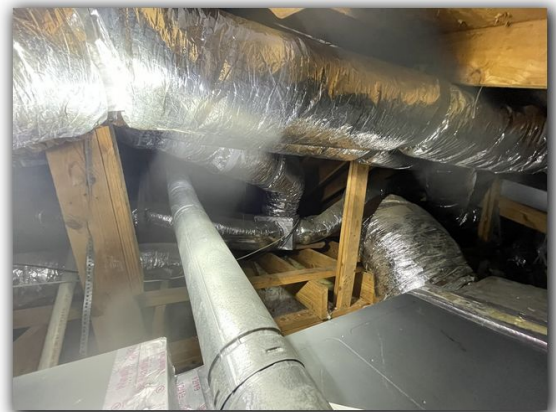
- The components of the duct system(s), chases, and vents appeared to be in satisfactory condition at the time of the inspection. Recommend periodic inspection of ducts and connections to ensure that all are sealed satisfactorily.

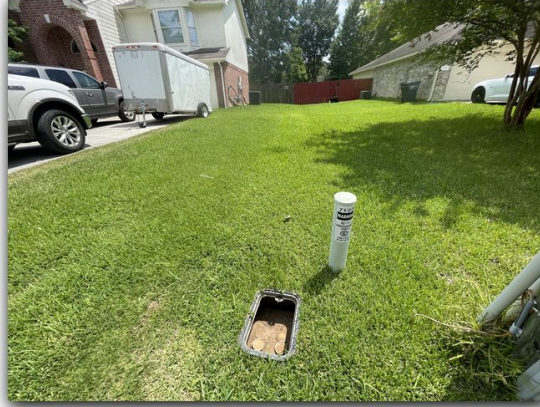
Location of water meter: *Front of the yard*

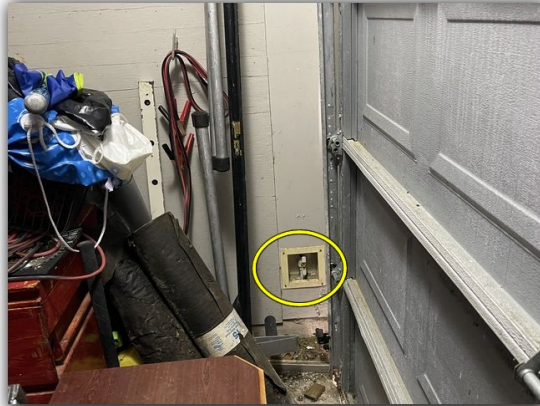
Location of main water supply valve: *Garage wall*

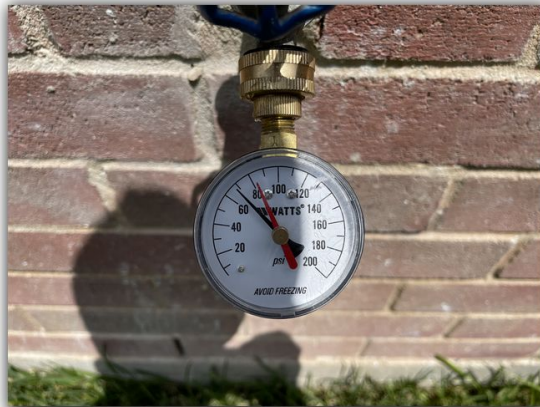
Static water pressure reading: *65 to 70 psi*

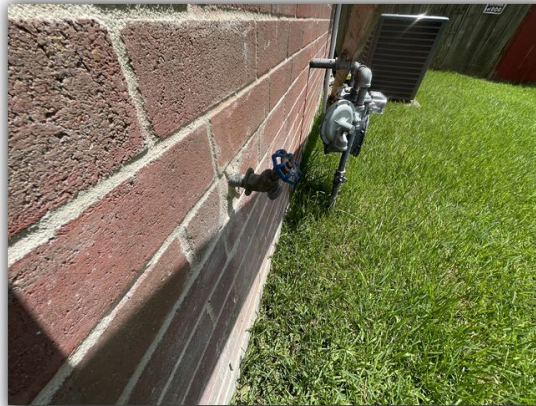
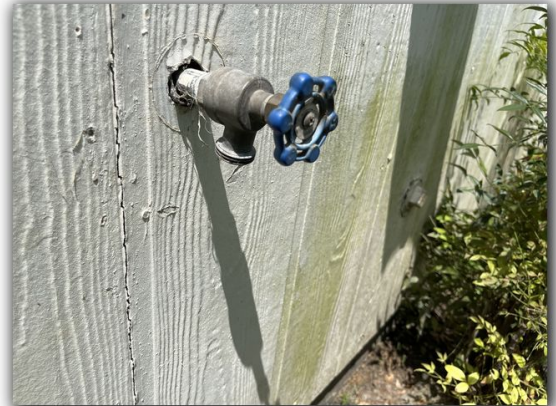
Exterior Faucets/Fixtures

- The exterior faucets / hose bibbs appeared to be performing properly and were in satisfactory condition at the time of the inspection.
- One or more of the exterior water hose bibbs (faucet) do not have a back-flow or anti-siphon device (Vacuum Breakers) in place. **Note:** *This is not uncommon to observe with a home of this age.*

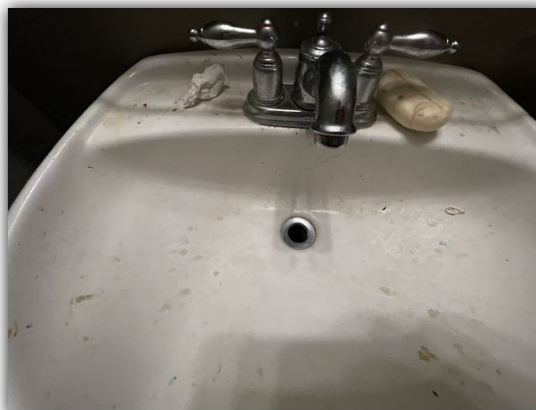
- Multiple bathtubs and sinks were observed to be missing the stopper.

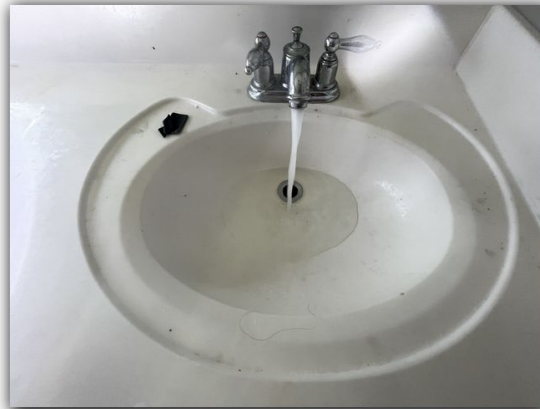
- The right side master sink and the secondary bathroom sink were observed to be slow draining.

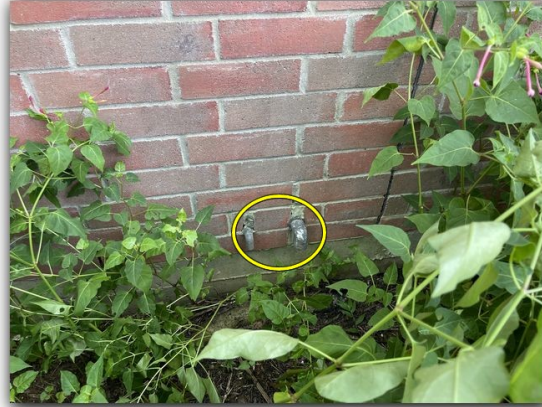
Location and Importance of Water Heater Drain Pipes

- The T &P Relief Valve and Overflow Pan drain pipes are located on the left side of the house. If water is ever seen draining from either of these pipes, contact a licensed plumber to evaluate the water heater(s) for necessary repair.

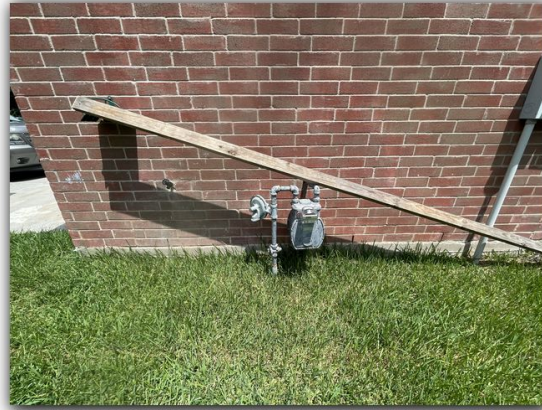
- The gas meter, visible gas plumbing system and gas valves appeared to be function properly and were in satisfactory condition at the time of the inspection.

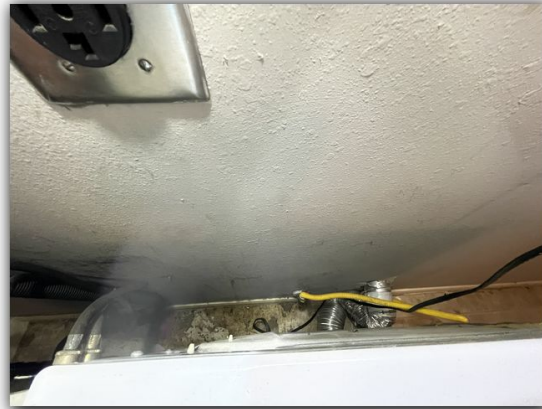
Laundry Gas Valve

- A gas valve was installed in the laundry room for a gas dryer. When not in use, this and any unused gas valve ends should be capped off for safety purposes. If a gas dryer is connected, ensure that the connection is properly installed and sealed.

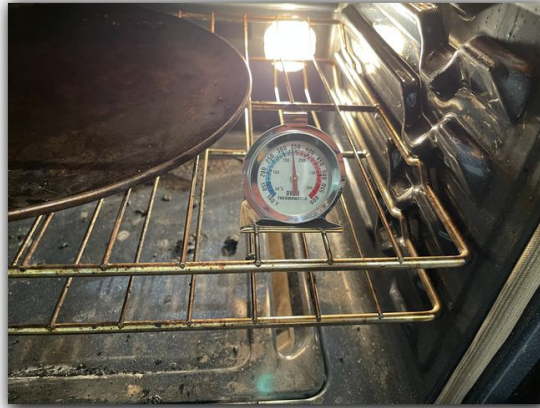
- The oven functioned satisfactorily on a normal temperature setting of 350 degrees and Broil setting. The oven light was operational, and the door seal appeared to be in good condition at the time of the inspection.

Model # NX58M6850SS/AA
S/N 0ETV7DDK600251R

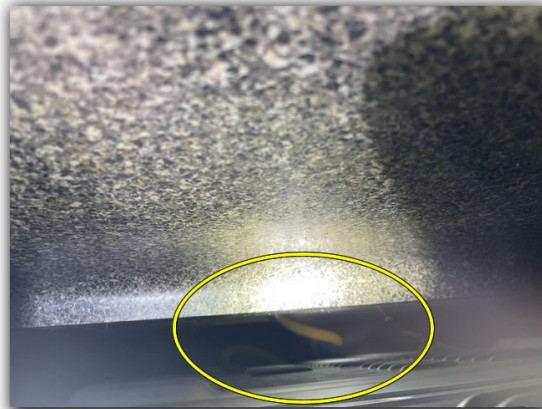
Gas Valve Location

- The gas shut-off valve for the cooktop / range was located behind the cooktop.

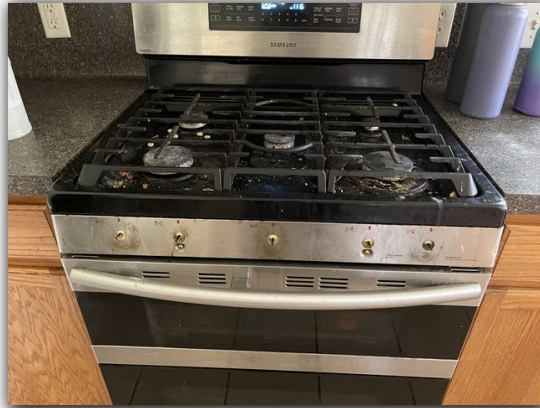
- Multiple control knobs are missing.

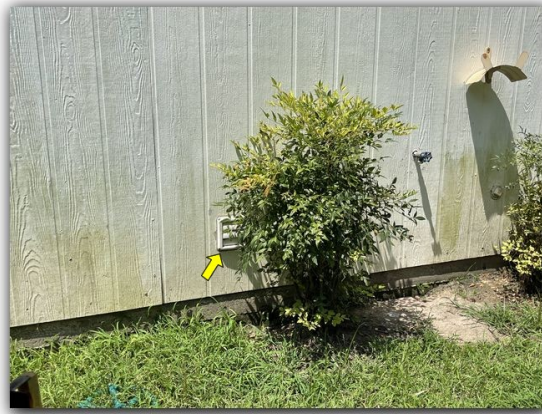
- The dryer vent location - Rear exterior wall
