Inspection Report

Property Address:
321 Preston Ln.
League City Tx 77573

PROPERTY INSPECTION REPORT

By: Jared Buchanan 22516 22516 / Buchanan Home Inspection 11/2/2021

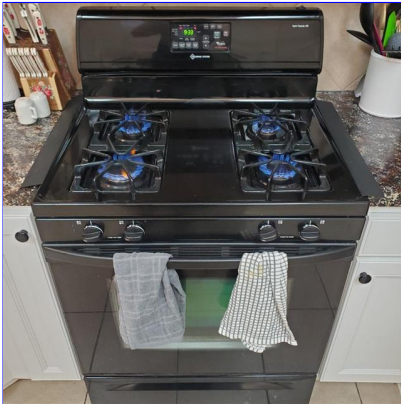
Anti tip brackets should be installed on the oven to help prevent tipping if children climb on oven.

C. Item 1(Picture) General view of Whirlpool range/ oven

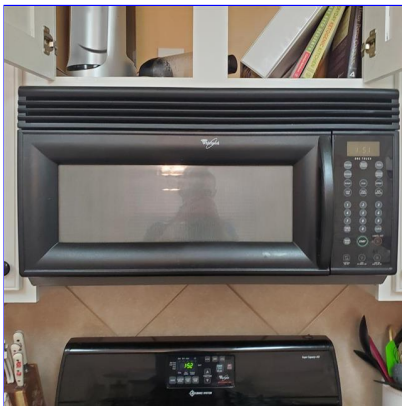
E. Item 1(Picture) General view of Whirlpool microwave
