## PROPERTY INSPECTION REPORT

Prepared For: Paul Varello  
(Name of Client)

Concerning: 22 Hepplewhite Way, Spring, TX 77382  
(Address or Other Identification of Inspected Property)

By: Dennis Inman, Lic #20664 05/17/2021  
(Name and License Number of Inspector) (Date)

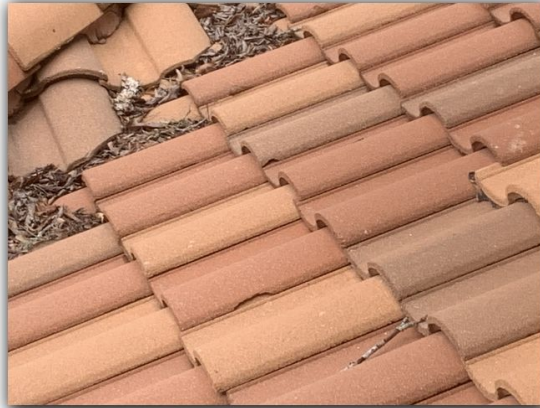
The debris should be cleaned from the gutters to allow proper drainage of rainwater from the roof covering.

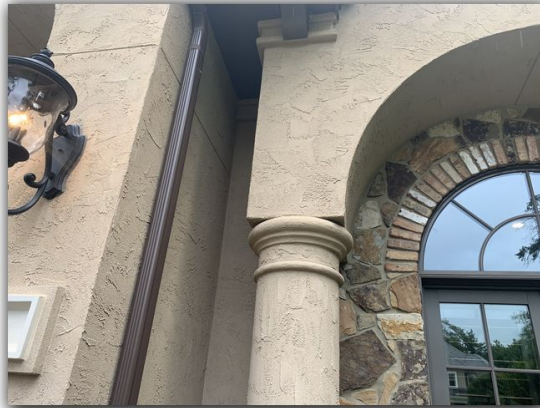
- Weepscreeds / drainage openings missing at the stucco walls - This could lead to the build up of moisture / water in the wall cavities and create future problems.

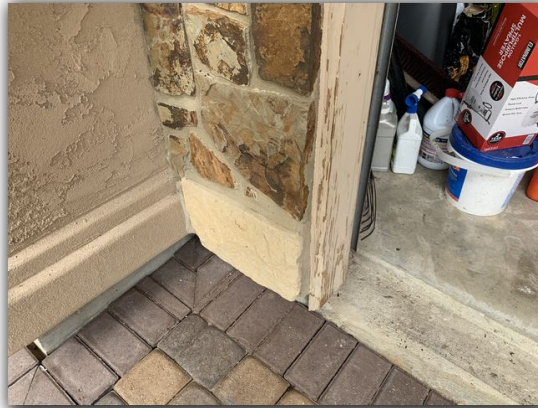
Flaking / damaged coatings were found at the garage overhead door jambs.

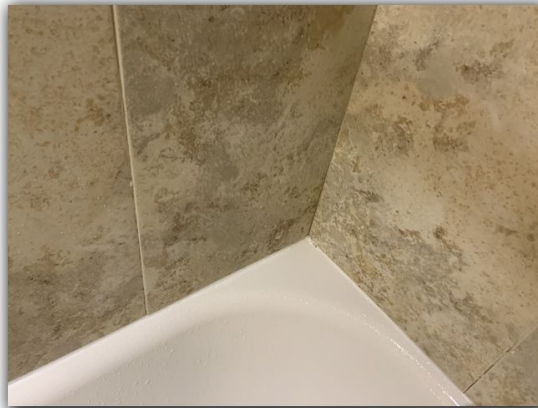
Damaged and missing grout/caulking was noted in the upstairs front middle guest bathroom shower/bathtub enclosure.

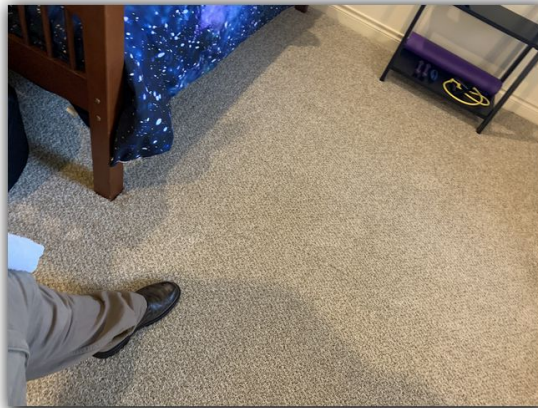
Loose flooring was noted on the second floor as evident by noise when walking. Recommend securing / re-nailing all loose flooring.

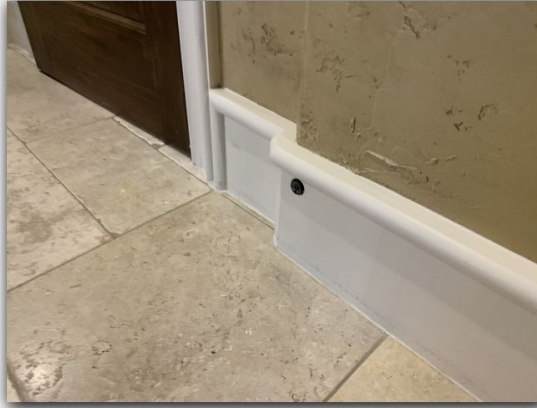
Missing door stops were found. Recommend the installation of missing door stops.

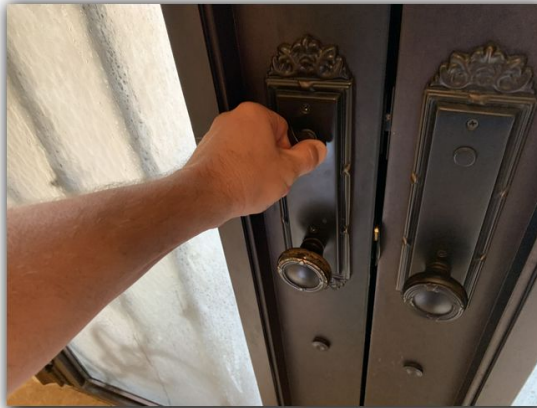
The dead bolt is difficult to operate at the front exterior door. All dead bolts should be adjusted to operate properly and easily.

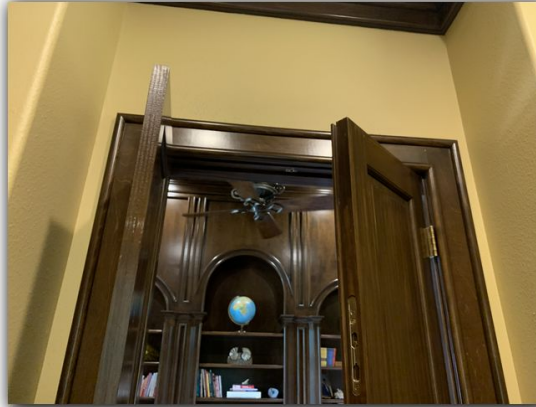
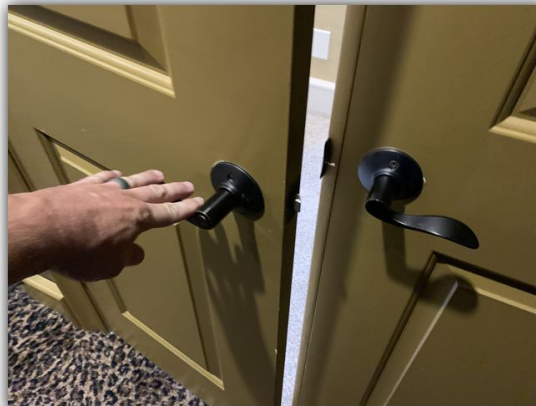
1. Study (Upper latch)
2. Master bathroom entry (Upper latch)
3. Movie room

All doors at the property should be adjusted to operate properly.

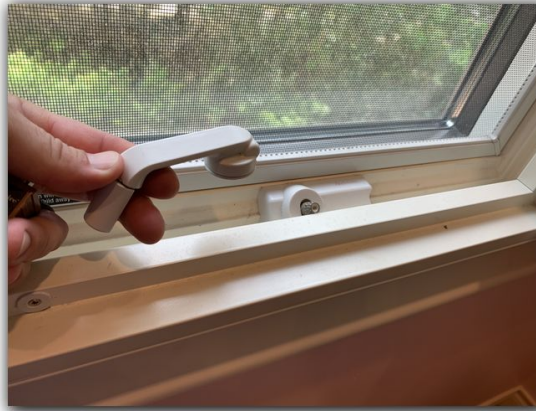
Operational cranks/handles did not have proper clearance for operation in the upstairs right guest bedroom. Improvement is recommended.

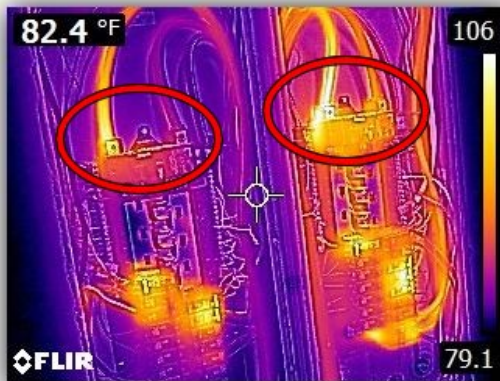
Missing screws were noted at the dead front cover located at the main service panel. Approved screws should be installed at the dead front to properly secure the cover.

A thermal imbalance was measured at the main service conductors possibly indicating a loose connection. Recommend further evaluation and repair by a licensed electrician.

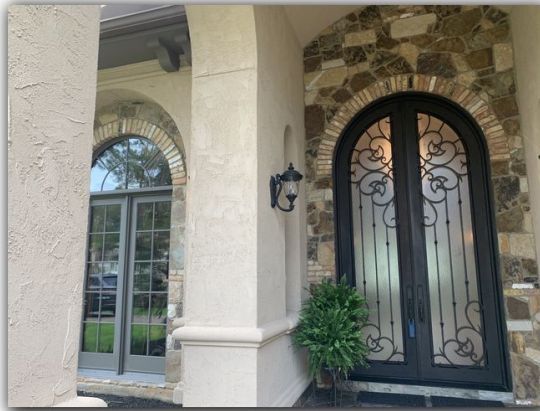
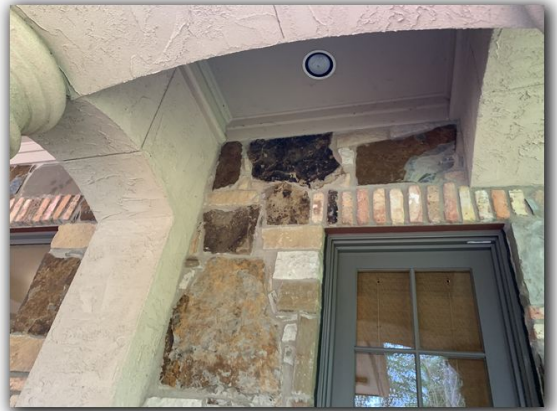
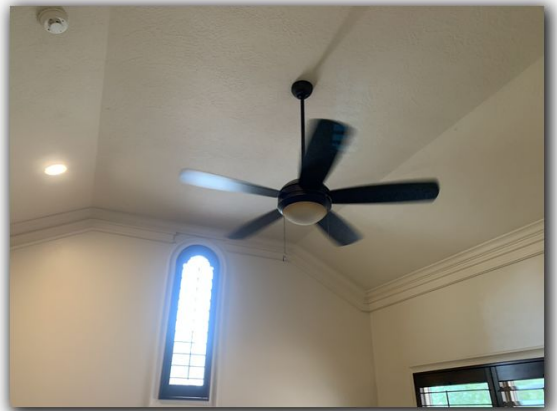
1. Front entry (Left fixture)
2. Rear left exterior
3. Front left guest bedroom
4. Front middle guest bedroom closet

If the bulbs are not blown, the circuit should be investigated.

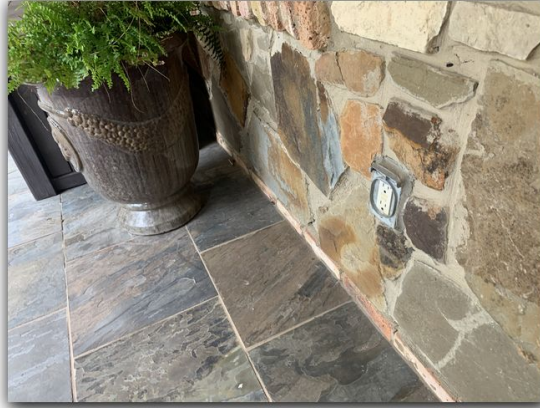
A missing receptacle cover should be repaired at the rear exterior.

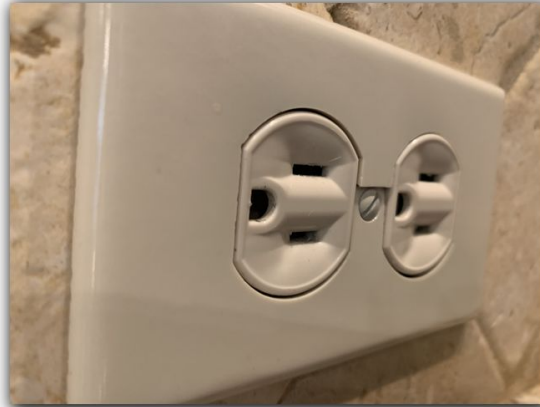
Damaged cover plates were found in many rooms in the home. Recommend replacement of the plates.

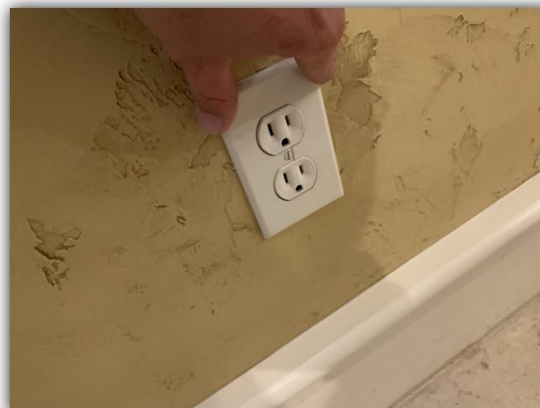
Loose receptacles were found at various locations. The receptacles should be better secured.

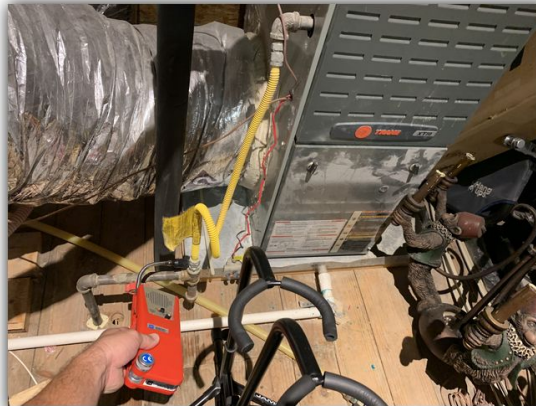
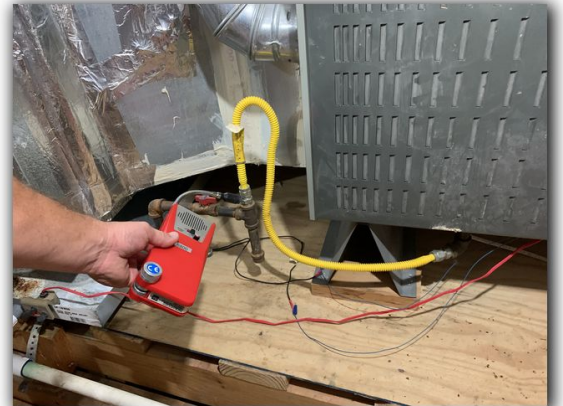
No gas leaks were detected by our gas detector during the inspection of the accessible gas lines and components at this fixture.

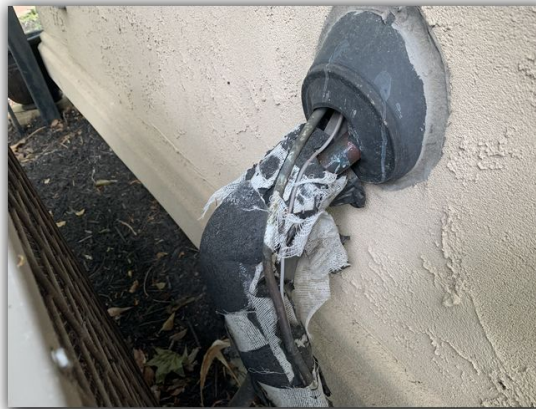
Damaged and missing insulation on the visible portions of the refrigerant lines should be repaired/replaced.

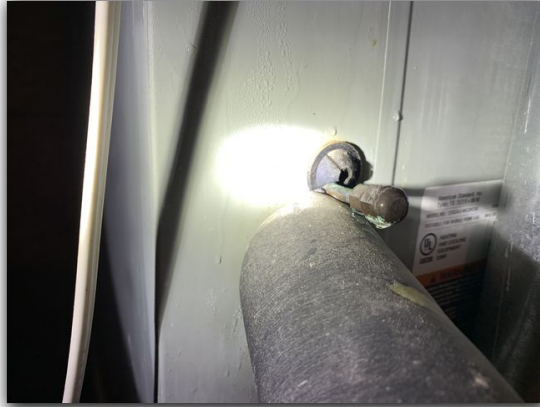
Voids and/or air leakage was found at the evaporator coil housing / plenum of unit(s) # 3 in the attic. Repair by a licensed HVAC contractor is recommended.

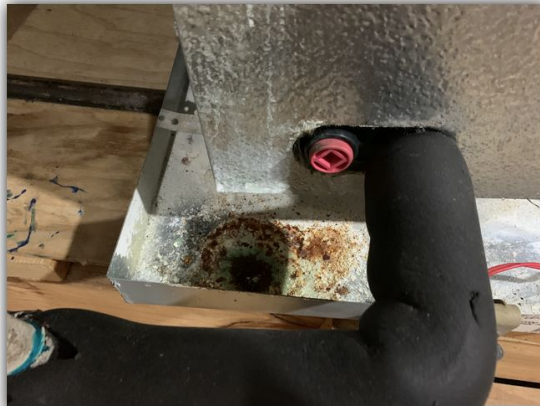
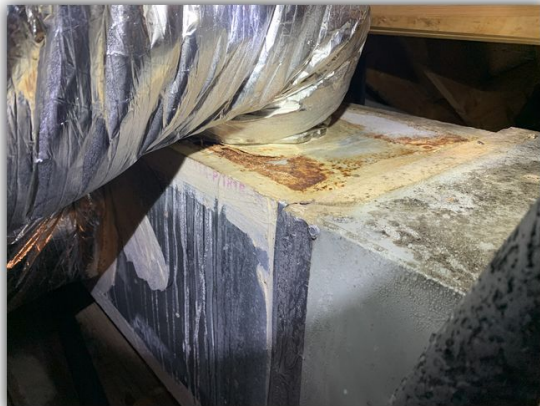
Moisture was observed at the evaporator housing of and/or pan beneath the cooling units in the attic. The moisture appears to be coming from under the evaporator or it could be a result of the refrigerant line not being properly insulated, thus allowing condensation to form on the line and drip into the housing pan. A licensed A/C technician should be consulted to inspect/repair any conditions causing the rust buildup in the pan.

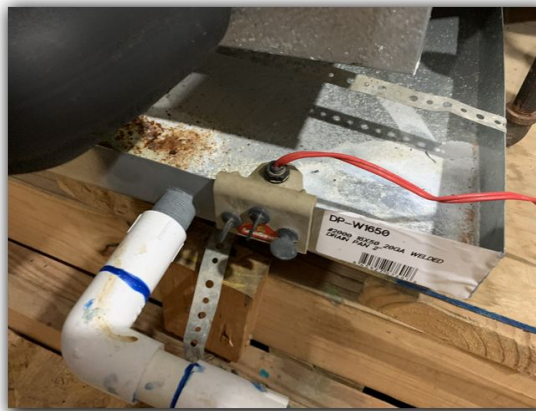
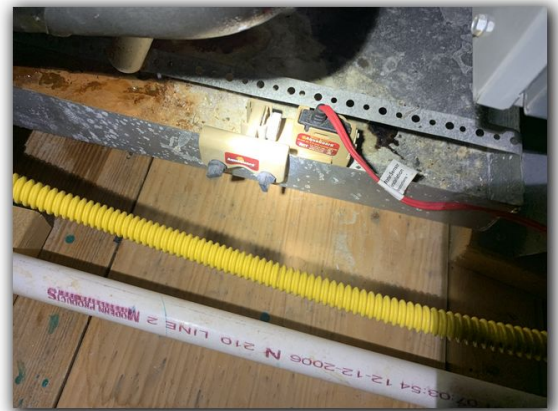
Float switch(es) have been installed at the emergency drain pan(s) located below the evaporator coil(s) in the attic. This is a feature that turns off the outside unit in the event water collects in the drain pan.

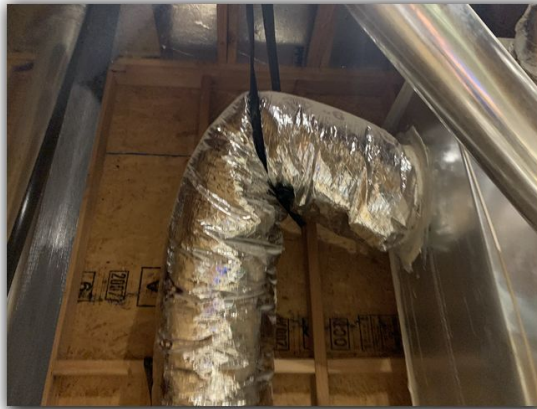
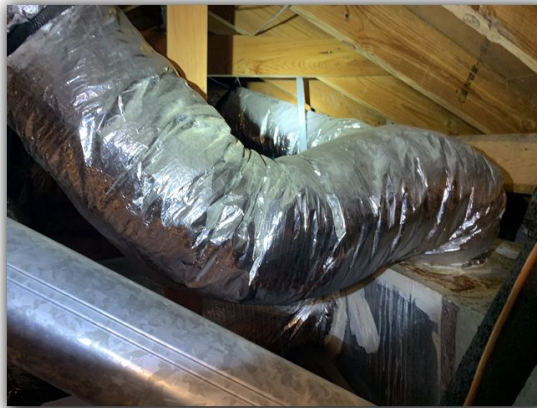
- Bends at ductwork improper

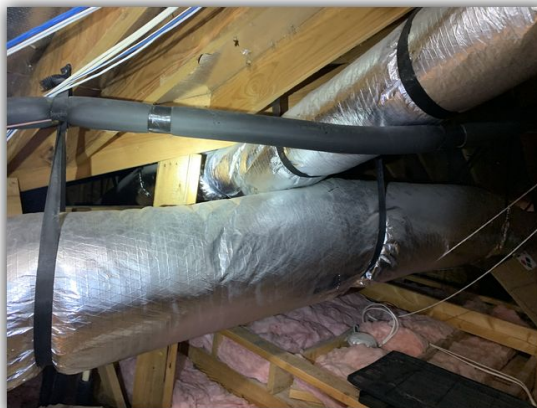
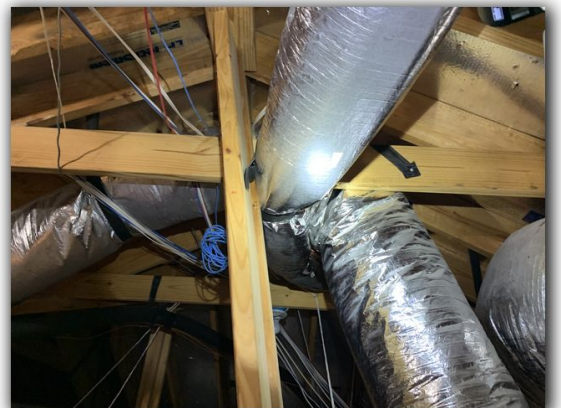
- Ducts In contact in attic

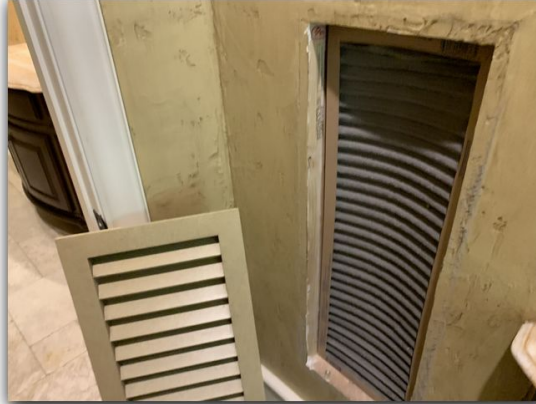
The return air filter(s) is dirty and need(s) to be changed.

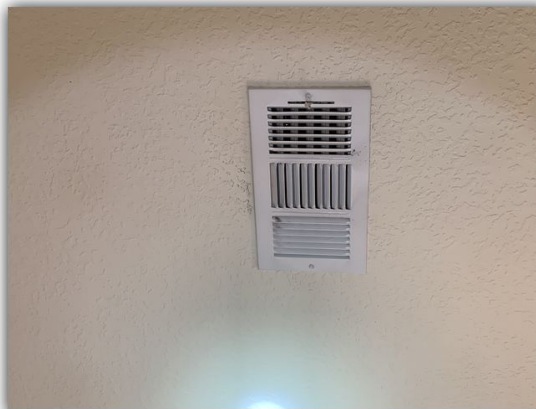
Debris was noted at some of the air registers in the property.

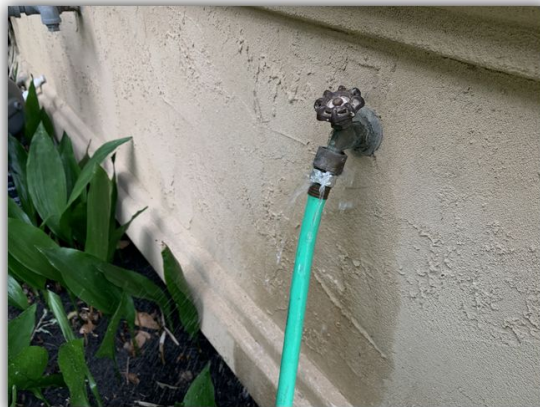
The left hose bib backflow prevention device is not functioning properly.

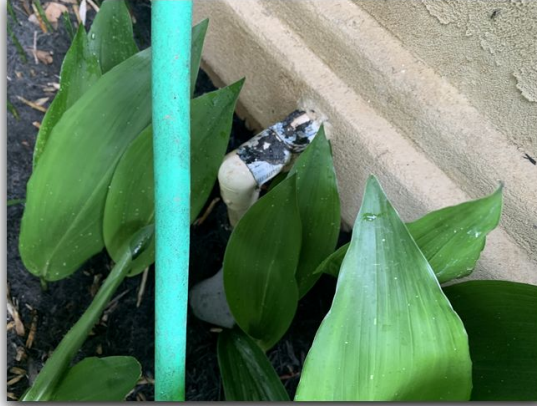
The supply piping on the exterior of the building / structure should be insulated to protect from freezing.

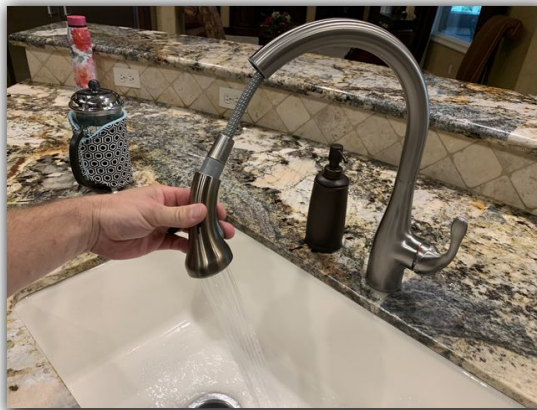
**Kitchen**

The sink sprayer attachment does not return to main spout after sprayer use. The spout does not properly retract after extension. Improvement is recommended.

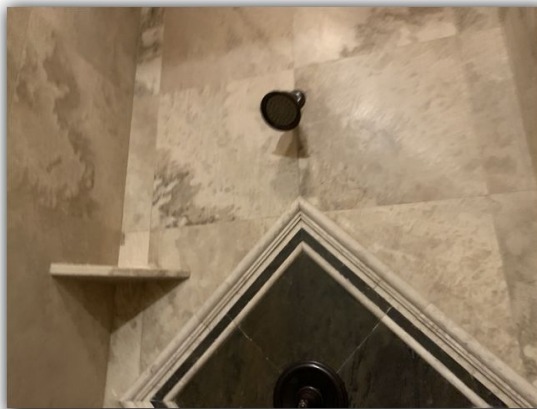
**First Floor Guest Bathroom**

Loose supply piping was found at the shower.

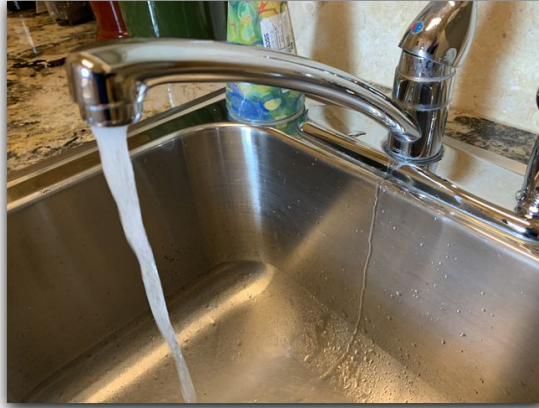
**Laundry Room**

The faucet base is leaking during operation of the supply plumbing as evident by water dripping. Repairs or replacement of the valve is recommended.

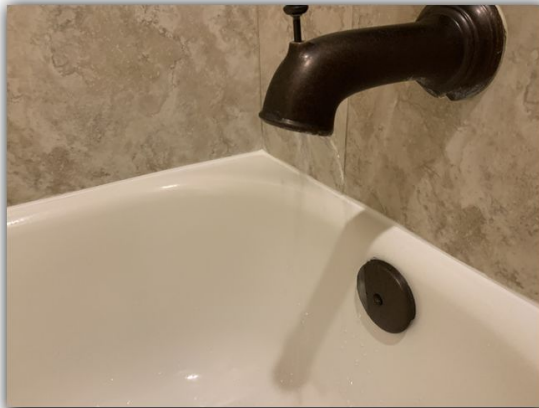
**Upstairs Front Left Guest Bathroom**

The shower/tub valve is not operating as intended. When the valve is in the shower position, the tub downspout continues to flow water resulting in low water pressure at the shower. Recommend repairs.

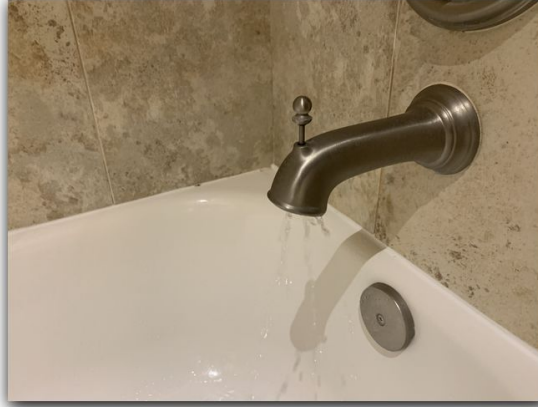
**Upstairs Front Middle Guest Bathroom**

The shower/tub valve is not operating as intended. When the valve is in the shower position, the tub downspout continues to flow water resulting in low water pressure at the shower. Recommend repairs.

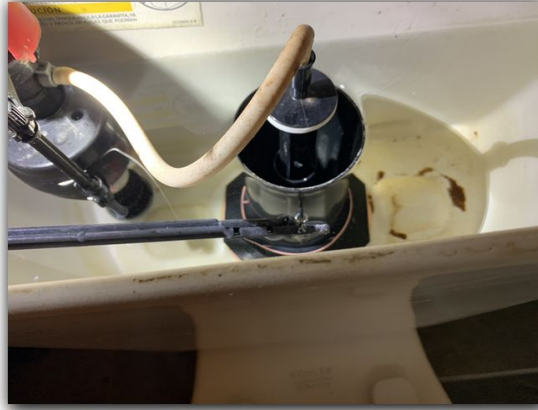
**Pool Bathroom**

The toilet float assembly should be adjusted/improved to prevent contiguous filling/overflow of the toilet tank.

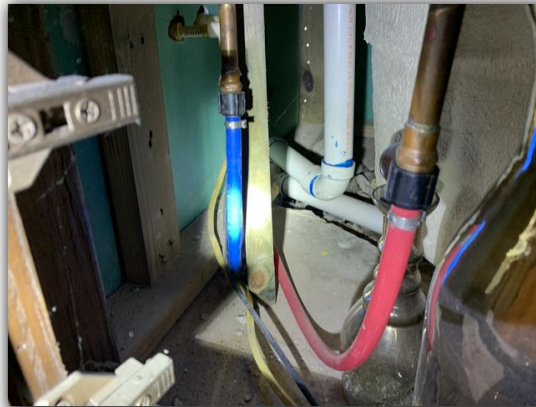
Active leaks were found at the tub. Recommend repairs of the leaks by a licensed plumber and repairs of any damage caused by the leaks.

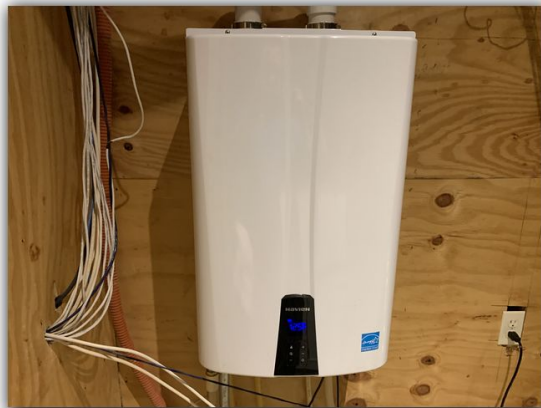
A single tankless water heater was found in the attic, appearing to supply the entire home. It was not determined during this inspection if this installation will be adequate for full occupancy/usage in the home. A licensed plumber should further evaluate for the client the water heater capacity and anticipated hot water usage and occupancy of the home.

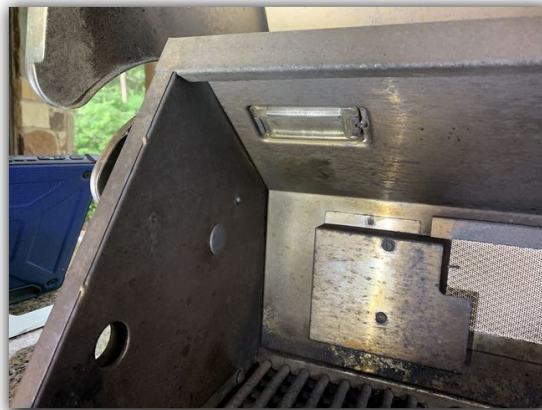
The outdoor grill light did not function during testing.

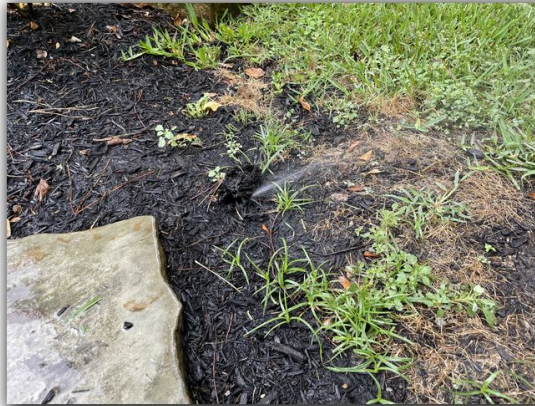
**Heads were found in zone #7,19,20 that need to be raised due to the height of the grass and other vegetation. This problem is preventing the heads from properly watering the designated area.**

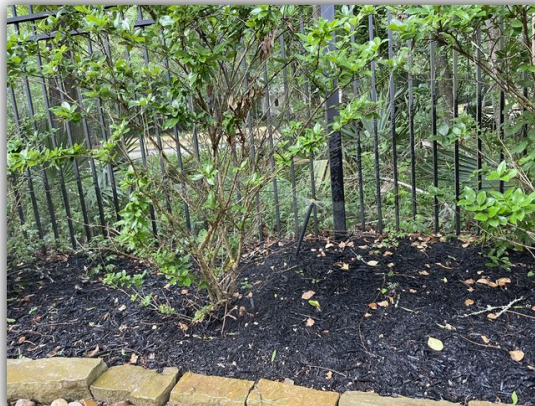
**Sprinkler head is not level in zone #13 causing the head to not provide proper coverage to the area intended. Recommend re-aligning the heads to insure proper watering and coverage.**

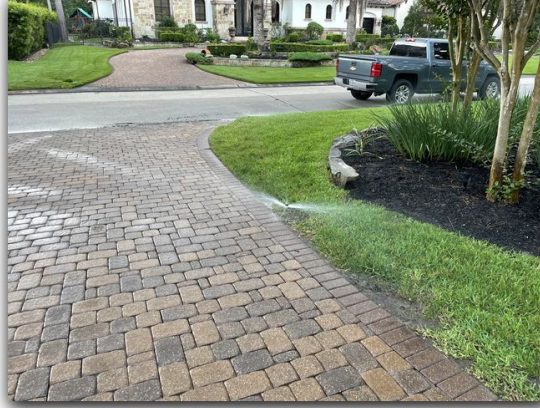
Broken sprinkler heads were found in zone(s) #\_10\_. A qualified tradesman should be consulted to perform all necessary repairs.

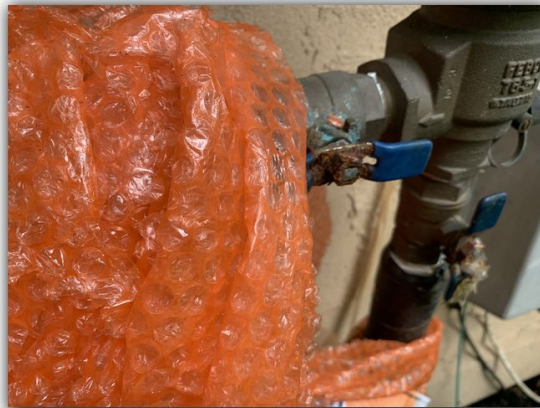
Rust and corrosion were found at the valve handles installed at the backflow prevention device. The valve handles should be repaired as the rust will eventually cause the handles to become inoperative.

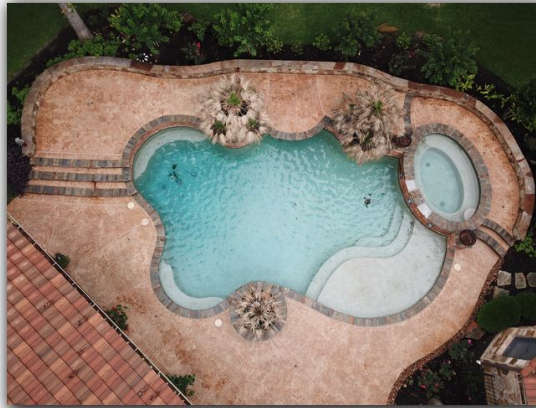
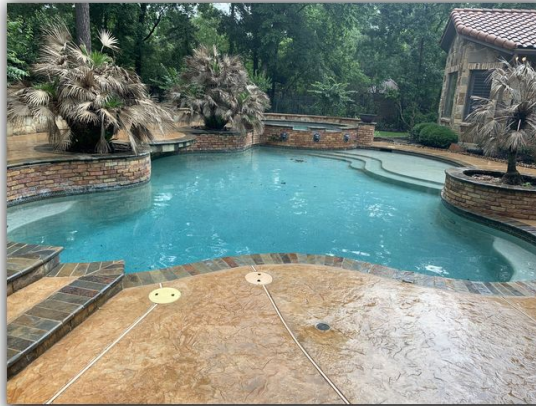
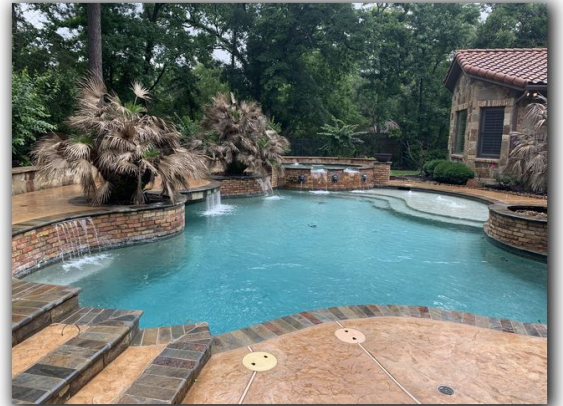
**Type of Construction: Gunitite - Pebble Surface**

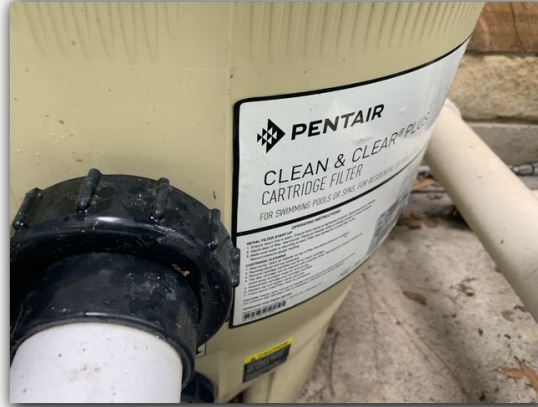
**Type of Filter:** Cartridge

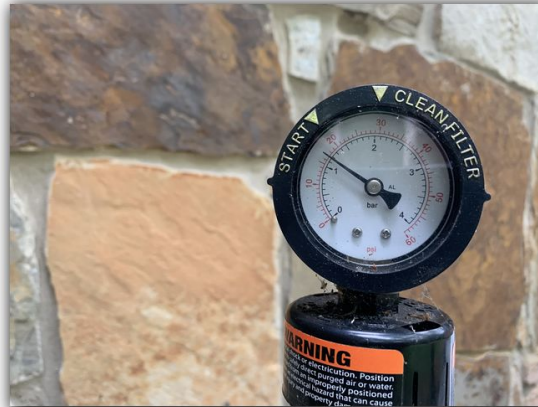
**Main Filter Pressure:** 15 to 20 psi

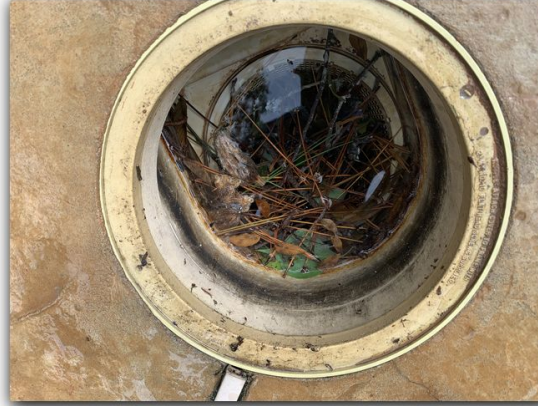
The pool baskets should be cleaned of debris.

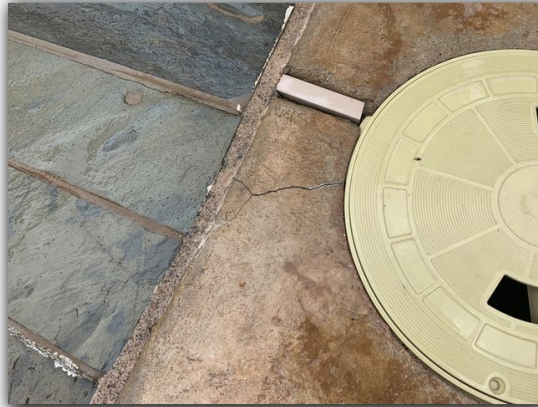
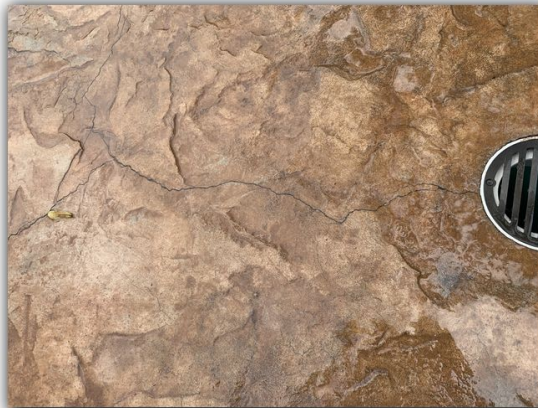
Damaged/cracked decking was found at multiple portions of the pool perimeter.

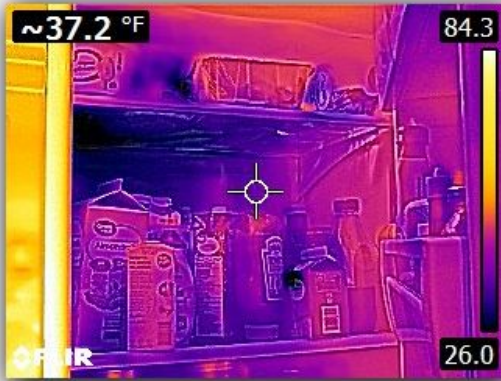
- Refrigerator Temperature Measured: 35 - 39 Degrees F
- Infrared Image:

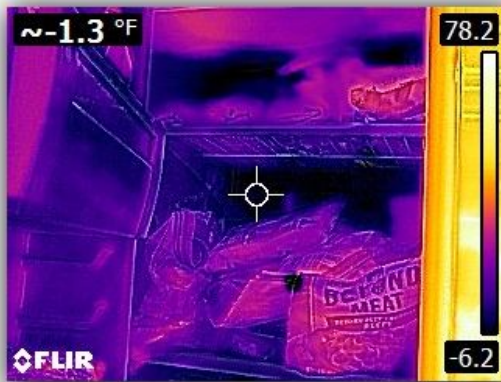
- Freezer Temperature Measured: 0 - -4 Degrees F
- Infrared Image

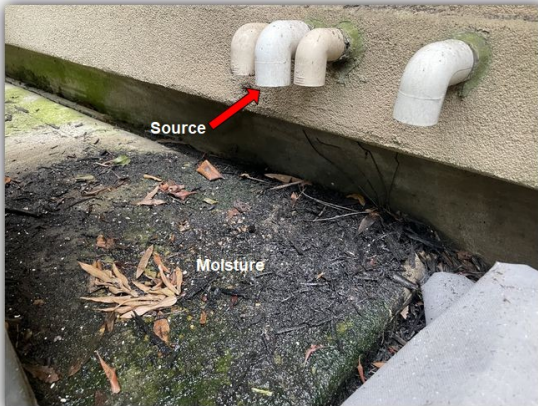
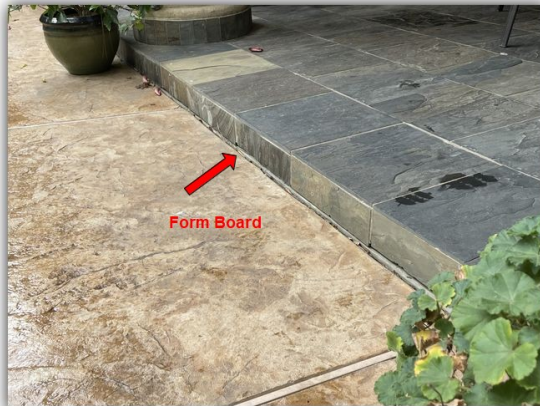
Conductive conditions were found during the inspection of the property, which could conceal insect activity or promote future insect activity or conceal damage. DUE TO THE CONDUCTIVE CONDITIONS FOUND WE CANNOT GUARANTEE THE ABSENCE OF WOOD DESTROYING INSECTS. The conductive conditions should be corrected. After the conductive conditions have been corrected it is recommended that the property be re-inspected for wood destroying insects. The client should take into consideration the cost of associated with correcting the conductive and / or performing a treatment and plan accordingly.

Conducive Conditions Present: Yes (Sample Pictures Below)

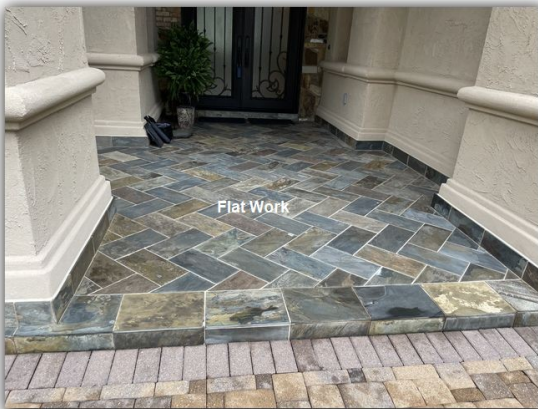
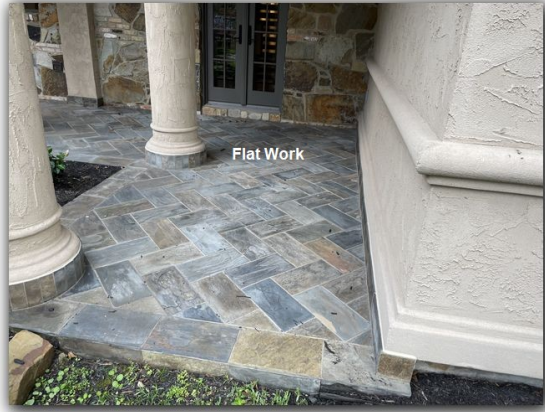
Inaccessible Areas Present: The foundation walls are not visible on porches in the front and back of the structure
