## PROPERTY INSPECTION REPORT

**Concerning:** 14724 Perthshire Road Unit F, Houston, TX 77079  
(Address or Other Identification of Inspected Property)

**By:** Kelly M Herbert, Lic #TREC21822 10/22/2021  
(Name and License Number of Inspector) (Date)

Report Identification: P21-1212 Bounds, 14724 Perthshire Road Unit F, Houston, TX

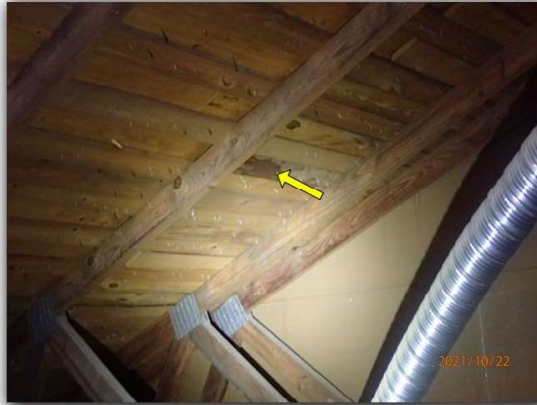
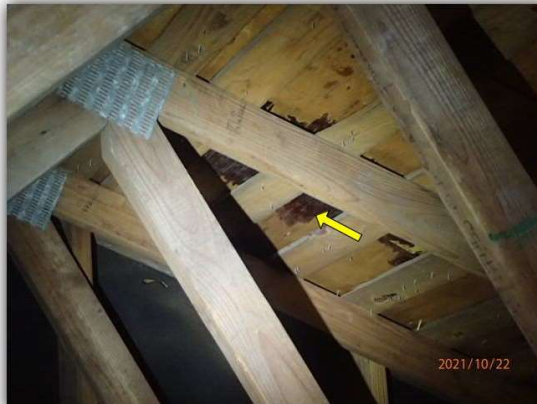
**Observed Water Stains on Roof Deck at Main Structure. Recommend Further inspection by Qualified Roofer.**

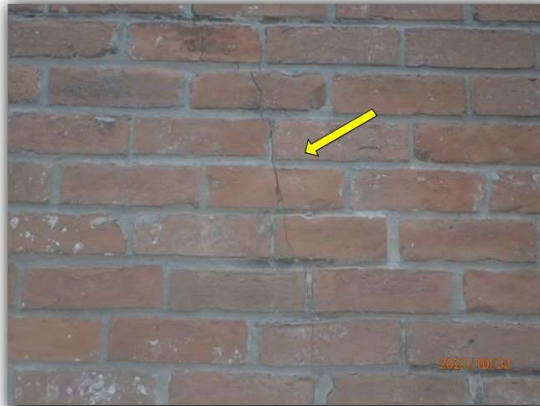
Observed mortar cracks/voids at Front & Right-sides of Structure. Recommend re-pointing mortar.

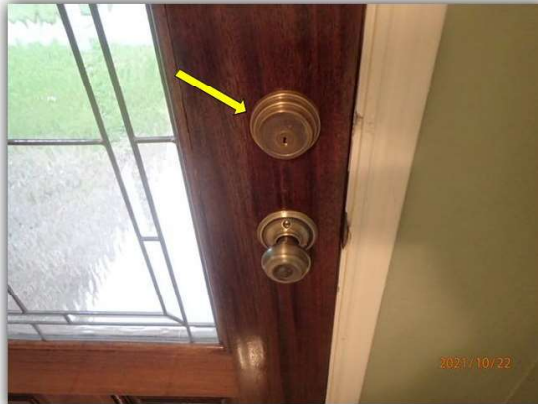
**Exterior door deadbolt double keyed. This could create an egress issue during an emergency. Recommend replacing with a thumb latch.**

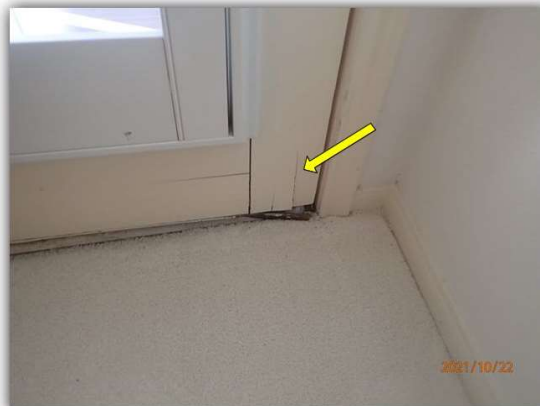
**Wood Deterioration observed on Right-Side Balcony Access Door. Recommend replacing Door.**

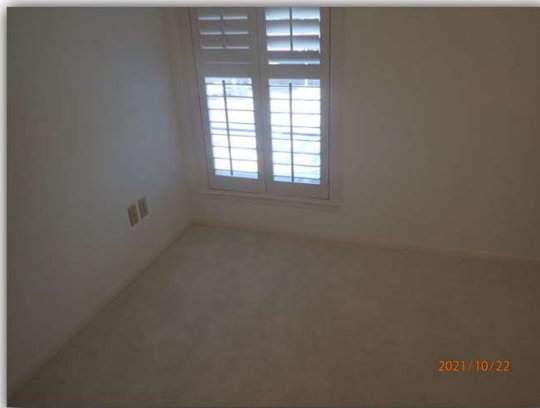
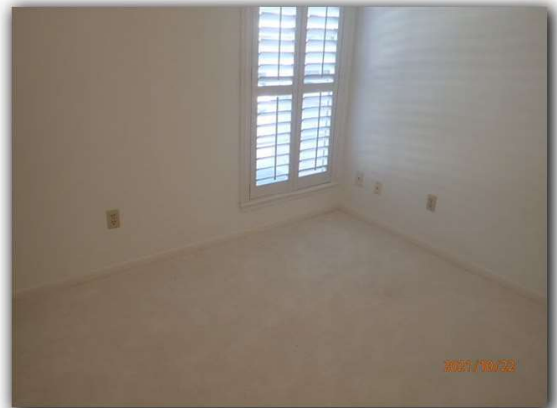
**Upstairs Bedroom windows less than 24" above floor and more than 72" above grade. Per today's standards these window should not open more than 4" for safety reasons.**

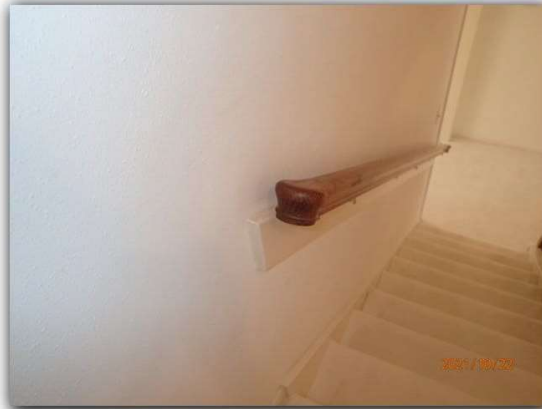
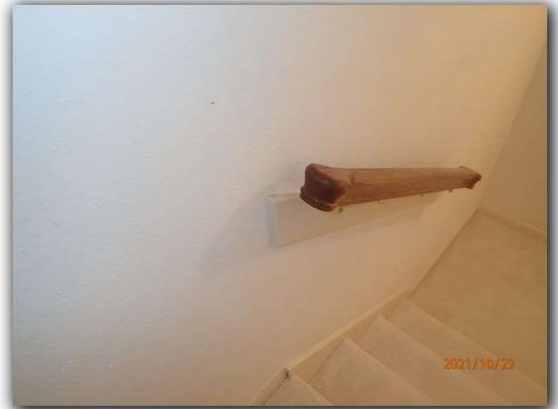
**Stairway hand rail does not terminate to wall per today's standards.**

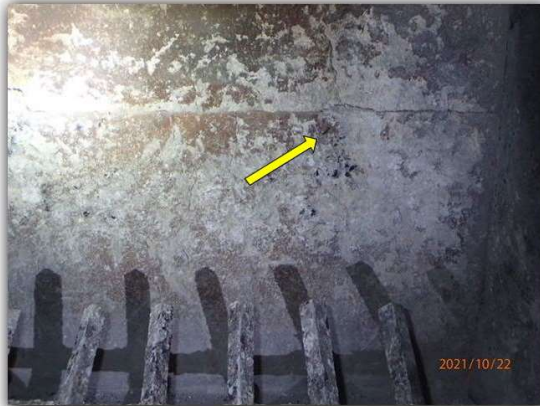
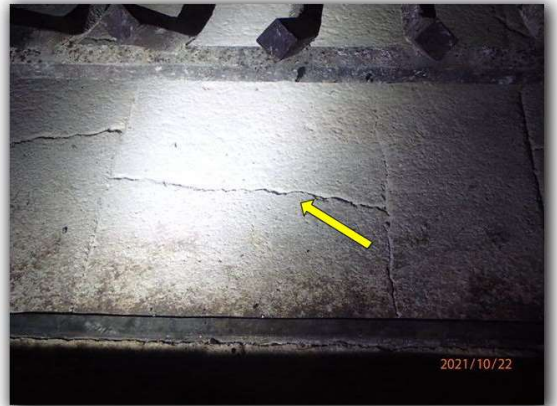
Bricks in back of firebox need pointing up with fire clay.

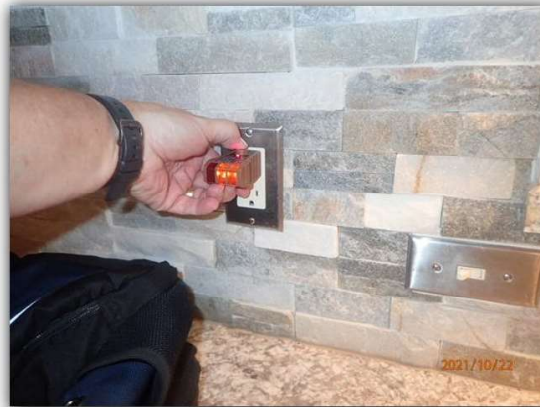
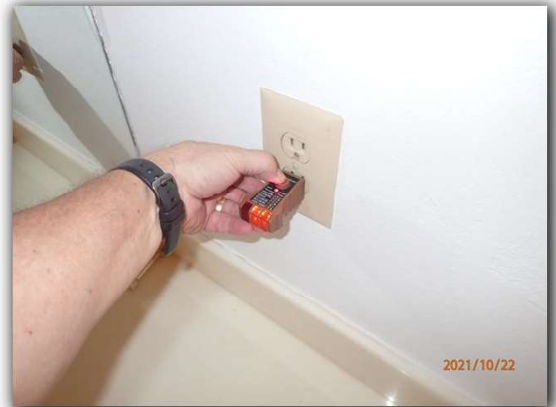
**GFCI lacking at Exterior, Kitchen, Master Bath, Hall Bath(s), Powder Room, Wet Bar, Utility. Per today's standards ALL these area outlets require GFCI protection.**

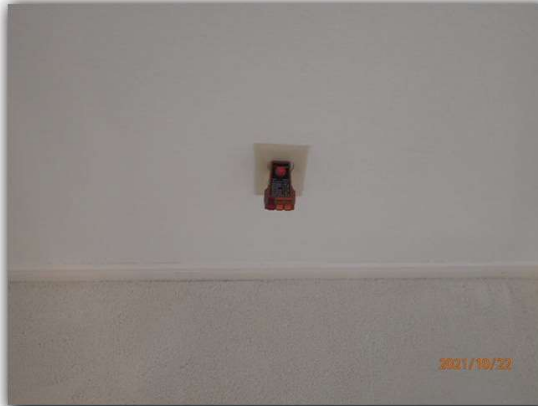
**Electrical Outlet inoperable at Master Bedroom.**

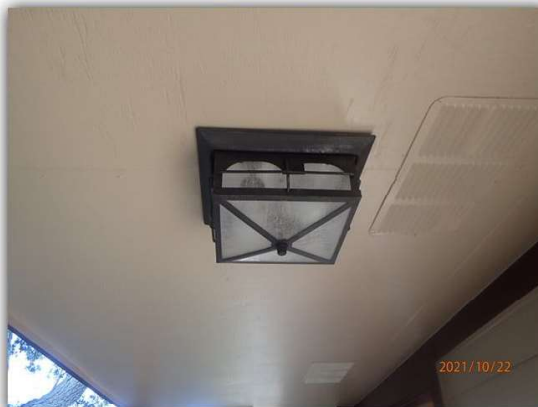
**Light fixture bulb missing/non-functional at Balcony, Left-Rear Bedroom & Master Bath.**

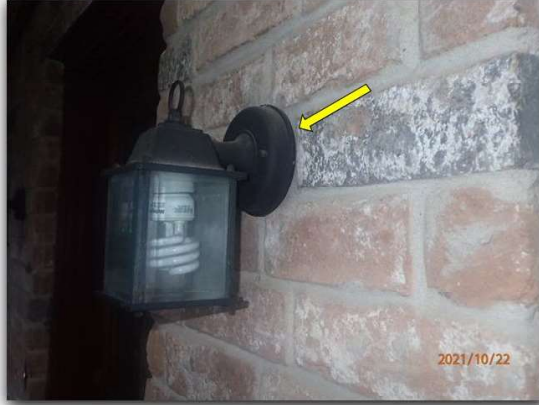
Exterior Light fixtures not sealed to wall. Recommend sealing to prevent moisture problems.

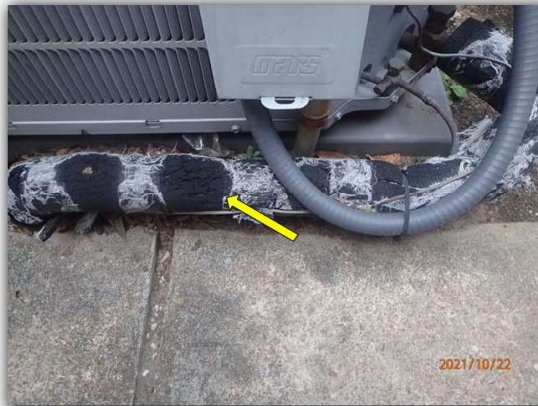
Insulation damaged/missing on Suction line at Condenser.

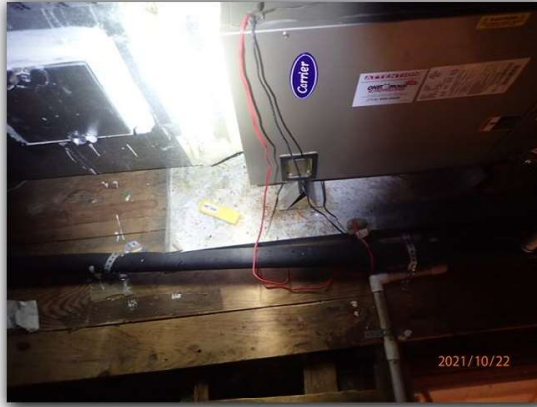
**Rust/Water Stains observed in secondary A/C Drain pan(s).**

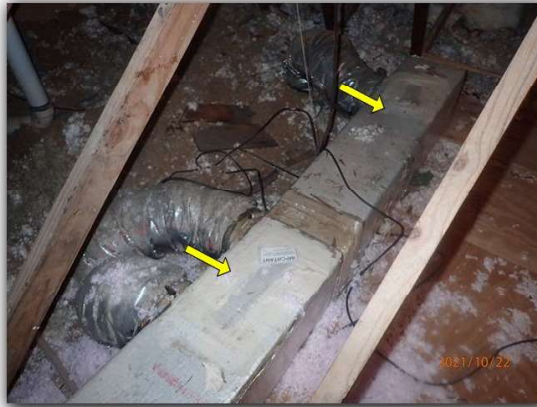
**NOTE: Duct work appears to be old and may not be efficiently distributing air. Recommend consulting with Licensed HVAC Contractor.**

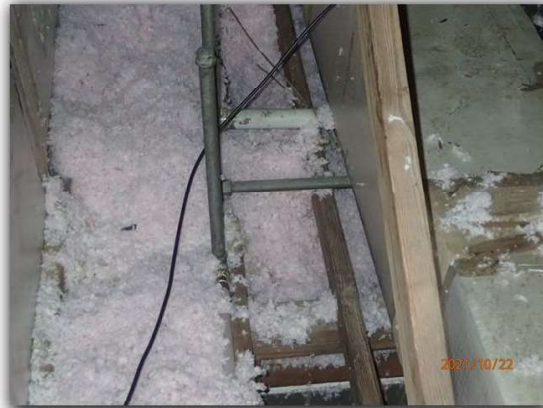
**Note: The water supply pipes in this home are made of Galvanized Pipes. I have attached a document to the bottom of this inspection report giving more information and history about this type of water supply pipe. It is the buyers discretion to have the water supply pipes reviewed by a licensed plumber.**

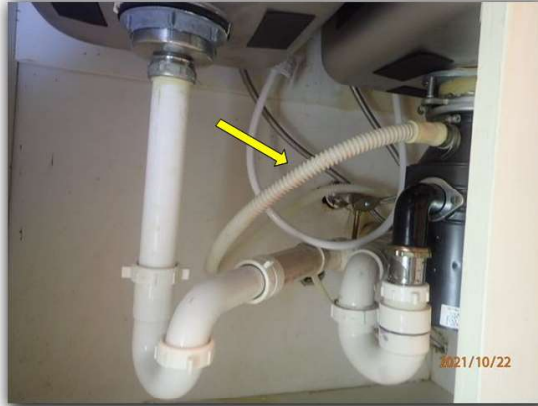
**Insufficient loop in drain line to disposal. Elevate line to counter top level.**
