Home Inspection Report

4635 Pippin Glen Dr, Humble, TX 77396

Thursday, October 14, 2021

PROPERTY INSPECTION REPORT

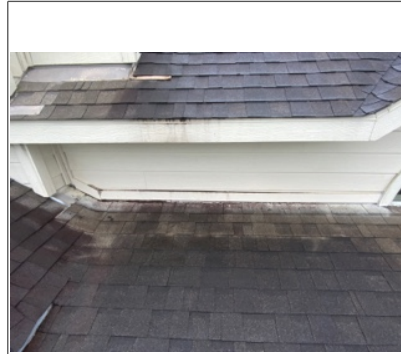
Flashing incorrectly installed.

- Repair/Replace damaged and flashings.
- seal all exposed nail heads.

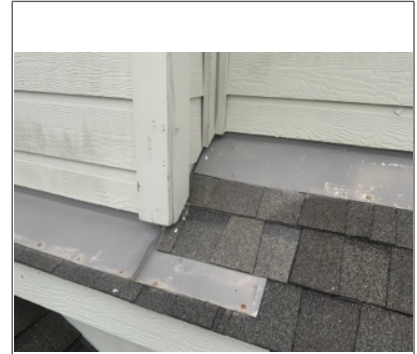
Seal all exposed nail heads.

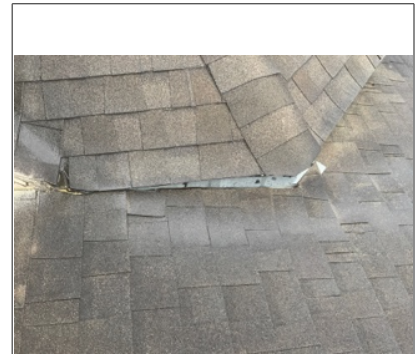
Soft spot on Roof at Back of home.

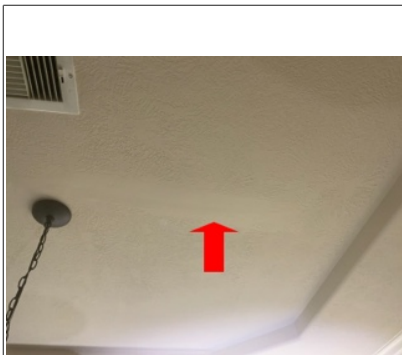
Patching in areas throughout the home.

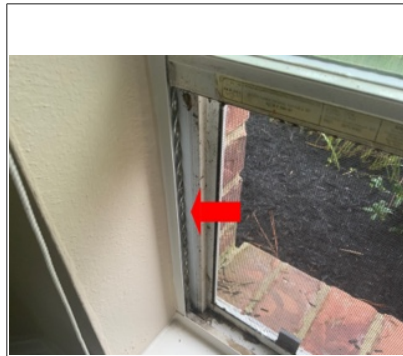
Sprung balance spring at dining area.

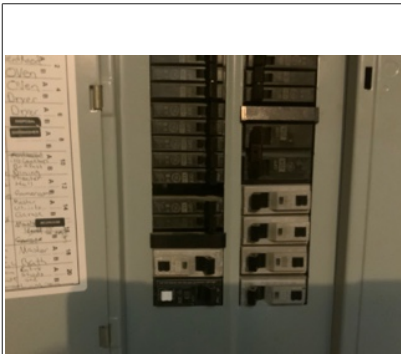
Comments: • You have 150 amp service to your house.
• Home is supplied with aluminum service wires.
• Any openings in the main panel should be covered.

Openings in Panel.
