# *514 Inspections*

22 Artist Grove, Spring , TX 77382

Date of Inspection: 12/11/2021 Time: 8:30 AM Size: 0

## PROPERTY INSPECTION REPORT

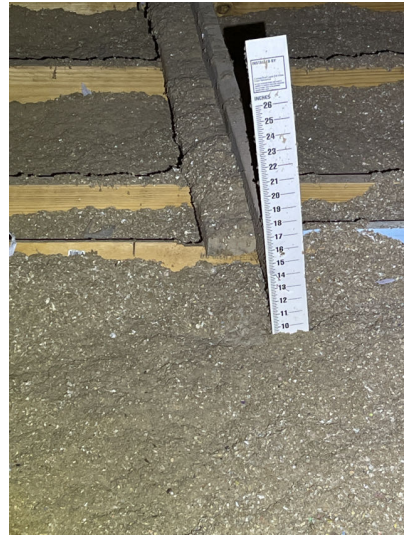
*Insulation depth*

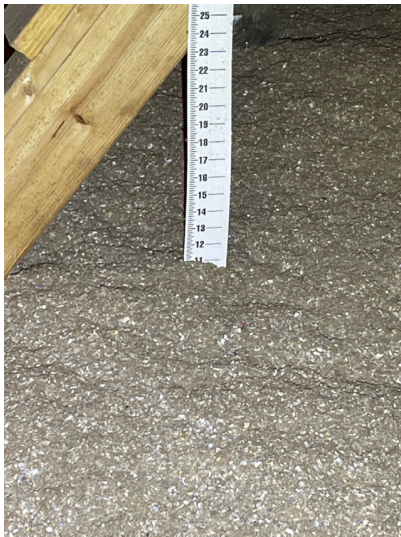
*Insulation depth*

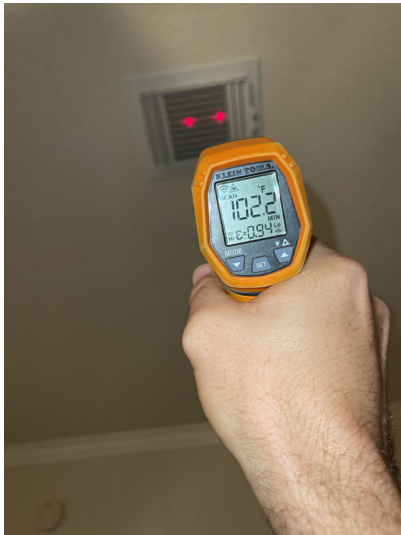
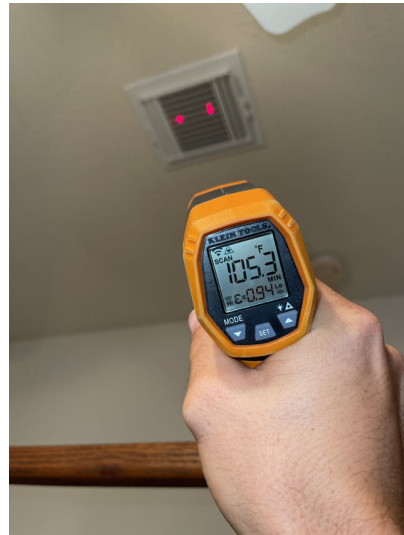
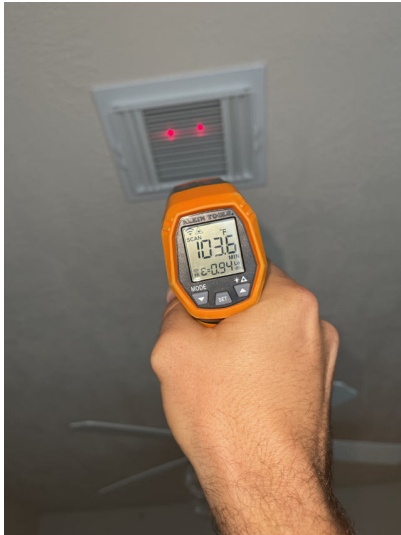
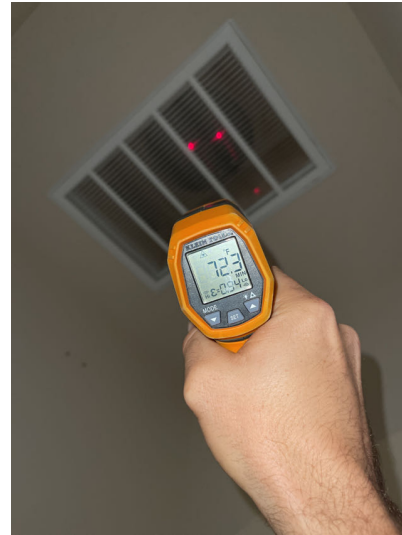
- Note: HVAC systems are prone to recalls. The client should investigate the system and check for any recalls. A good site to check this is at [www.hvacrecall.com](http://www.hvacrecall.com)
- Strongly recommend an HVAC technician review the system prior to each heating season and perform maintenance as needed. Please note that to fully inspect the heat exchanger and components, the unit must be physically dismantled and heat exchangers removed for examination. Due to the limitations of TREC, this procedure is prohibited, and the inspection of the heat exchanger was limited to a visual inspection of the outside of the unit. No covers were removed
- The unit appeared to be functioning as intended at the time of the inspection
- Temperatures were taken at both the heat supply air registers and the return air register. The differential was measured and does fall within the acceptable range

Supply temp

Return temp

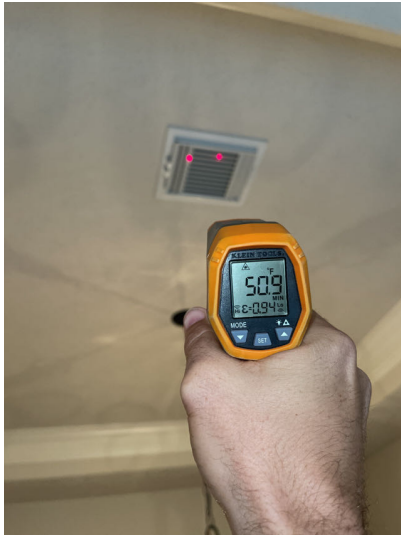
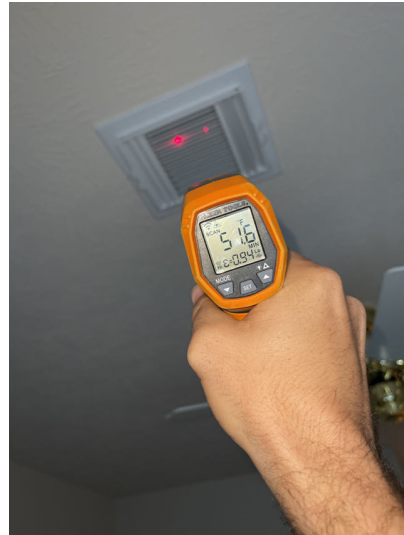
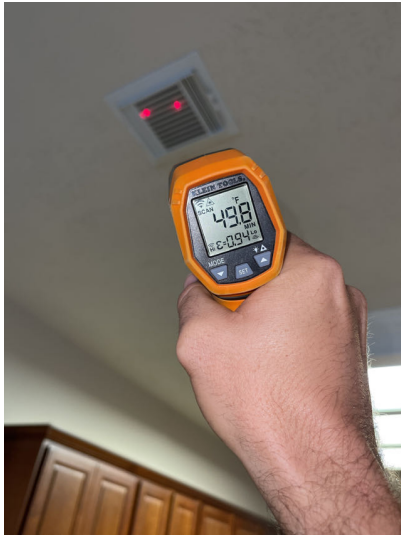
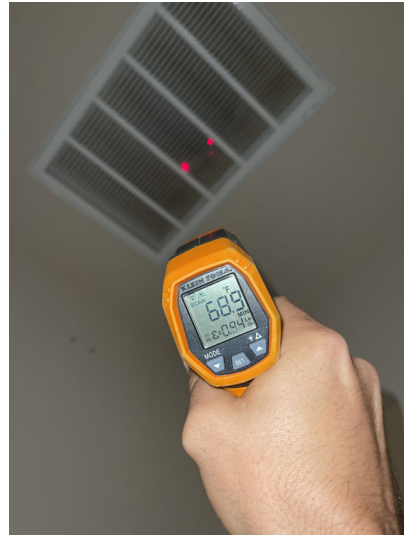
*Supply temp*

*Return temp*

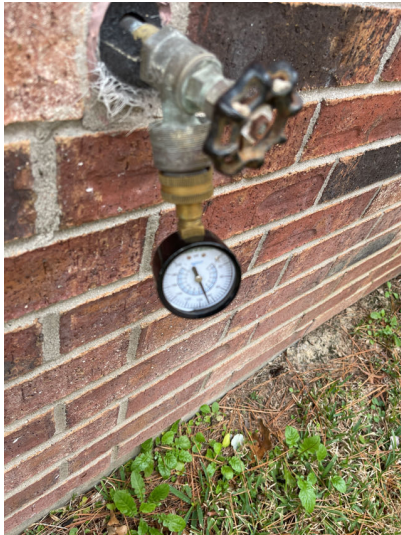
*Water pressure*

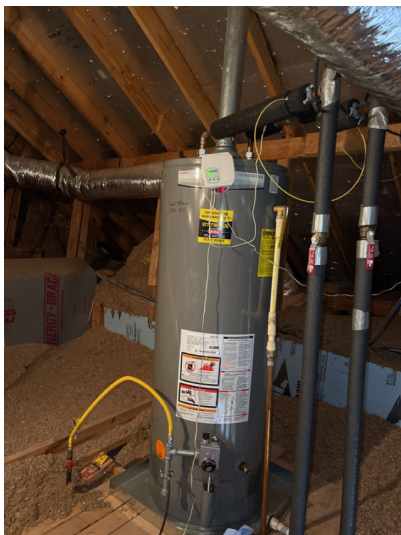
- The water heater and its components were found to be performing and in satisfactory condition at the time of the inspection
- There was a shut off valve on the hot water supply. This should be removed or disabled

Overview

50 gallon unit, manufactured in 2018

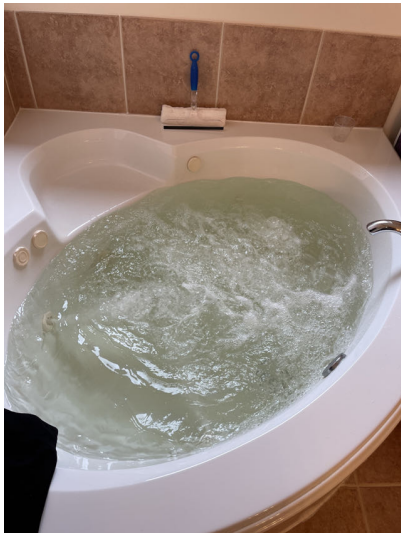
- This component appeared to be functioning as intended at the time of the inspection
- It was observed that no access panel {s} were readily available to view the motor and/or equipment lines
- There was no GFCI receptacle for the hydromassage component was located inside the master closet

Operational

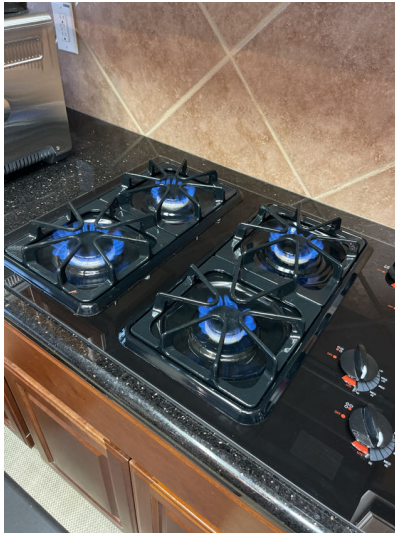
*Operational*
