## Property Inspection Report

3923 Laguna Dr, Galveston, TX 77554

Date of Inspection: 5/20/2020 Time: 10:00 AM - 12:30 PM

Inspector: Ruben Vasquez

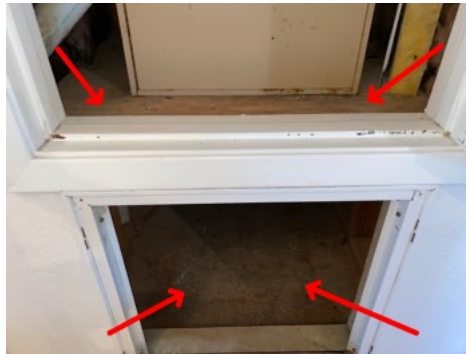
No safety pan

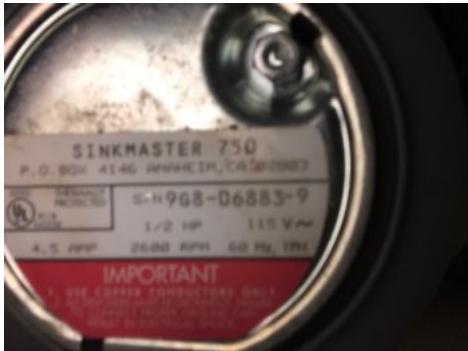
Model and Serial numbers

The garbage disposal was missing the splash guard at the time of the inspection. We recommend a new insert be installed to prevent injury from items ejected during disposal operation.

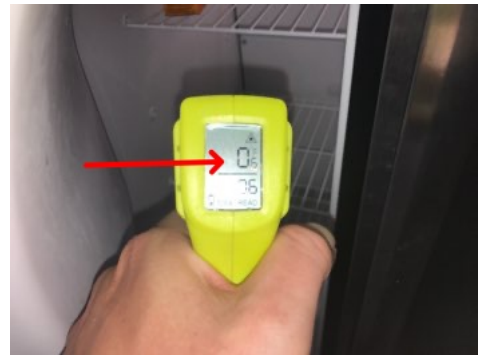
Freezer cool temperature

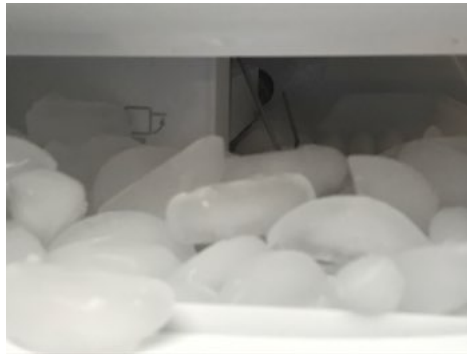
Ice maker ok
