PROPERTY INSPECTION REPORT

Concerning: 9322 Eckert, Arcola, TX 77583
(Address or Other Identification of Inspected Property)

By: Riley Rundquist, Lic #24486
(Name and License Number of Inspector)

02/11/2021
(Date)

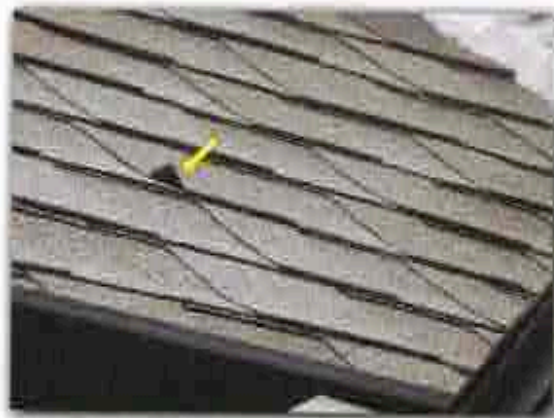
There are shingles lifted at the front.

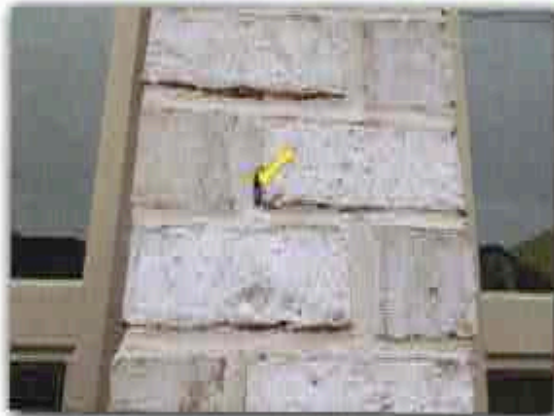
There is a gap in the mortar at the front left side.

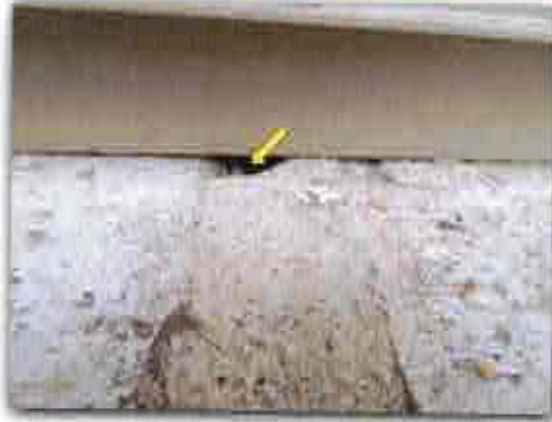
There are gaps in the mortar around windows in multiple locations.

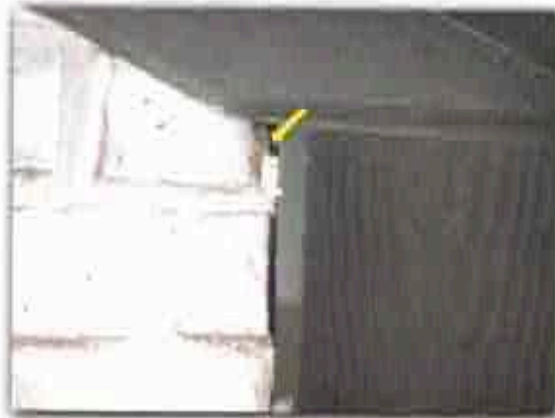
There is a gap where the fascia board meets the wall near entryway.

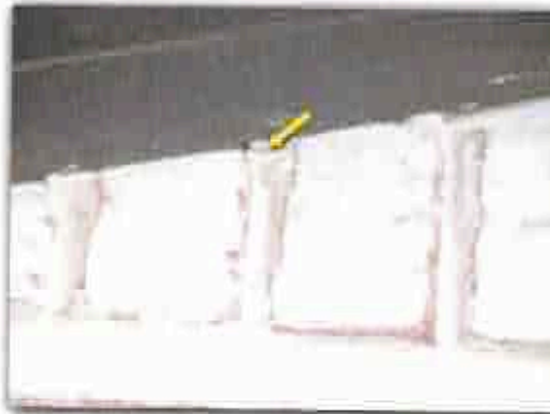
There are gaps in the mortar above the garage.

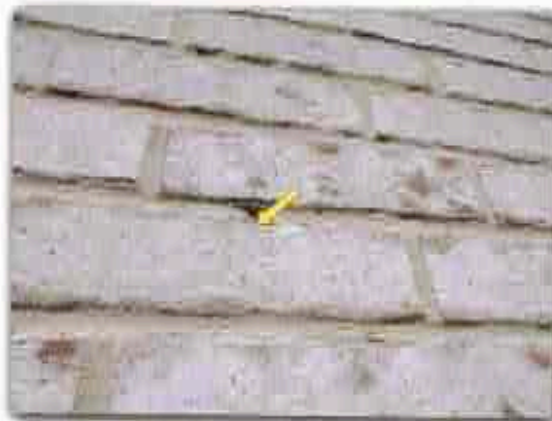
There is a gap in the mortar on the right side.

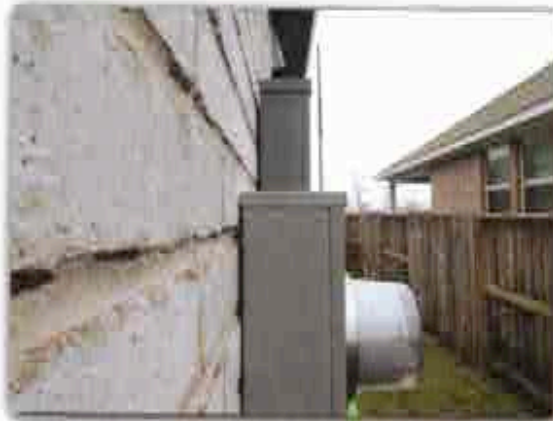
The electric meter and service panels are not properly weather-sealed/caulked on the exterior wall.

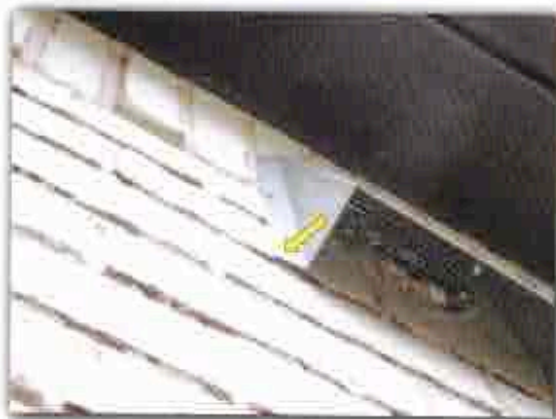
The vent is not sealed to the wall.

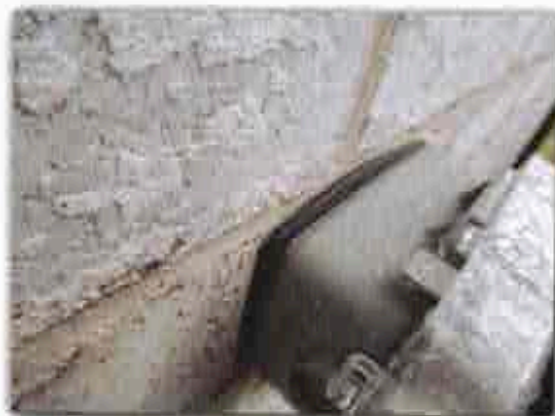
The exterior outlets are weather sealed but not caulked.

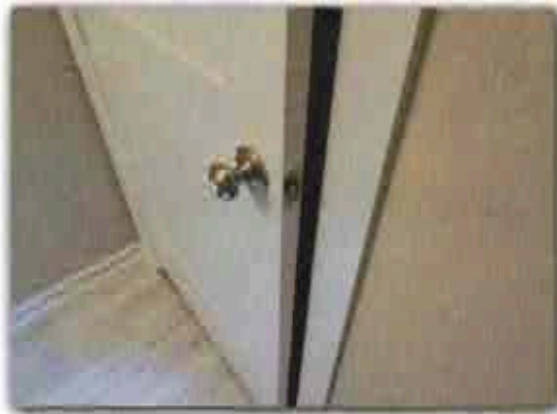
The bathroom door at the left side does not latch properly.

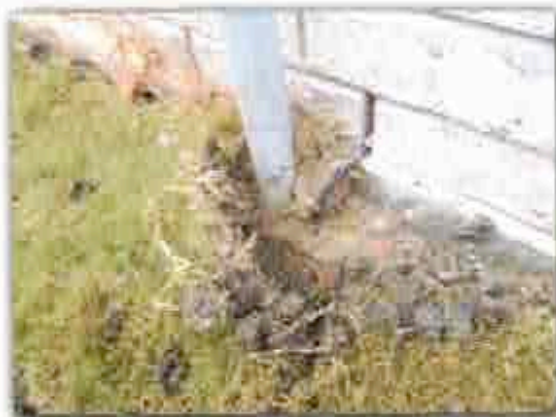
NOTE: The ground rod and wire are buried in the soil. I cannot determine if the proper clamp has been used or if it is appropriately rated for direct burial. I cannot determine if the wire is properly secured to the rod.

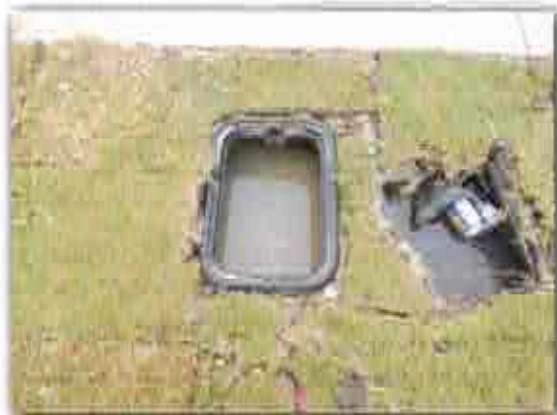
The water meter is full of water and was not visible / accessible for inspection.

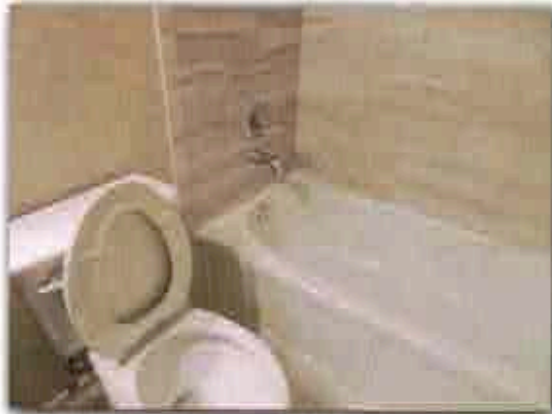
Bath 4: (Right side hall)

Tub plumbing connections are required to be readily accessible. There is no immediate access opening installed. The water supply and drain connections could not be inspected in this area.

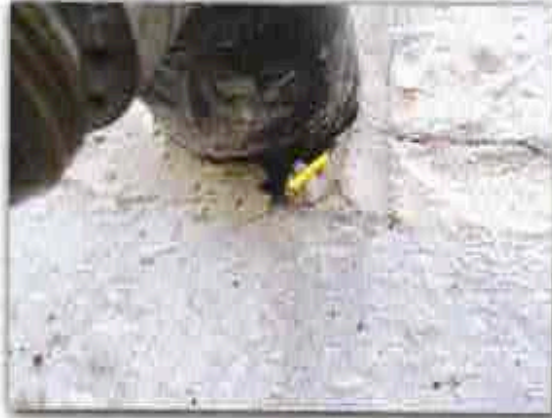
There is a gap in the mortar under the right side spigot.
