Inspection for Property located at 20960 Young Meadows Way
05/20/2020
Prepared for : Donna Dukes

PROPERTY INSPECTION REPORT

Concerning: 20960 Young Meadows Way, Katy, TX 77449
(Address or Other Identification of Inspected Property)

By: Robert Hughes, Lic #20949 TPCL 787224 05/20/2020
(Name and License Number of Inspector) (Date)
Anthony Hughes Lic #21356
(Name and License Number of Inspector)
Gregory Hughes Lic #22420
(Name and License Number of Inspector)

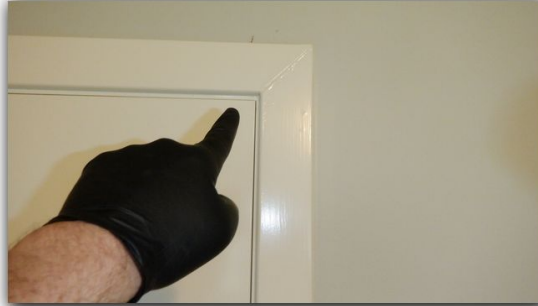
Comments: Some doors rub frame/not square.

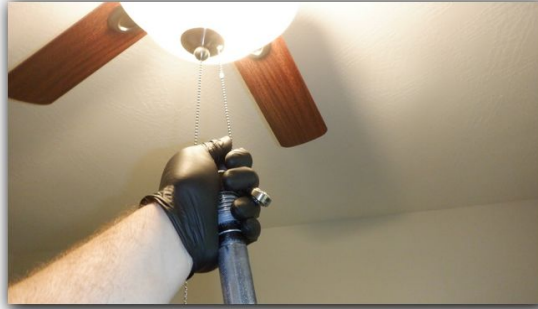
Fan not operational.

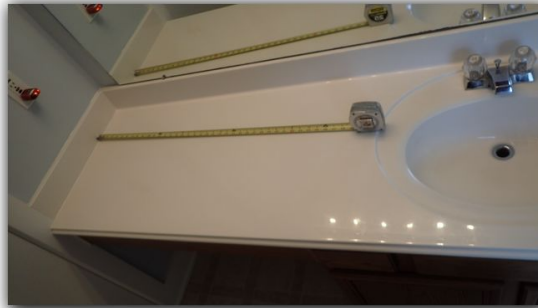
There should be at least one GFCI outlet within 36 inches of the lavatory in each bath.

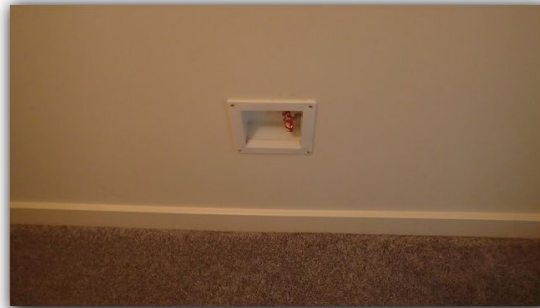
Comments: Kitchen faucet line is frayed.

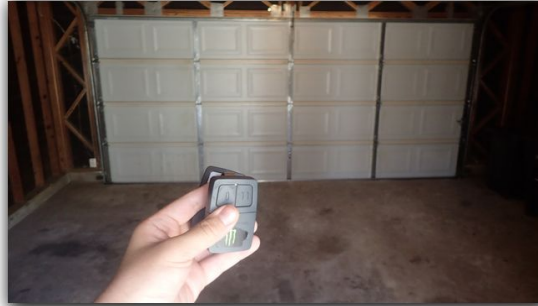
Comments: Garage door remote operators were not functional at the time of inspection.

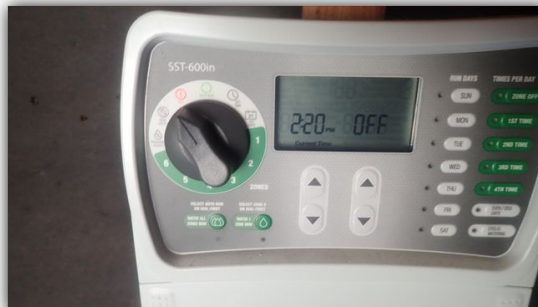
Comments: The sprinkler controller was off at the time of inspection. We turned the controller on for testing and then returned it to off before the inspection was completed.

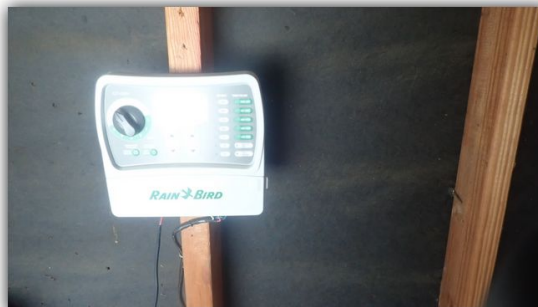
Sprinkler stations/zones were not labeled or listed.

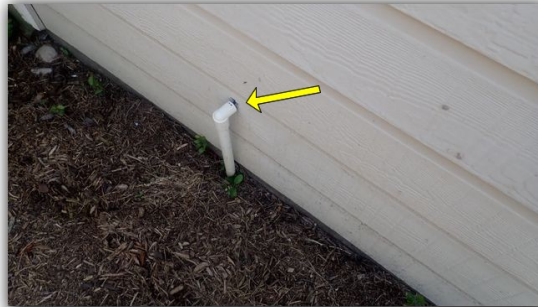
The conduit for the irrigation control wiring should be painted to protect it from UV radiation. It should also be caulked/sealed where it penetrates the wall.
